Coburg Police Dept

Lane_pol05A

FEMA 154 Rapid Visual Screening Score Card

Rapid Visual Screening - Senate Bill #2 - Seismic Needs Assessment
Oregon Department of Geology and Mineral Industries

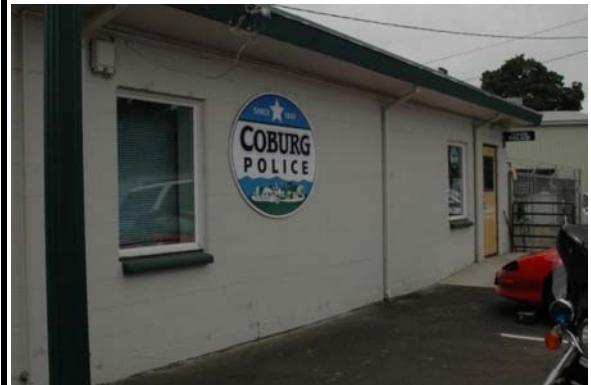
Type	Basic Score	Vert Irreg	Plan Irreg	Pre-Code	Post-Bench	Soil C	Soil D	Soil E	RVS Score
Primary	RM1	2.8	0	-0.5	0	0	0	-0.6	0	1.7
Secondary		0	0	0	0	0	0	0	0	0
Tertiary		0	0	0	0	0	0	0	0	0

Final Type	Final Score
RM1	1.7

Moderate (>1%)

Enrollment	Year Built (Field Verified)	Year Built (Alt. Source)	Est. Decade Built
			1960
Total Area (square ft)	Number of Stories	Basement	Pounding Potential
	1	No	No
Plan Irregularities		Vertical Irregularities	
Reentrant Corners: L Shaped		None	
None		None	
None		None	
Falling Hazards		Poor Conditions	
None		None	
None		None	
None		None
