Oregon State Police

Building Type Police - State	County Lane	
Street 76389 Fish Hatchery Rd		
City Oakridge	State OR	Zip 97463
Latitude 43.74274	Longitude 122.44472	
Tracking Code RVS in 2006	Inspection Date 7/20/2006

FEMA 154 Rapid Visual Screening Score Card

Rapid Visual Screening - Senate Bill #2 - Seismic Needs Assessment
Oregon Department of Geology and Mineral Industries

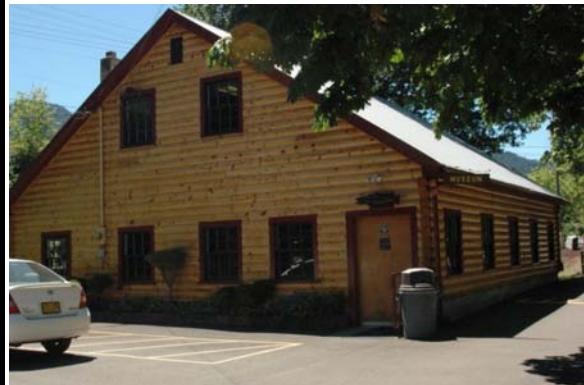
N Other the first floor is the museum for the fish hatchery -- there is a small room above for the state police. Note OSP emblem on door.
