Pleasant Hill High School

Lane_sch01A

FEMA 154 Rapid Visual Screening Score Card

Rapid Visual Screening - Senate Bill #2 - Seismic Needs Assessment
Oregon Department of Geology and Mineral Industries

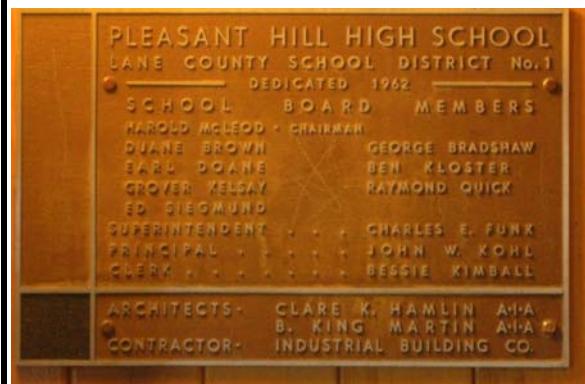
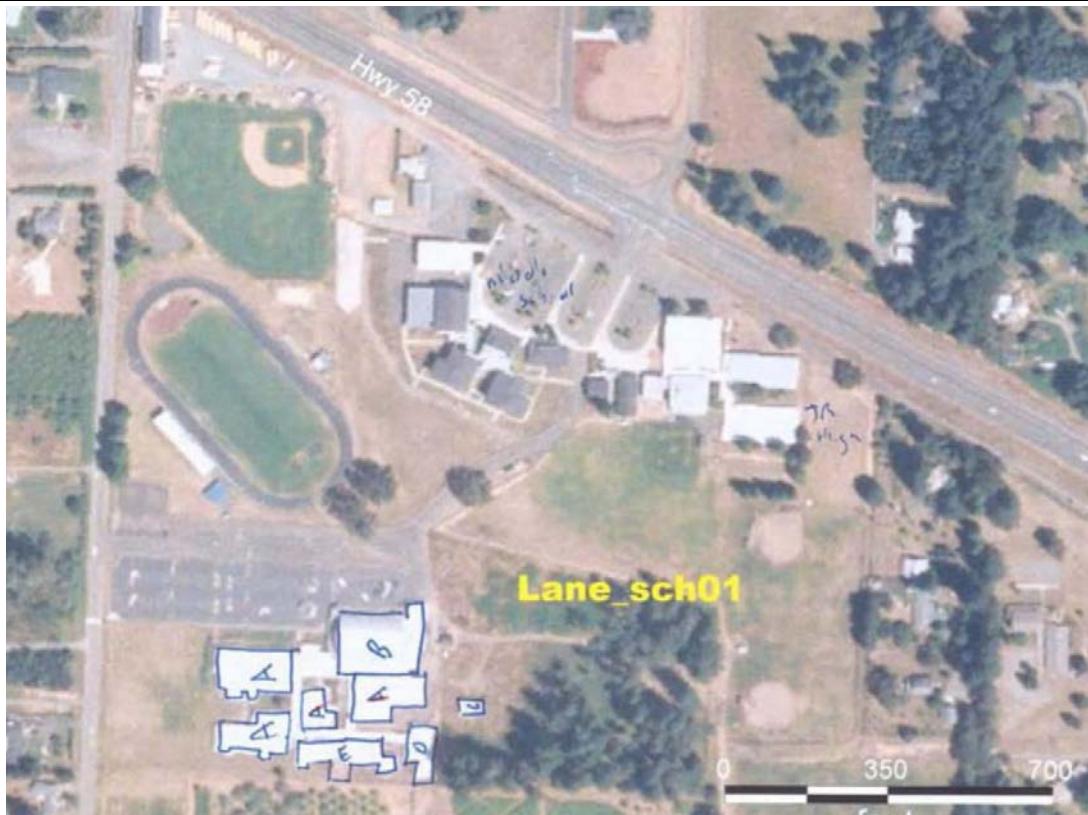
Final Type	Final Score
RM1	-0.1

Very High (100%)

Enrollment 387	Year Built (Field Verified) 1962	Year Built (Alt. Source) 1962	Est. Decade Built 1960
Total Area (square ft) 80180	Number of Stories 1	Basement	Pounding Potential No
Plan Irregularities Reentrant Corners: Other None None		Vertical Irregularities Steps in Elevation View: 2 to 3 Changes None None	
Falling Hazards None None None		Poor Conditions None None None

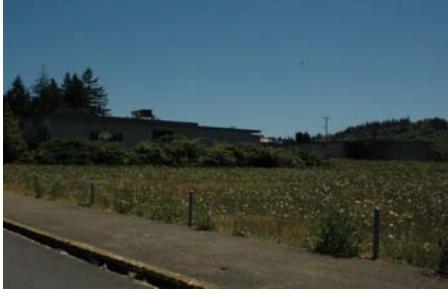
W General Site

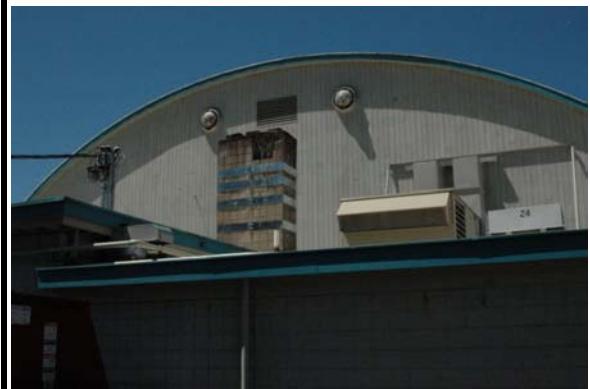
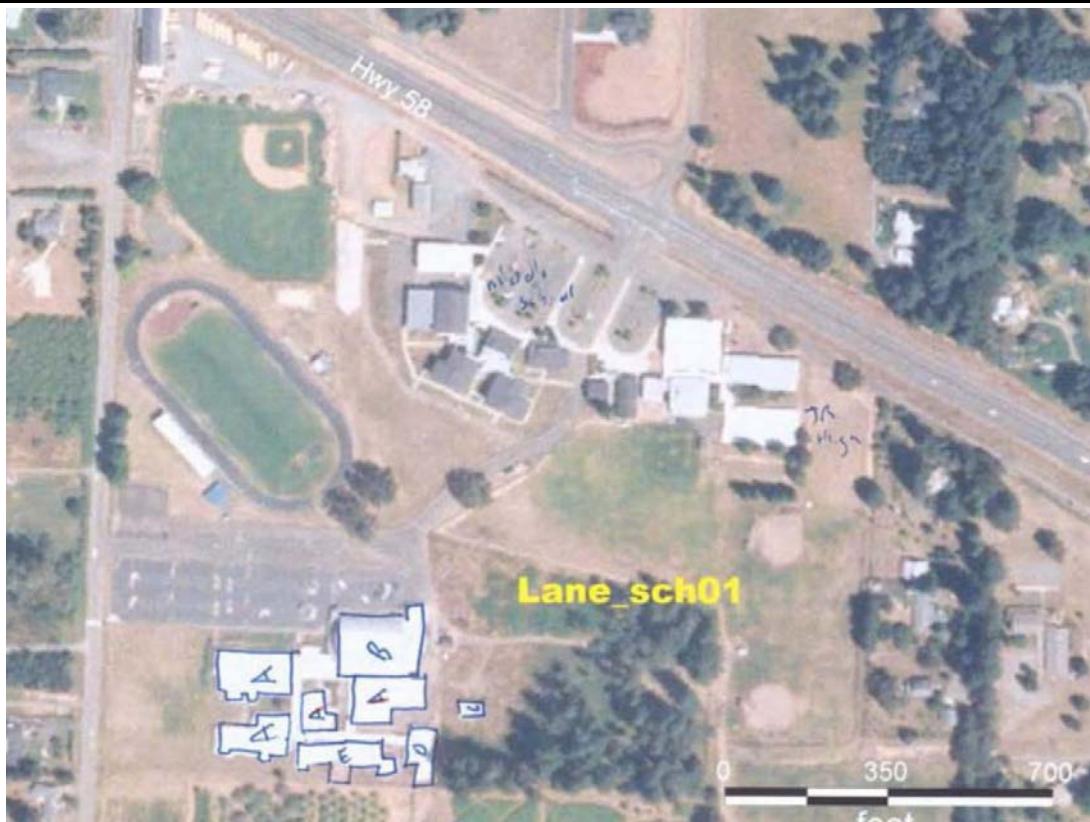
Lane_sch01B

Final Type RM1	Final Score 0.4
-------------------	--------------------

High (>10%)

Enrollment 387	Year Built (Field Verified) 1962	Year Built (Alt. Source) 1962	Est. Decade Built 1960
Total Area (square ft) 80180	Number of Stories 1	Basement	Pounding Potential No
Plan Irregularities Reentrant Corners: Other None None		Vertical Irregularities Steps in Elevation View: 2 to 3 Changes None None	
Falling Hazards Unreinforced Chimneys None None		Poor Conditions None None None

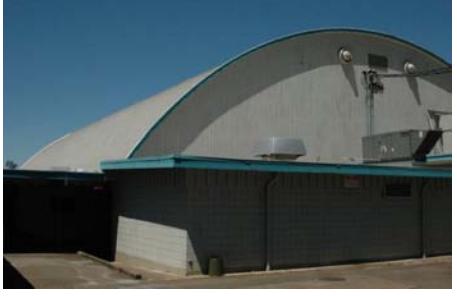
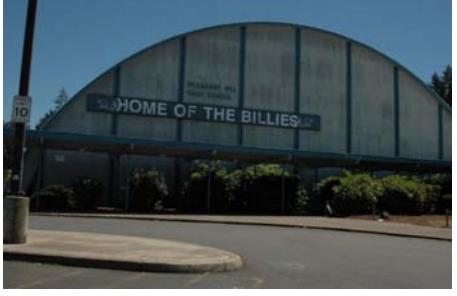
SE General Site W General Site NW Other connection between arch and ground

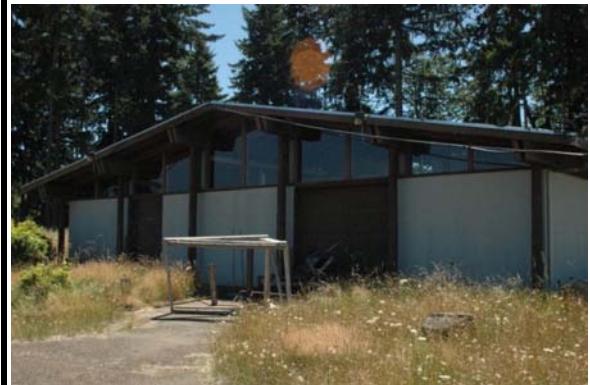
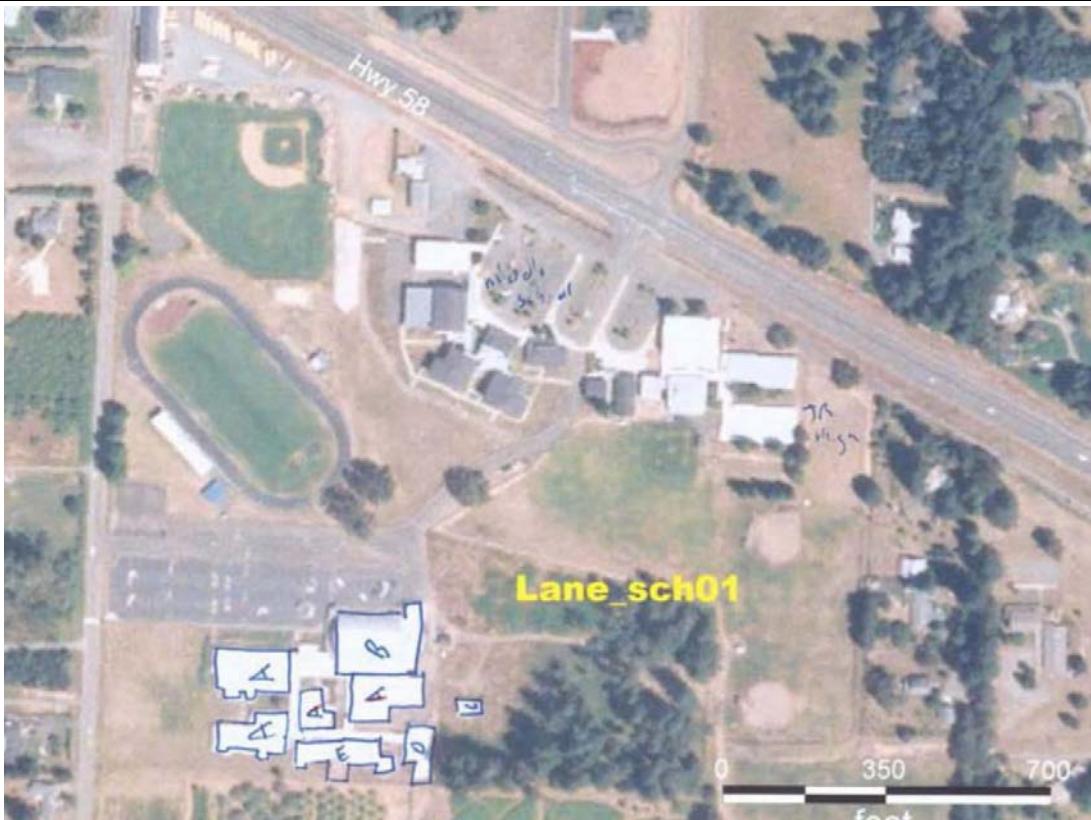
Lane_sch01C

Final Type	Final Score
W1	6.2

Low (<1%)

Enrollment 387	Year Built (Field Verified) 1962	Year Built (Alt. Source) 1962	Est. Decade Built 1980
Total Area (square ft) 80180	Number of Stories 1	Basement	Pounding Potential No
Plan Irregularities None None None		Vertical Irregularities None None None	
Falling Hazards None None None		Poor Conditions None None None

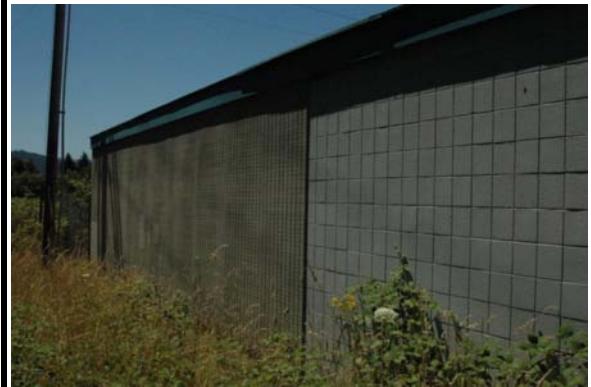
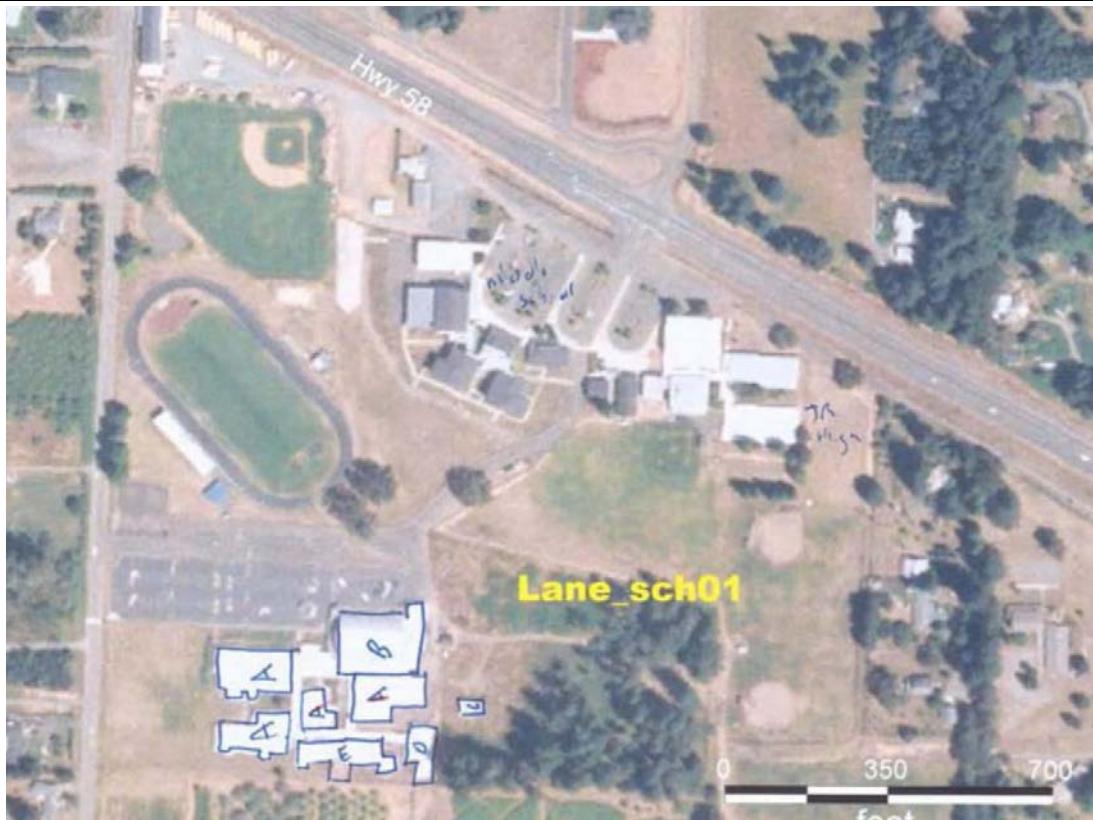
Lane_sch01D

Final Type	Final Score
RM1	1.9

Moderate (>1%)

Enrollment 387	Year Built (Field Verified) 1962	Year Built (Alt. Source) 1962	Est. Decade Built 1960
Total Area (square ft) 80180	Number of Stories 1	Basement	Pounding Potential No
Plan Irregularities Reentrant Corners: L Shaped None None		Vertical Irregularities None None None	
Falling Hazards None None None		Poor Conditions None None None

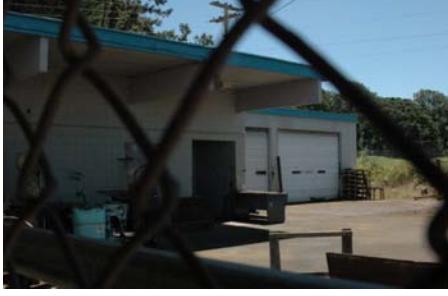
W Plan Irregularity Primary

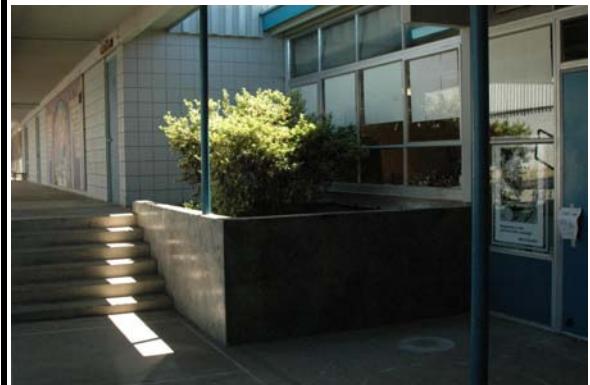
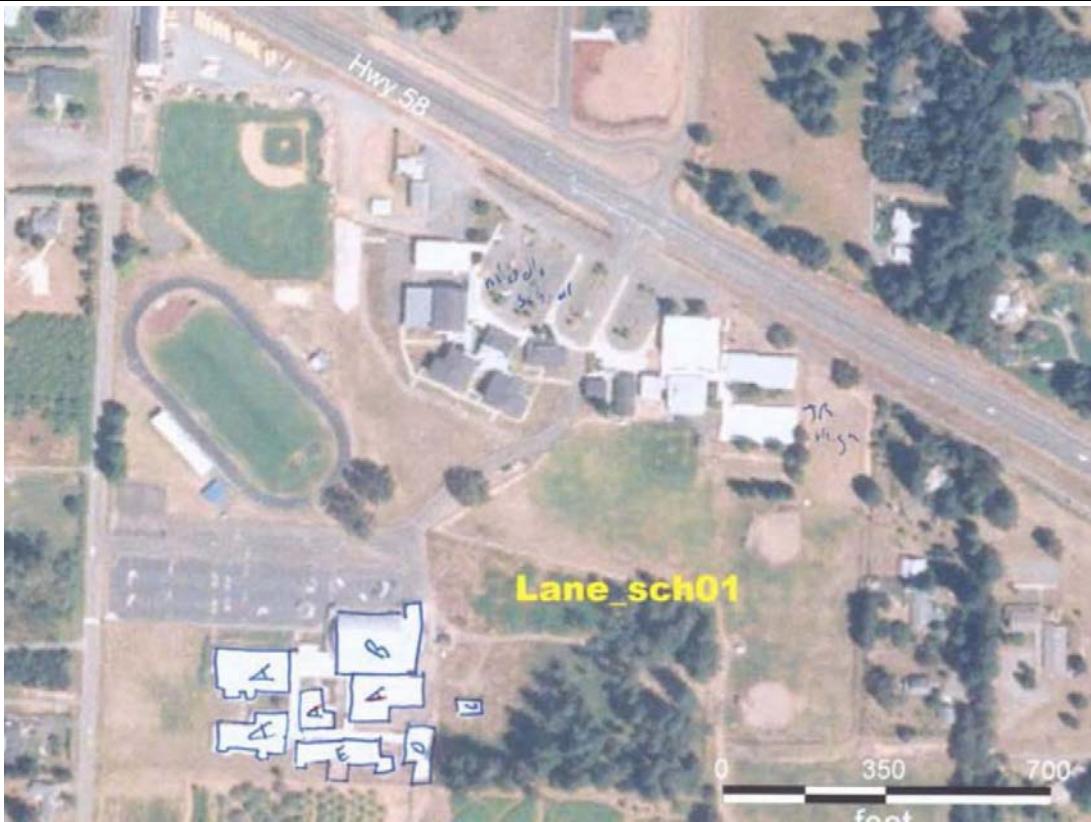
Lane_sch01E

RM1

-0.1

Very High (100%)

Enrollment 387	Year Built (Field Verified) 1962	Year Built (Alt. Source) 1962	Est. Decade Built 1960
Total Area (square ft) 	Number of Stories 1	Basement No	Pounding Potential No
Plan Irregularities Reentrant Corners: Other None None		Vertical Irregularities Steps in Elevation View: 2 to 3 Changes Building On Hill or Sloped Site None	
Falling Hazards None None None		Poor Conditions None None None

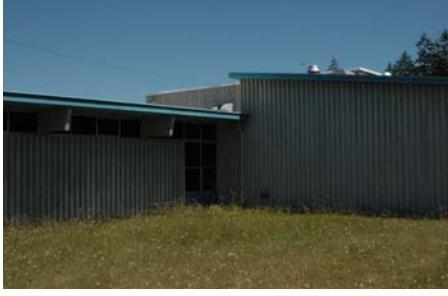
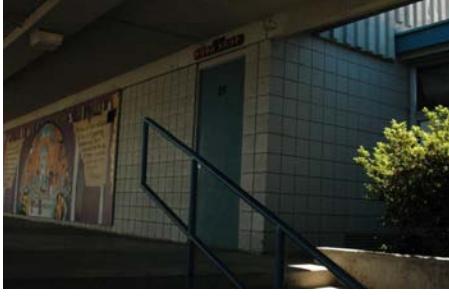
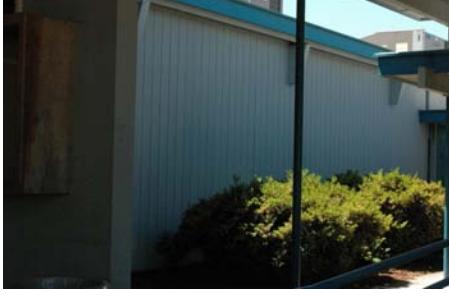
SE Plan Irregularity Primary step in elevation	W Secondary Structural Type	W General Site
