Twin Oaks Elementary School

Eugene SD 4J

Lane_sch22A

Rapid Visual Screening - Senate Bill #2 - Seismic Needs Assessment
Oregon Department of Geology and Mineral Industries

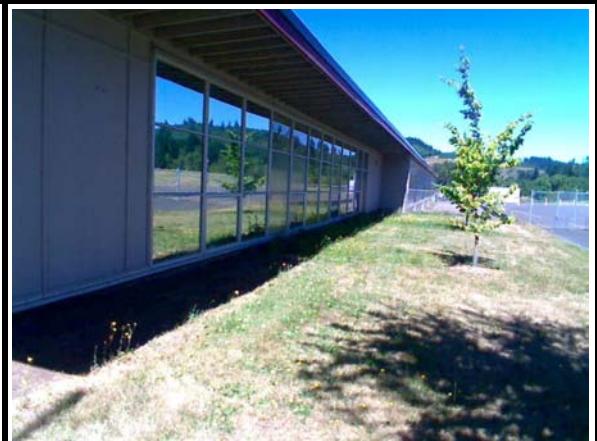
Seismicity Zone: High

Type	Basic Score	Vert Irreg	Plan Irreg	Pre-Code	Post-Bench	Soil C	Soil D	Soil E	RVS Score
Primary	RM1	2.8	-1	-0.5	0	0	-0.4	0	0	0.9
Secondary	W2	3.8	-2	-0.5	0	0	-0.4	0	0	0.9
Tertiary		0	0	0	0	0	0	0	0	0

Final Type	Final Score
RM1	0.9

High (>10%)

Enrollment 252	Year Built (Field Verified) 1958	Year Built (Alt. Source) 1958	Est. Decade Built 1950
Total Area (square ft) 33910	Number of Stories 2	Basement	Pounding Potential No
Plan Irregularities		Vertical Irregularities	
Reentrant Corners: Other		Steps in Elevation View: Very Irregular Changes	
Out of Plane Lateral-Force-Resistance Elements		Building On Hill or Sloped Site	
Torsion: Eccentric Stiffness		Steps in Elevation View: Single Change (Adjacent Building/Entity)	
Falling Hazards		Poor Conditions	
None		None	
None		None	
None		None	
W Plan Irregularity Primary steps in elevation	W Vertical Irregularity Primary	W Vertical Irregularity Secondary sloped site	
S Vertical Irregularity Tertiary shows building A on the right and B on the left.	E Plan Irregularity Primary	E Vertical Irregularity Primary	
NW Plan Irregularity Tertiary Approximately 100 ft of windows with no apparent lateral system indicating a potential torsion problem.

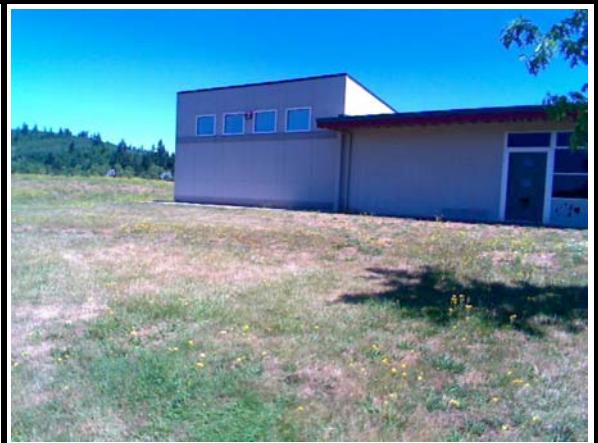
Lane_sch22B

Seismicity Zone: High

Type	Basic Score	Vert Irreg	Plan Irreg	Pre-Code	Post-Bench	Soil C	Soil D	Soil E	RVS Score
Primary	W1	4.4	-2.5	-0.5	0	2.4	0	0	0	3.8
Secondary		0	0	0	0	0	0	0	0	0
Tertiary		0	0	0	0	0	0	0	0	0

Enrollment 252	Year Built (Field Verified) 1958	Year Built (Alt. Source) 1958	Est. Decade Built 1990
Total Area (square ft) 33910	Number of Stories 1	Basement	Pounding Potential No
Plan Irregularities Reentrant Corners: Other Reentrant Corners: Other (Adjacent Build/Entity) None		Vertical Irregularities Steps in Elevation View: Single Change Steps in Elevation View: Single Change (Adjacent Building/Entity) None	
Falling Hazards None None None		Poor Conditions None None None

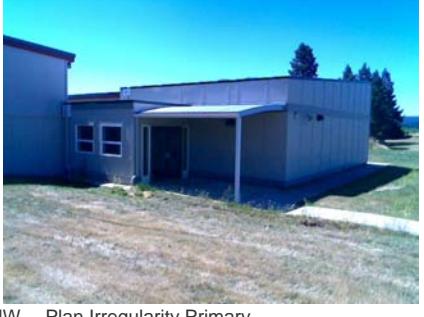
NW Plan Irregularity Primary Also shows a vertical irregularity.
