# Clear Lake Elementary School

Lane\_sch55A

## FEMA 154 Rapid Visual Screening Score Card

Rapid Visual Screening - Senate Bill #2 - Seismic Needs Assessment  
Oregon Department of Geology and Mineral Industries

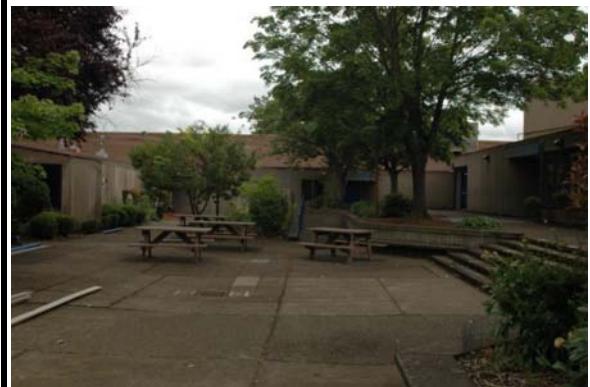
Type	Basic Score	Vert Irreg	Plan Irreg	Pre-Code	Post-Bench	Soil C	Soil D	Soil E	RVS Score
Primary	W2	3.8	0	-0.5	0	0	-0.4	0	0	2.9
Secondary		0	0	0	0	0	0	0	0	0
Tertiary		0	0	0	0	0	0	0	0	0

Final Type	Final Score
W2	2.9

Low (<1%)

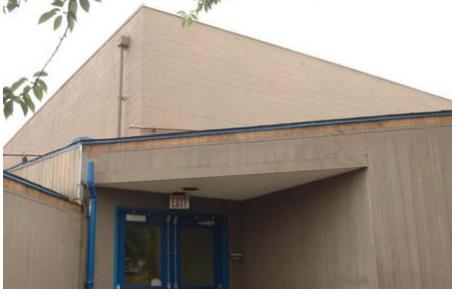
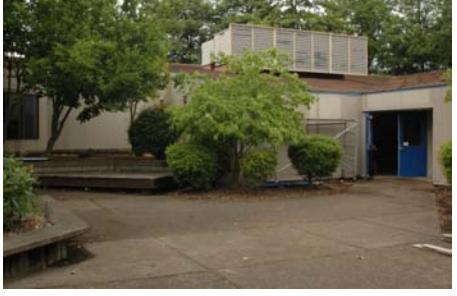
NW Vertical Irregularity Tertiary		SW Vertical Irregularity Primary Minor sloped site.	
		SW Plan Irregularity Secondary

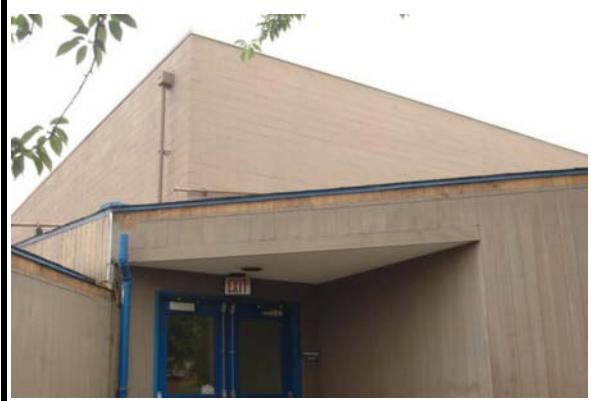
Type	Basic Score	Vert Irreg	Plan Irreg	Pre-Code	Post-Bench	Soil C	Soil D	Soil E	RVS Score
Primary	RM1	2.8	-1	-0.5	0	0	0	0	0	1.3
Secondary		0	0	0	0	0	0	0	0	0
Tertiary		0	0	0	0	0	0	0	0	0

Final Type	Final Score
RM1	1.3

Moderate (>1%)

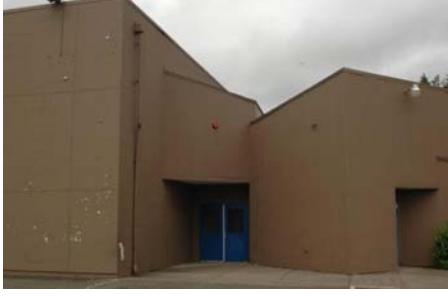
S Vertical Irregularity Primary Due to adjacent building, building A is in the right and building B is on the left.		E Primary Structural Type
