Oakridge Elementary School

Lane_sch65A

FEMA 154 Rapid Visual Screening Score Card

Rapid Visual Screening - Senate Bill #2 - Seismic Needs Assessment
Oregon Department of Geology and Mineral Industries

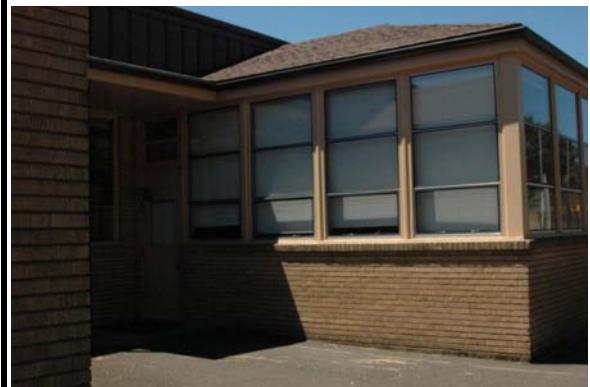
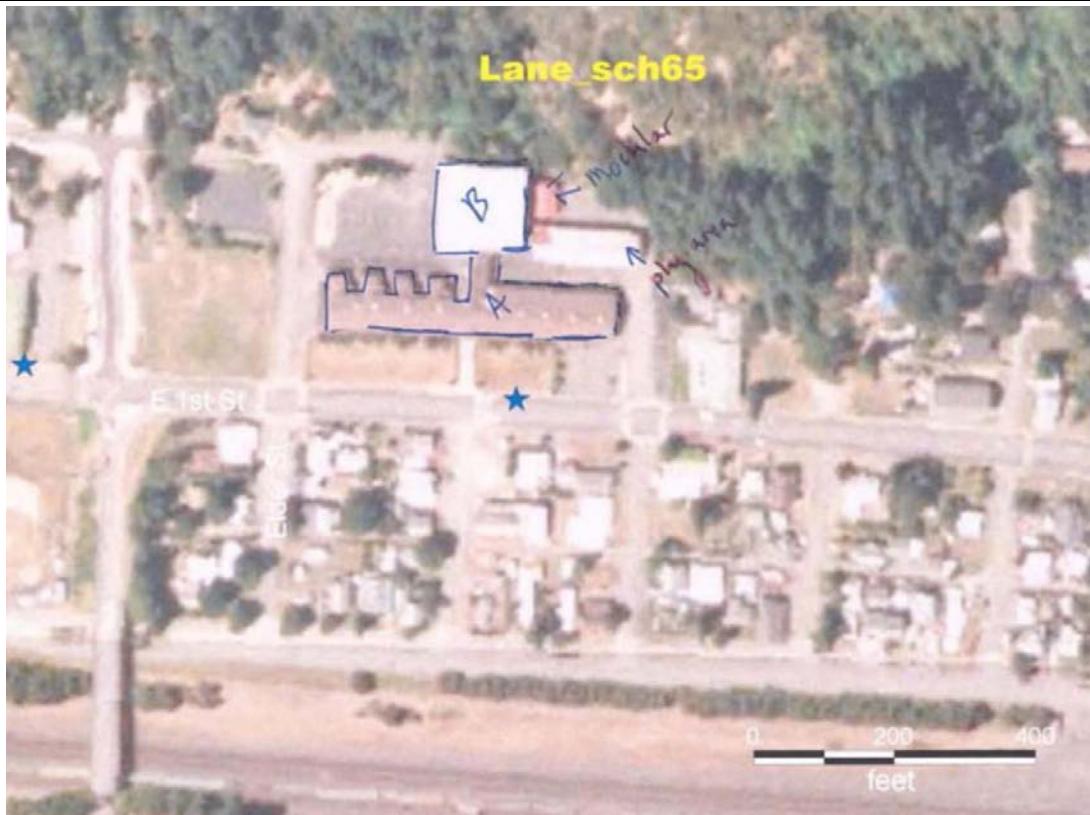
Type	Basic Score	Vert Irreg	Plan Irreg	Pre-Code	Post-Bench	Soil C	Soil D	Soil E	RVS Score
Primary	W2	4.8	-3	-0.5	0	0	-0.8	0	0	0.5
Secondary	RM1	3.6	-2	-0.5	0	0	-0.8	0	0	0.3
Tertiary		0	0	0	0	0	0	0	0	0

Final Type RM1	Final Score 0.3
-------------------	--------------------

High (>10%)

Enrollment 270	Year Built (Field Verified) 1948	Year Built (Alt. Source) 1948	Est. Decade Built 1960
Total Area (square ft) 48960	Number of Stories 1	Basement	Pounding Potential No
Plan Irregularities Reentrant Corners: Other None None		Vertical Irregularities Steps in Elevation View: Single Change (Adjacent Building/Entity) None None	
Falling Hazards None None None		Poor Conditions None None None

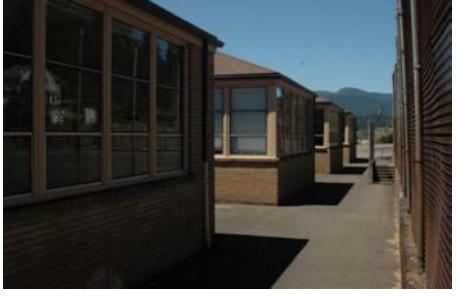
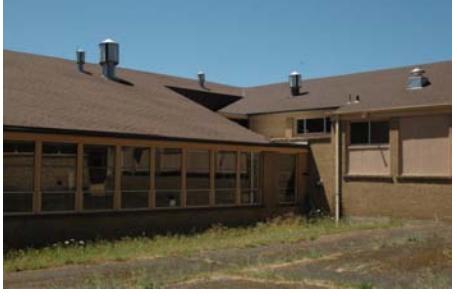
NE Plan Irregularity Primary		S General Site	
		S General Site

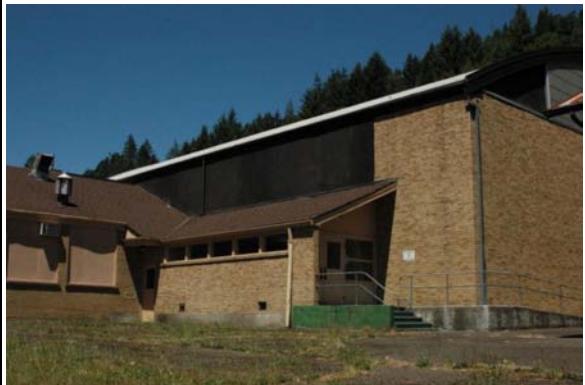
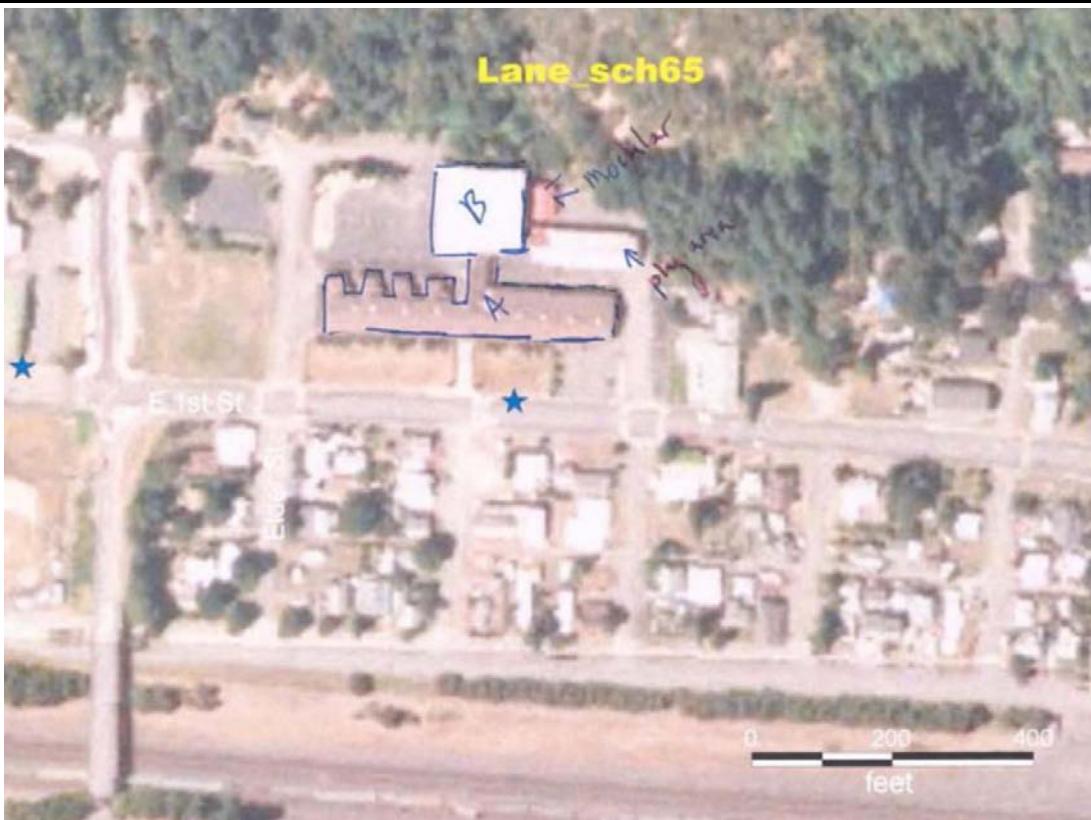
Lane_sch65B

Type	Basic Score	Vert Irreg	Plan Irreg	Pre-Code	Post-Bench	Soil C	Soil D	Soil E	RVS Score
Primary	W2	4.8	0	-0.5	0	0	-0.8	0	0	3.5
Secondary	RM1	3.6	0	-0.5	0	0	-0.8	0	0	2.3
Tertiary		0	0	0	0	0	0	0	0	0

Final Type	Final Score
RM1	2.3

Low (<1%)

Enrollment 270	Year Built (Field Verified) 1948	Year Built (Alt. Source) 1948	Est. Decade Built 1960
Total Area (square ft) 48960	Number of Stories 1	Basement	Pounding Potential No
Plan Irregularities Reentrant Corners:T shaped (Adjacent Build/Entity) None None		Vertical Irregularities None None None	
Falling Hazards None None Other: Brick Veneer		Poor Conditions None None None
