# Seal Rock RFPD

Building Type Fire - RFPD	County Lincoln	
Street 10333 NW Rand St		
City Seal Rock	State OR	Zip 97376
Latitude 44.49926	Longitude 124.08131	
Tracking Code RVS in 2006	Inspection Date 8/12/2006

### FEMA 154 Rapid Visual Screening Score Card

Rapid Visual Screening - Senate Bill #2 - Seismic Needs Assessment  
Oregon Department of Geology and Mineral Industries

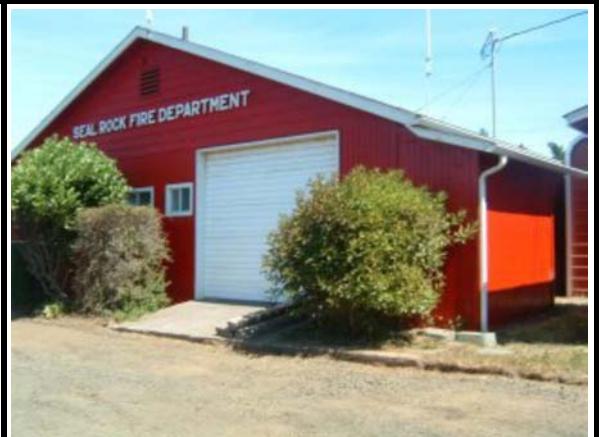
Seismicity Zone: Very High

Type	Basic Score	Vert Irreg	Plan Irreg	Pre-Code	Post-Bench	Soil C	Soil D	Soil E	RVS Score
Primary	W1	4.4	0	0	0	0	0	0	0	4.4
Secondary		0	0	0	0	0	0	0	0	0
Tertiary		0	0	0	0	0	0	0	0	0

Final Type	Final Score
W1	4.4

Low (<1%)

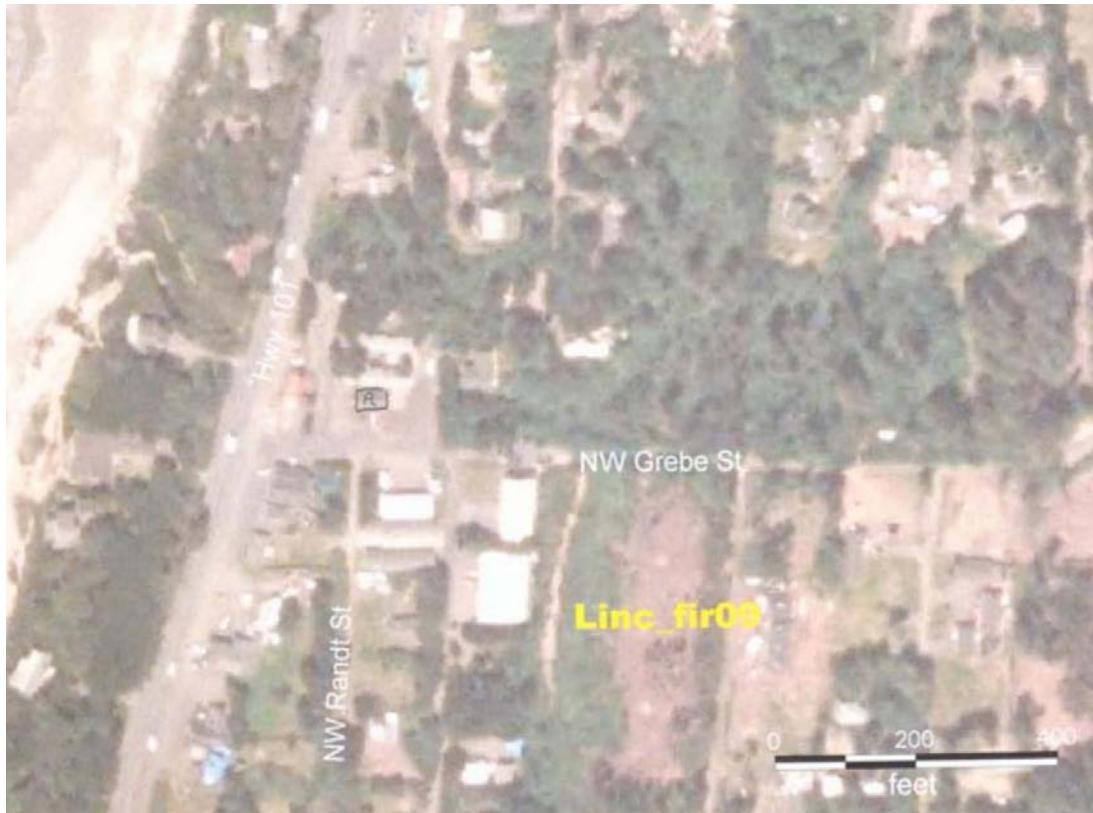
Enrollment	Year Built (Field Verified)	Year Built (Alt. Source)	Est. Decade Built
			1950
Total Area (square ft)	Number of Stories	Basement	Pounding Potential
	1	No	No
Plan Irregularities		Vertical Irregularities	
Out of Plane Lateral-Force-Resistance Elements		None	
Torsion: Eccentric Stiffness		None	
None		None	
Falling Hazards		Poor Conditions	
None		None	
None		None	
None		None

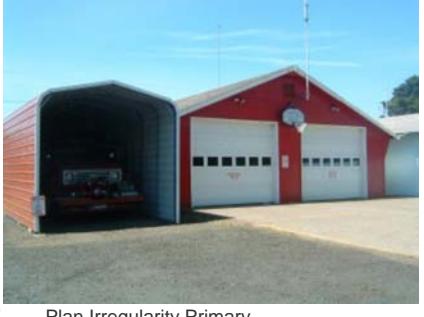
E Plan Irregularity Primary
