Brownsville Rural Fire Dist #61

Linn_fir10A

Building Type Fire - RFPD	County Linn	
Street 255 N Main St.		
City Brownsville	State OR	Zip 97327
Latitude 44.39312	Longitude 122.98472	
Tracking Code RVS in 2006	Inspection Date 7/7/2006

FEMA 154 Rapid Visual Screening Score Card

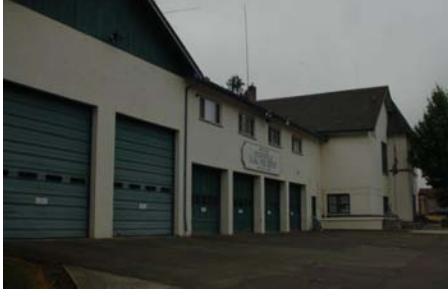
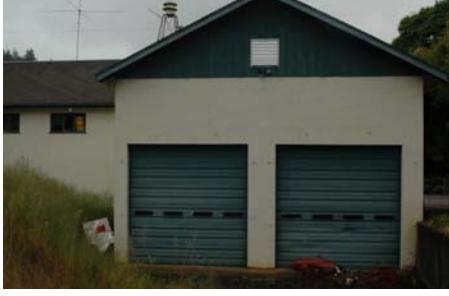
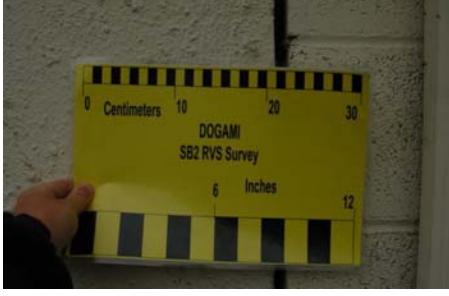
SE Plan Irregularity Primary	W General Site	W Other	
		Pounding potential -- building are separate -- and are separate structural types.

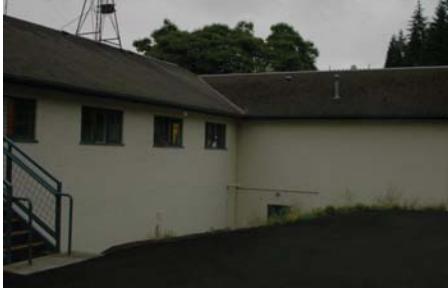
NE Plan Irregularity Primary
