# Mill City Fire Department

Linn\_fir13A

## FEMA 154 Rapid Visual Screening Score Card

Rapid Visual Screening - Senate Bill #2 - Seismic Needs Assessment  
Oregon Department of Geology and Mineral Industries

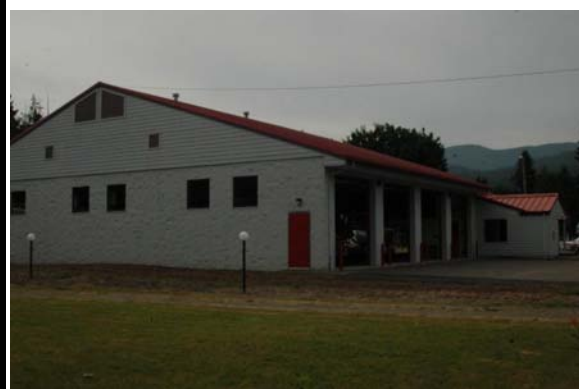
Seismicity Zone: Moderate

Type	Basic Score	Vert Irreg	Plan Irreg	Pre-Code	Post-Bench	Soil C	Soil D	Soil E	RVS Score
Primary	RM1	3.6	-2	-0.5	0	0	0	-1.2	0	-0.1
Secondary		0	0	0	0	0	0	0	0	0
Tertiary		0	0	0	0	0	0	0	0	0

-0.1

Very High (100%)

Plan Irregularities	Vertical Irregularities
Reentrant Corners: Other (Adjacent Build/Entity)	Steps in Elevation View: Single Change
None	None
None	None

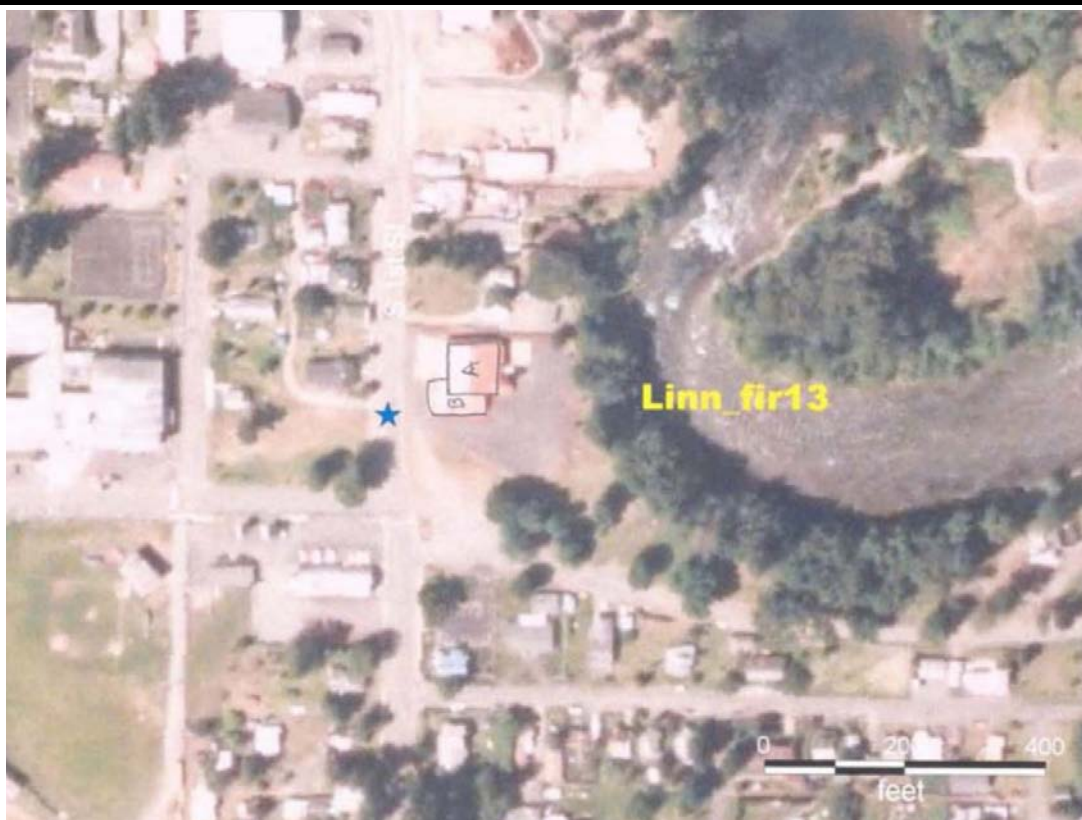
SE Vertical Irregularity Primary

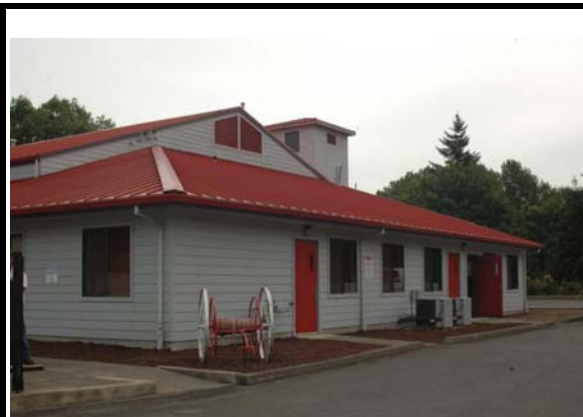
Linn\_fir13B

Seismicity Zone: Moderate

Type	Basic Score	Vert Irreg	Plan Irreg	Pre-Code	Post-Bench	Soil C	Soil D	Soil E	RVS Score
Primary	W1	5.2	-3.5	-0.5	0	1.6	0	-0.6	0	2.2
Secondary		0	0	0	0	0	0	0	0	0
Tertiary		0	0	0	0	0	0	0	0	0

2.2

Low (<1%)

Plan Irregularities	Vertical Irregularities
Reentrant Corners:Other (Adjacent Build/Entity)	Steps in Elevation View: Single Change (Adjacent Building/Entity)
None	None
None	None

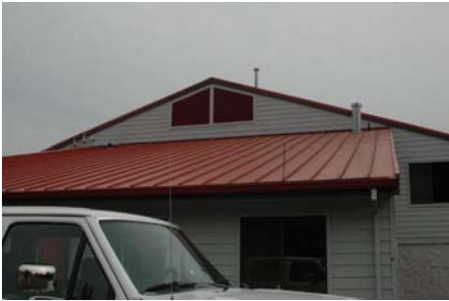
S Vertical Irregularity Primary  
reentrant corner
