Linn County Sheriff's Office

FEMA 154 Rapid Visual Screening Score Card

Rapid Visual Screening - Senate Bill #2 - Seismic Needs Assessment
Oregon Department of Geology and Mineral Industries

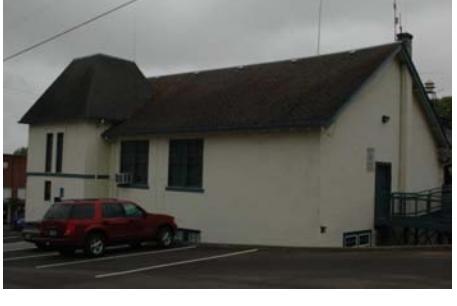
W Falling Hazard Right above door -- didn't look safe.	NW Plan Irregularity Tertiary	NW Vertical Irregularity Primary building on slope.
