Sweet Home Junior High School

Linn_sch18A

FEMA 154 Rapid Visual Screening Score Card

Rapid Visual Screening - Senate Bill #2 - Seismic Needs Assessment
Oregon Department of Geology and Mineral Industries

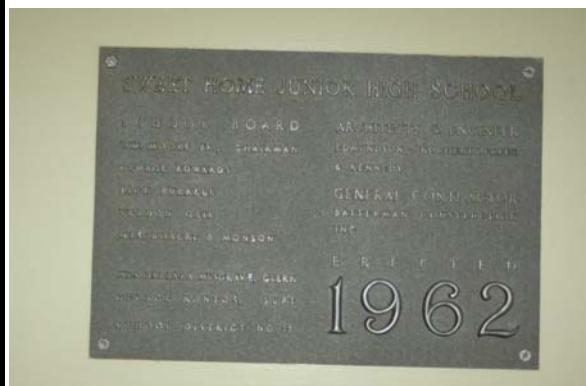
Final RVS Score

Final Type Final Score

S1 0.5

FEMA-154 Collapse Potential

High (>10%)

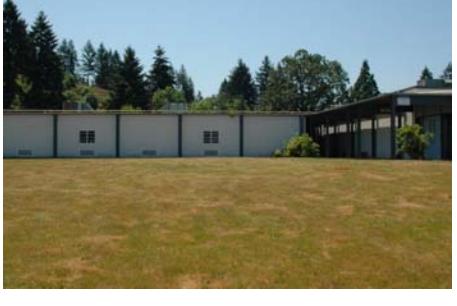
Enrollment 394	Year Built (Field Verified) 1962	Year Built (Alt. Source) 1962	Est. Decade Built 1960
Total Area (square ft) 53512	Number of Stories 1	Basement	Pounding Potential No
Plan Irregularities Reentrant Corners: U shaped		Vertical Irregularities Steps in Elevation View: Single Change (Adjacent Building/Entity)	
Reentrant Corners: Other		None	
Reentrant Corners: Other (Adjacent Build/Entity)		None	
Falling Hazards None		Poor Conditions None	
None		None	
None		None

S Primary Structural Type steel columns -- wood beams	N Plan Irregularity Primary		N General Site

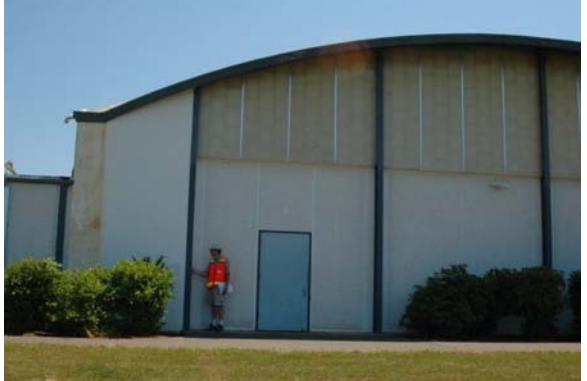
Linn_sch18B

Type	Basic Score	Vert Irreg	Plan Irreg	Pre-Code	Post-Bench	Soil C	Soil D	Soil E	RVS Score
Primary	C2	3.6	-2	-0.5	0	0	-0.8	0	0	0.3
Secondary	S4	3.6	-2	-0.5	0	0	-0.8	0	0	0.3
Tertiary		0	0	0	0	0	0	0	0	0

Final Type	Final Score
C2	0.3

FEMA-154 Collapse Potential

High (>10%)

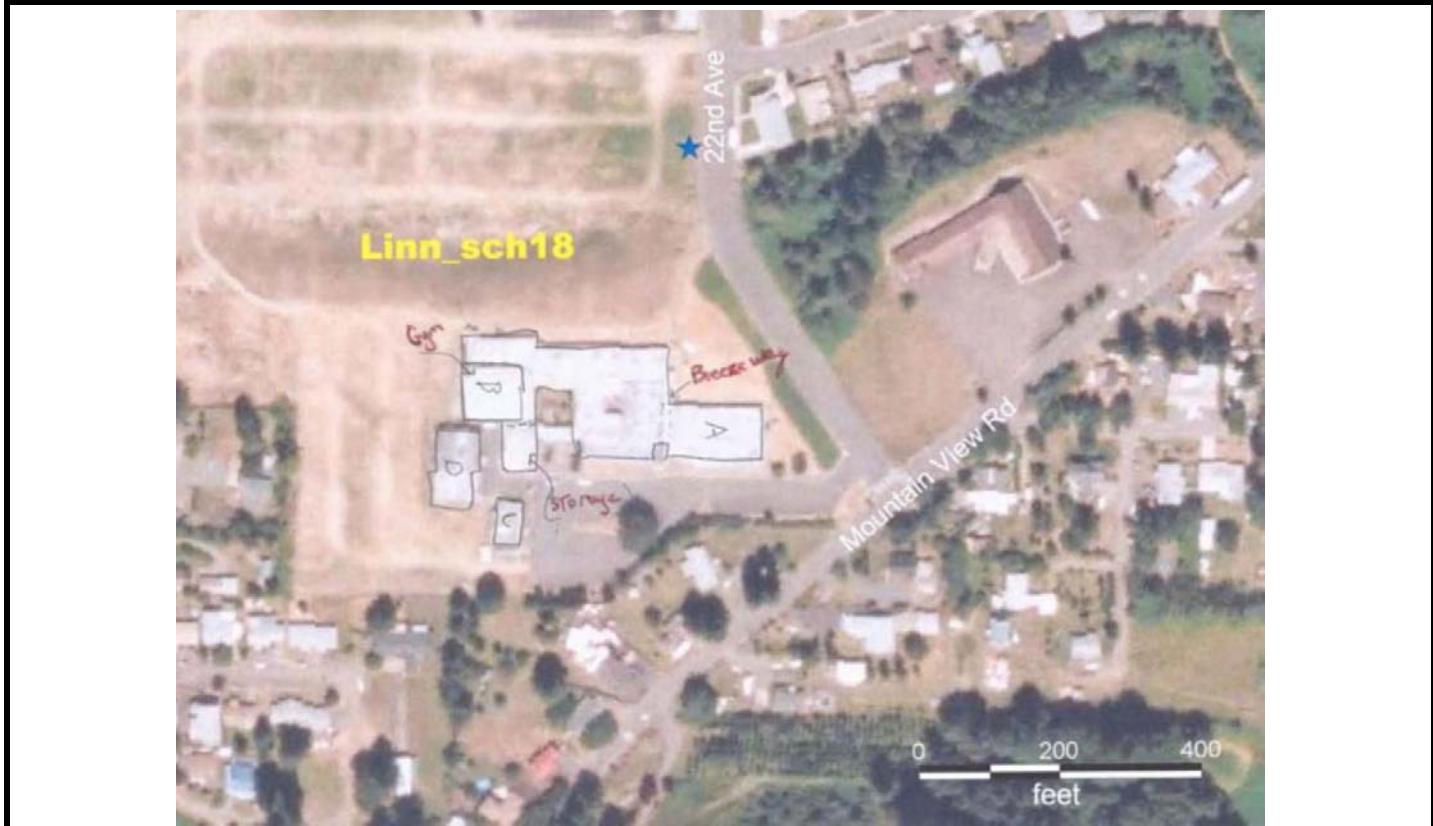
Final RVS Score

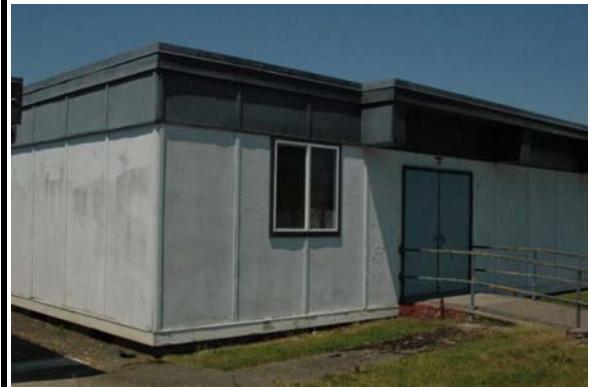
Linn_sch18C

Type	Basic Score	Vert Irreg	Plan Irreg	Pre-Code	Post-Bench	Soil C	Soil D	Soil E	RVS Score
Primary	W1	5.2	0	0	0	0	-0.2	0	0	5
Secondary		0	0	0	0	0	0	0	0	0
Tertiary		0	0	0	0	0	0	0	0	0

Final Type	Final Score
W1	5

FEMA-154 Collapse Potential

Low (<1%)

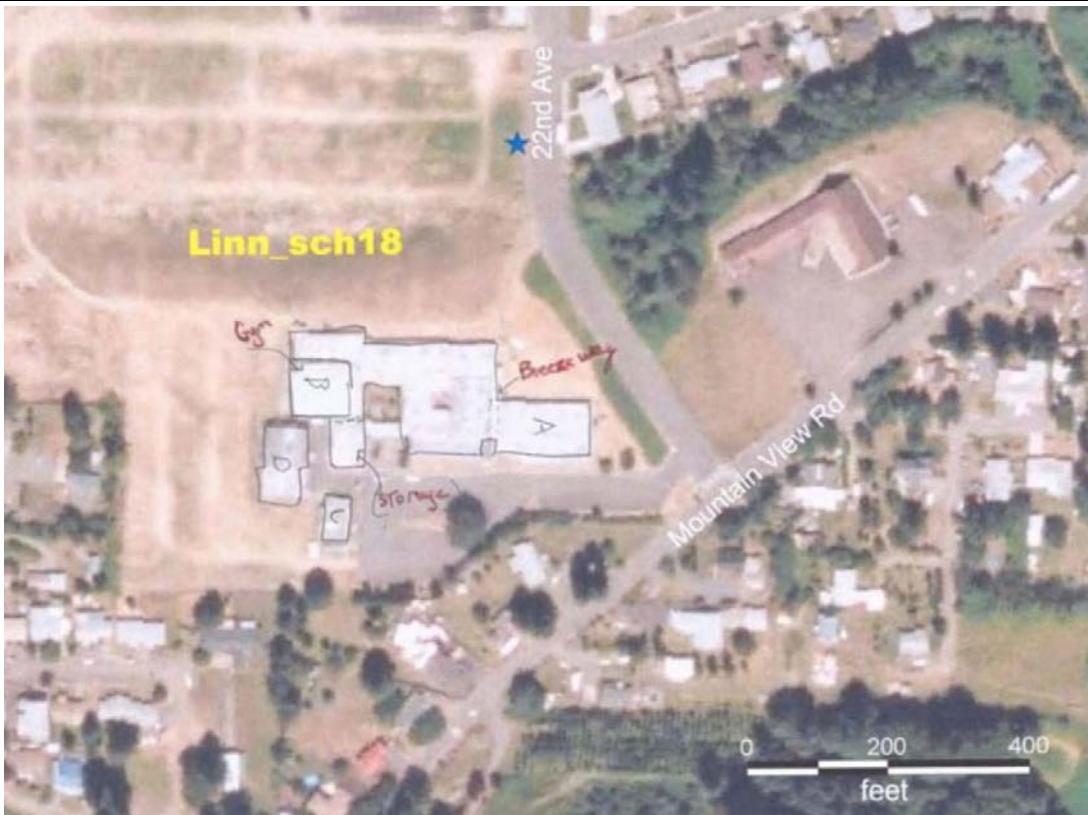
Final RVS Score

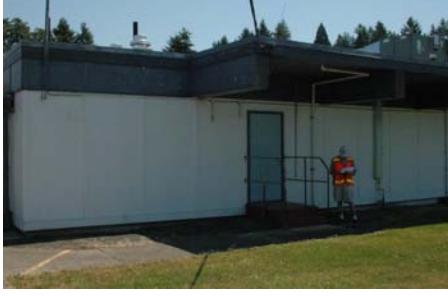
W General Site

Enrollment 394	Year Built (Field Verified) 1962	Year Built (Alt. Source) 1962	Est. Decade Built 1970
Total Area (square ft) 53512	Number of Stories 1	Basement	Pounding Potential No
Plan Irregularities None None None		Vertical Irregularities None None None	
Falling Hazards None None None		Poor Conditions None None None

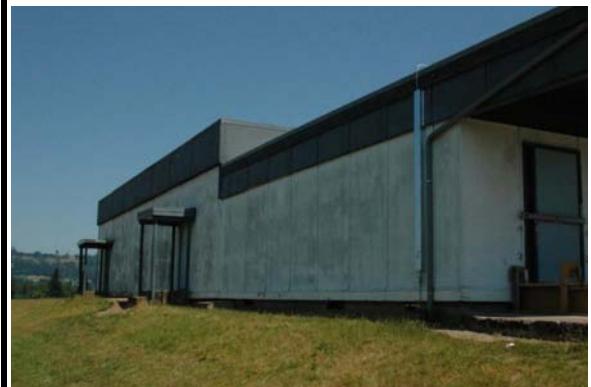
Linn_sch18D

Enrollment 394	Year Built (Field Verified) 1962	Year Built (Alt. Source) 1962	Est. Decade Built 1970
Total Area (square ft) 53512	Number of Stories 1	Basement	Pounding Potential No
Plan Irregularities Out of Plane Lateral-Force-Resistance Elements None None		Vertical Irregularities Steps in Elevation View: Single Change None None	
Falling Hazards None None None		Poor Conditions None None None

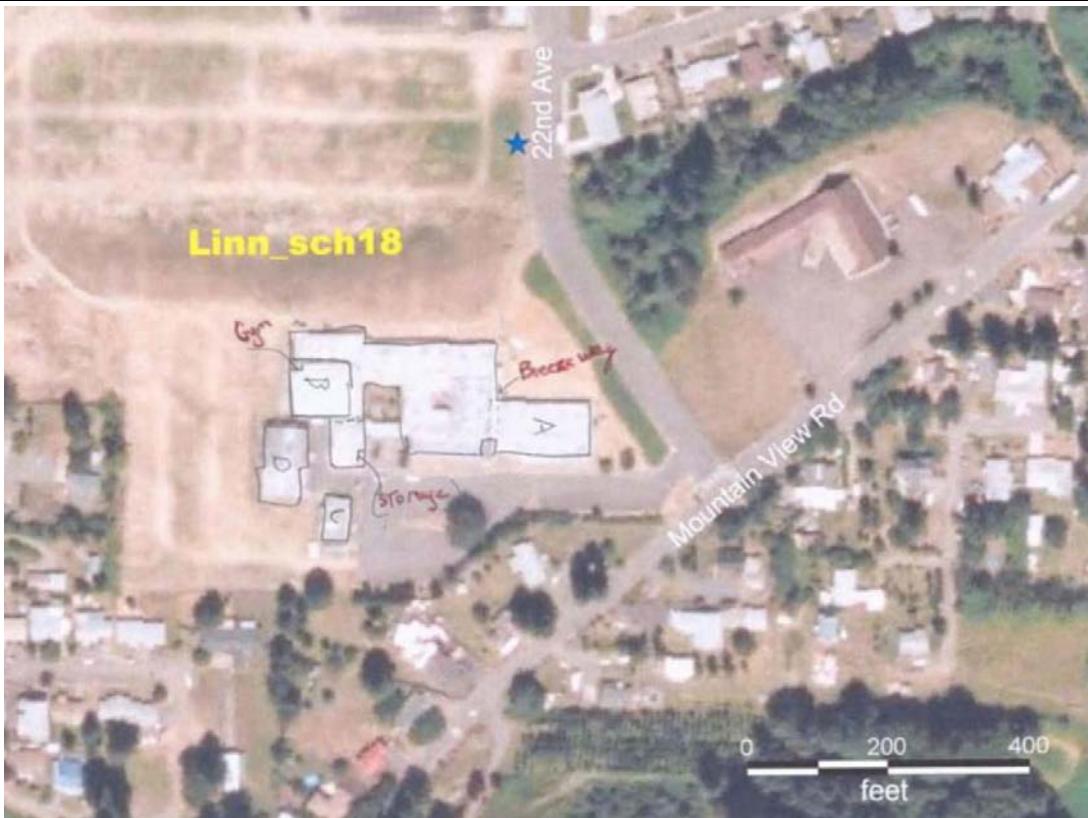
Type	Basic Score	Vert Irreg	Plan Irreg	Pre-Code	Post-Bench	Soil C	Soil D	Soil E	RVS Score
Primary	W2	4.8	-3	-0.5	0	0	-0.8	0	0	0.5
Secondary		0	0	0	0	0	0	0	0	0
Tertiary		0	0	0	0	0	0	0	0	0

Final RVS Score

Final Type	Final Score
W2	0.5

FEMA-154 Collapse Potential

High (>10%)

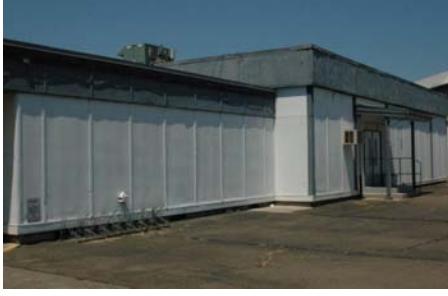
E Plan Irregularity Primary
