# Ontario Fire Department

City of Ontario

## FEMA 154 Rapid Visual Screening Score Card

Rapid Visual Screening - Senate Bill #2 - Seismic Needs Assessment  
Oregon Department of Geology and Mineral Industries

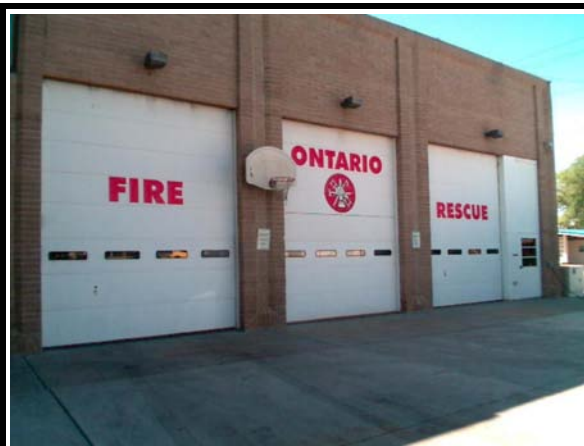
Seismicity Zone: Moderate

| | Type | Basic Score | Vert Irreg | Plan Irreg | Pre-Code | Post-Bench | Soil C | Soil D | Soil E | RVS Score |
| Primary | RM1 | 3.6 | -2 | 0 | 0 | 0 | 0 | 0 | -1.6 | 0 |

FEMA-154 Collapse Potential

Very High (100%)
