# Cairo Elementary School

Malh\_sch14A

## FEMA 154 Rapid Visual Screening Score Card

Rapid Visual Screening - Senate Bill #2 - Seismic Needs Assessment  
Oregon Department of Geology and Mineral Industries

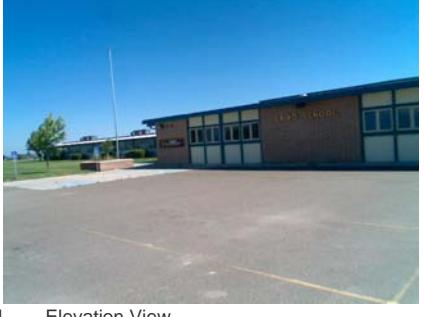
N Elevation View

Enrollment 151	Year Built (Field Verified) 1957	Year Built (Alt. Source) 1957	Est. Decade Built 1950
Total Area (square ft) 16888	Number of Stories 1	Basement	Pounding Potential No
Plan Irregularities Reentrant Corners: L Shaped None None		Vertical Irregularities None None None	
Falling Hazards Other: Brick Veneer None None		Poor Conditions None None None
