# Branch - Santiam Center (#104)

Chemeketa CC

## FEMA 154 Rapid Visual Screening Score Card

Rapid Visual Screening - Senate Bill #2 - Seismic Needs Assessment  
Oregon Department of Geology and Mineral Industries

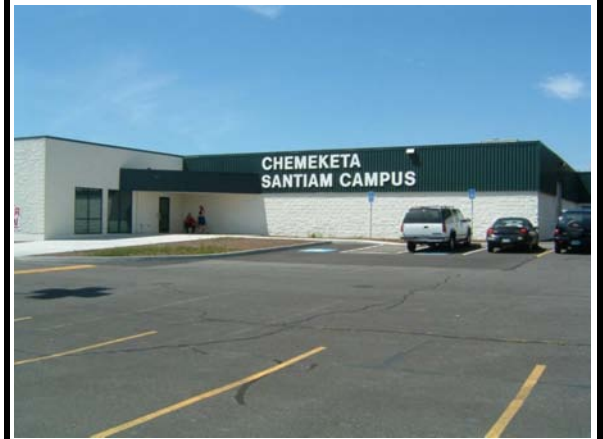
Seismicity Zone: Moderate

| | Type | Basic Score | Vert Irreg | Plan Irreg | Pre-Code | Post-Bench | Soil C | Soil D | Soil E | RVS Score |
|---|---|---|---|---|---|---|---|---|---|---|
| Primary | RM1 | 3.6 | -2 | -0.5 | 0 | 0 | -0.8 | 0 | 0 | 0.3 |

FEMA-154 Collapse Potential

High (>10%)
