# Woodburn Police Dept

Mari\_pol16A

## FEMA 154 Rapid Visual Screening Score Card

Rapid Visual Screening - Senate Bill #2 - Seismic Needs Assessment  
Oregon Department of Geology and Mineral Industries

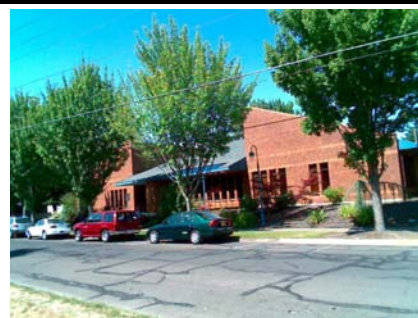
S Elevation View

Plan Irregularities	Vertical Irregularities
Reentrant Corners: Other	Steps in Elevation View: 2 to 3 Changes
None	None
None	None
