# Riverside Junior/Senior High School

Morr\_sch01A

## FEMA 154 Rapid Visual Screening Score Card

Rapid Visual Screening - Senate Bill #2 - Seismic Needs Assessment  
Oregon Department of Geology and Mineral Industries

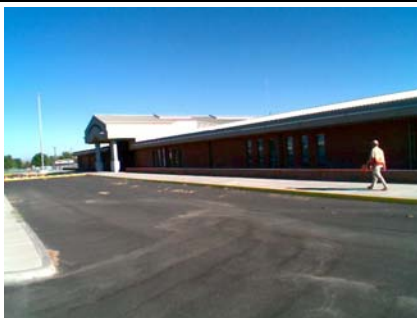
Plan Irregularities	Vertical Irregularities
Reentrant Corners: Other (Adjacent Build/Entity)	Steps in Elevation View: Single Change
None	Steps in Elevation View: Single Change (Adjacent Building/Entity)
None	None

SE Vertical Irregularity Primary

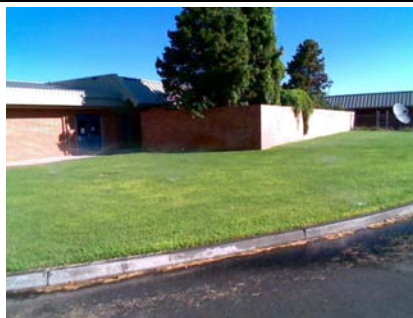
SE Plan Irregularity Primary

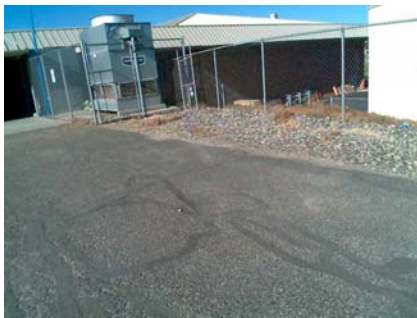
Plan Irregularities	Vertical Irregularities
Reentrant Corners:Other (Adjacent Build/Entity)	Steps in Elevation View: Single Change (Adjacent Building/Entity)
None	Building On Hill or Sloped Site
None	None

NE Vertical Irregularity Secondary

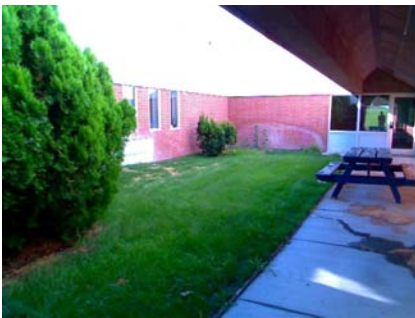
Plan Irregularities	Vertical Irregularities
Reentrant Corners: Other	None
None	None
None	None

NW Plan Irregularity Primary

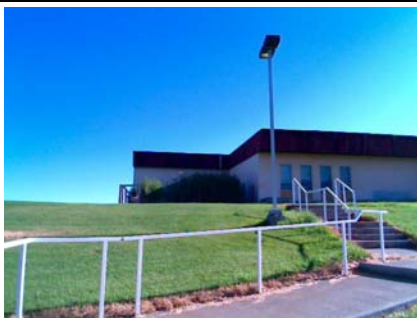
Plan Irregularities	Vertical Irregularities
Reentrant Corners: L Shaped	None
None	None
None	None

S Plan Irregularity Primary
