# A C Houghton Elementary School

Morr\_sch06A

## FEMA 154 Rapid Visual Screening Score Card

Rapid Visual Screening - Senate Bill #2 - Seismic Needs Assessment  
Oregon Department of Geology and Mineral Industries

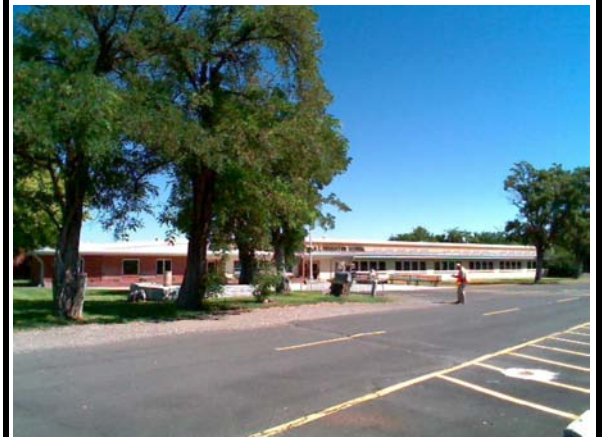
Type	Basic Score	Vert Irreg	Plan Irreg	Pre-Code	Post-Bench	Soil C	Soil D	Soil E	RVS Score
Primary	C2	3.6	0	-0.5	0	0	0	-1.2	0	1.9
Secondary	RM1	3.6	0	-0.5	0	0	0	-1.2	0	1.9
Tertiary		0	0	0	0	0	0	0	0	0

1.9

Moderate (>1%)

Plan Irregularities	Vertical Irregularities
Reentrant Corners: L Shaped	None
Reentrant Corners: U shaped	None
None	None

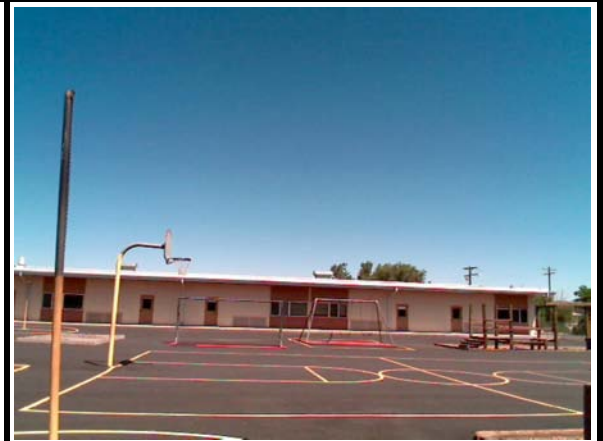
Morr\_sch06B

Type	Basic Score	Vert Irreg	Plan Irreg	Pre-Code	Post-Bench	Soil C	Soil D	Soil E	RVS Score
Primary	W2	4.8	0	-0.5	0	0	0	-1.2	0	3.1
Secondary	RM1	3.6	0	-0.5	0	0	0	-1.2	0	1.9
Tertiary		0	0	0	0	0	0	0	0	0

1.9

Moderate (>1%)

Plan Irregularities	Vertical Irregularities
Reentrant Corners:L shaped (Adjacent Build/Entity)	None
None	None
None	None

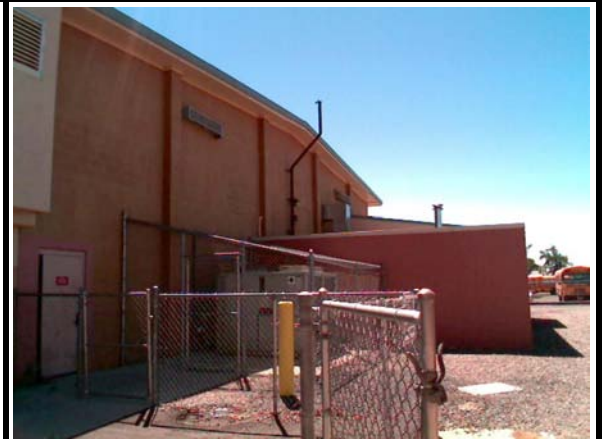
Morr\_sch06C

Type	Basic Score	Vert Irreg	Plan Irreg	Pre-Code	Post-Bench	Soil C	Soil D	Soil E	RVS Score
Primary	RM1	3.6	-2	0	0	0	0	-1.2	0	0.4
Secondary		0	0	0	0	0	0	0	0	0
Tertiary		0	0	0	0	0	0	0	0	0

0.4

High (>10%)

Plan Irregularities	Vertical Irregularities
None	Steps in Elevation View: 2 to 3 Changes (Adjacent Building/Entity)
None	None
None	None

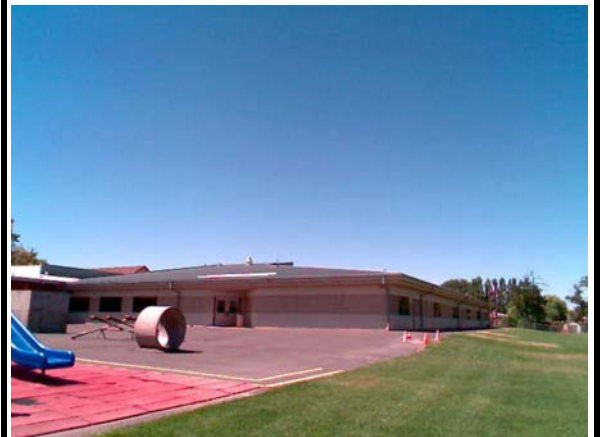
Morr\_sch06D

Type	Basic Score	Vert Irreg	Plan Irreg	Pre-Code	Post-Bench	Soil C	Soil D	Soil E	RVS Score
Primary	RM1	3.6	-2	-0.5	0	0	0	-1.2	0	-0.1
Secondary	W2	4.8	-3	-0.5	0	1.6	0	-1.2	0	1.7
Tertiary		0	0	0	0	0	0	0	0	0

-0.1

Very High (100%)

Plan Irregularities	Vertical Irregularities
Reentrant Corners:L shaped (Adjacent Build/Entity)	Steps in Elevation View: 2 to 3 Changes (Adjacent Building/Entity)
None	None
None	None
