Heppner Elementary School

Morr_sch08A

FEMA 154 Rapid Visual Screening Score Card

Rapid Visual Screening - Senate Bill #2 - Seismic Needs Assessment
Oregon Department of Geology and Mineral Industries

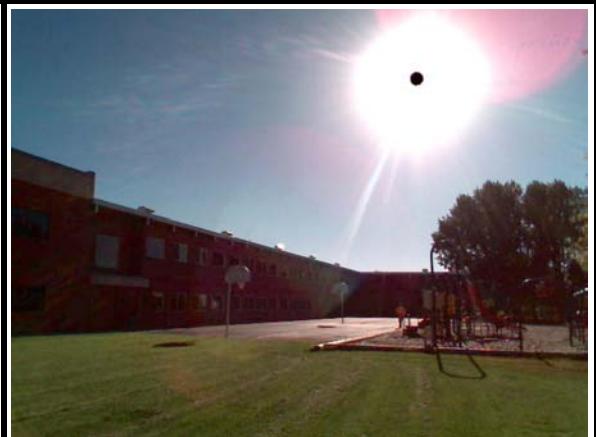
Type	Basic Score	Vert Irreg	Plan Irreg	Pre-Code	Post-Bench	Soil C	Soil D	Soil E	RVS Score
Primary	C2	3.6	-2	-0.5	0	0	0	0	0	1.1
Secondary	W2	4.8	-3	-0.5	0	0	0	0	0	1.3
Tertiary	RM1	3.6	-2	-0.5	0	0	0	0	0	1.1

Final Type	Final Score
C2	1.1

Moderate (>1%)

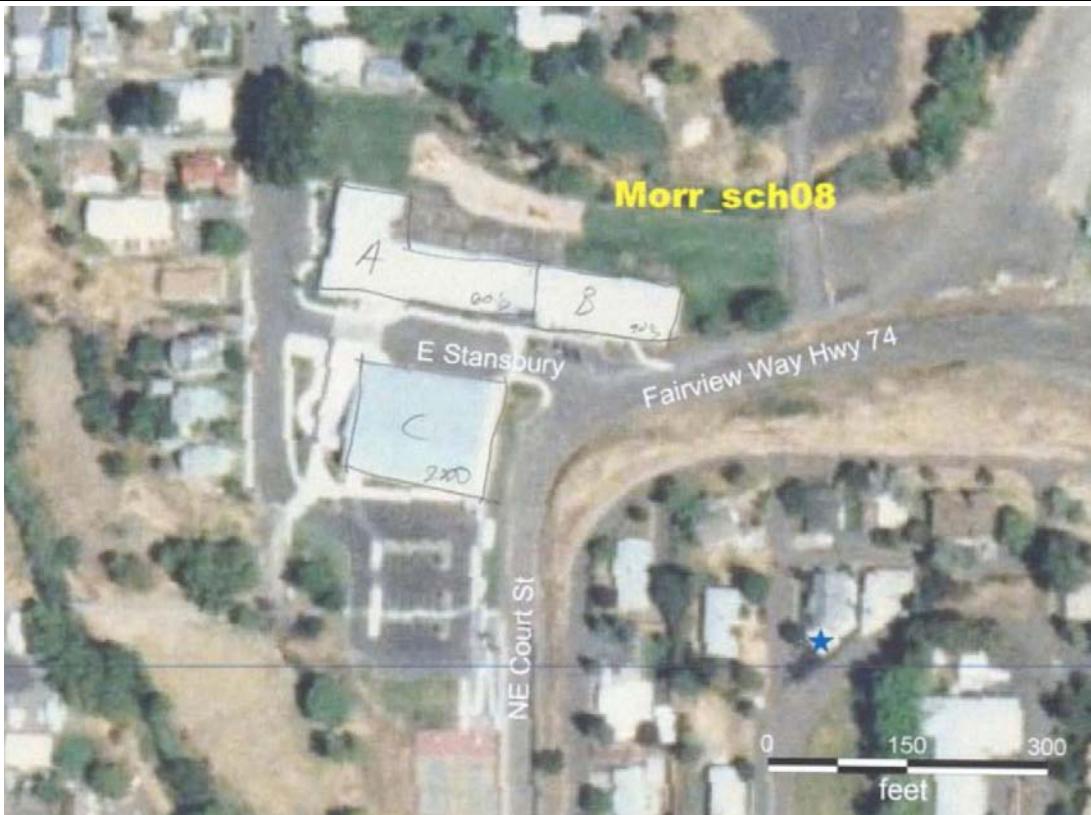
Morr_sch08A

Enrollment 188	Year Built (Field Verified) 1954	Year Built (Alt. Source) 1954	Est. Decade Built 1960
Total Area (square ft) 39318	Number of Stories 2	Basement	Pounding Potential No
Plan Irregularities Reentrant Corners: L Shaped None None		Vertical Irregularities Steps in Elevation View: Single Change (Adjacent Building/Entity) Building On Hill or Sloped Site None	
Falling Hazards None None None		Poor Conditions Cracks None None

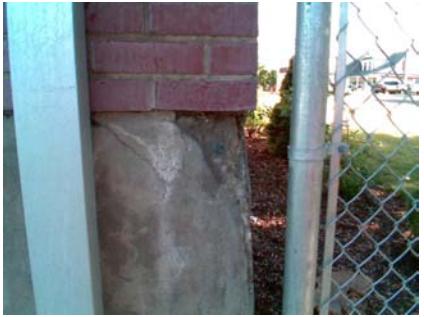
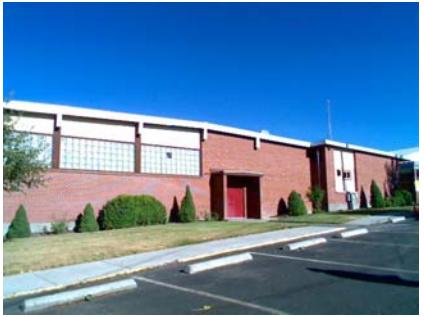
N Poor Condition		W Elevation View

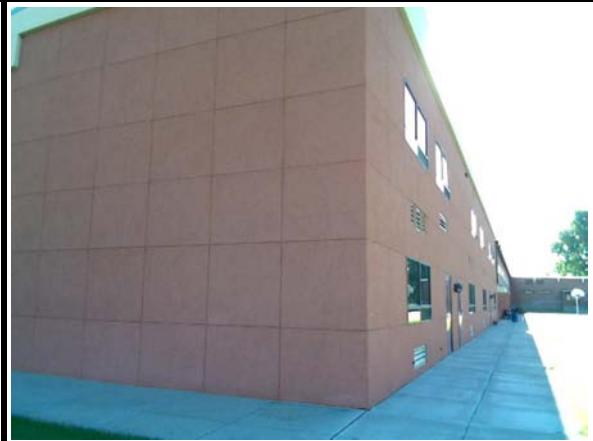
Morr_sch08B

Type	Basic Score	Vert Irreg	Plan Irreg	Pre-Code	Post-Bench	Soil C	Soil D	Soil E	RVS Score
Primary	C2	3.6	-2	0	0	0	0	0	0	1.6
Secondary	RM1	3.6	-2	0	0	0	0	0	0	1.6
Tertiary	W2	4.8	-3	0	0	1.6	0	0	0	3.4

Final Type	Final Score
C2	1.6

Moderate (>1%)

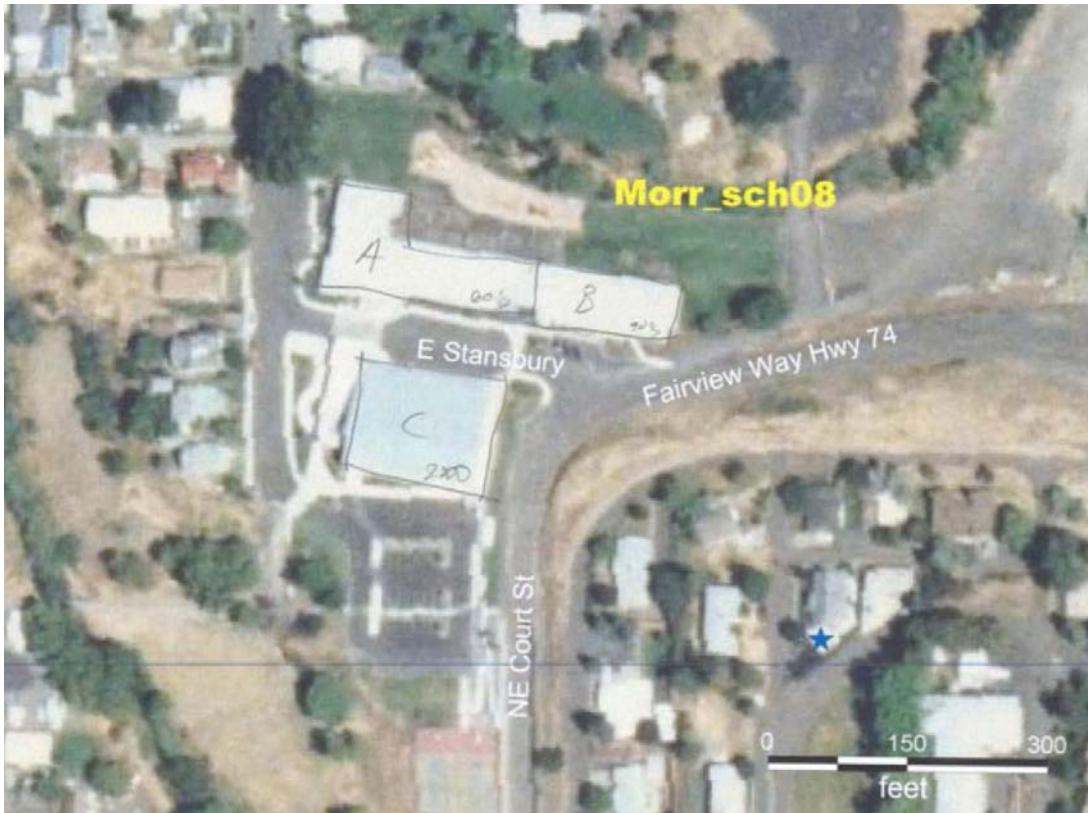
Morr_sch08B

Enrollment 188	Year Built (Field Verified) 1954	Year Built (Alt. Source) 1954	Est. Decade Built 1990
Total Area (square ft) 39318	Number of Stories 2	Basement	Pounding Potential No
Plan Irregularities None None None		Vertical Irregularities Steps in Elevation View: Single Change (Adjacent Building/Entity) Building On Hill or Sloped Site None	
Falling Hazards None None None		Poor Conditions None None None

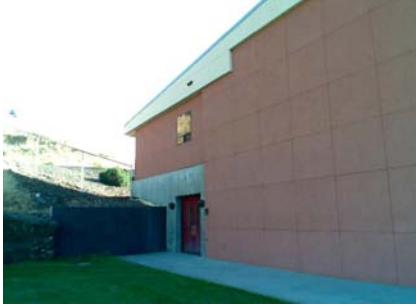
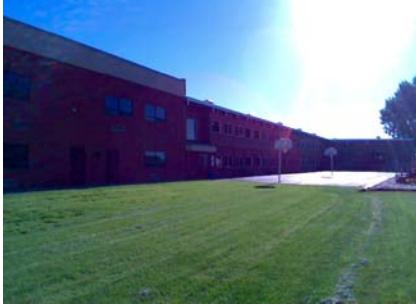
E Vertical Irregularity Secondary		NE Vertical Irregularity Primary

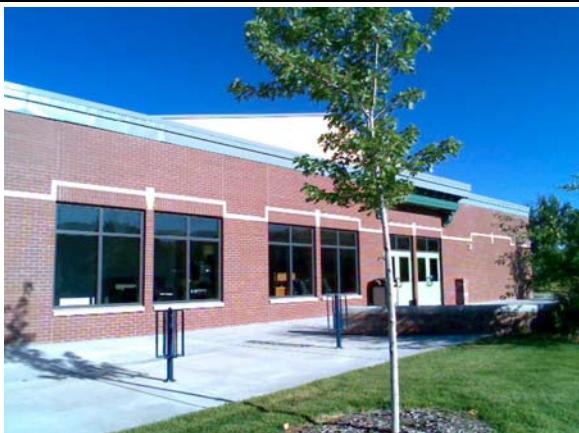
Morr_sch08C

Type	Basic Score	Vert Irreg	Plan Irreg	Pre-Code	Post-Bench	Soil C	Soil D	Soil E	RVS Score
Primary	RM1	3.6	-2	-0.5	0	2	0	0	0	3.1
Secondary		0	0	0	0	0	0	0	0	0
Tertiary		0	0	0	0	0	0	0	0	0

Final Type	Final Score
RM1	3.1

Low (<1%)

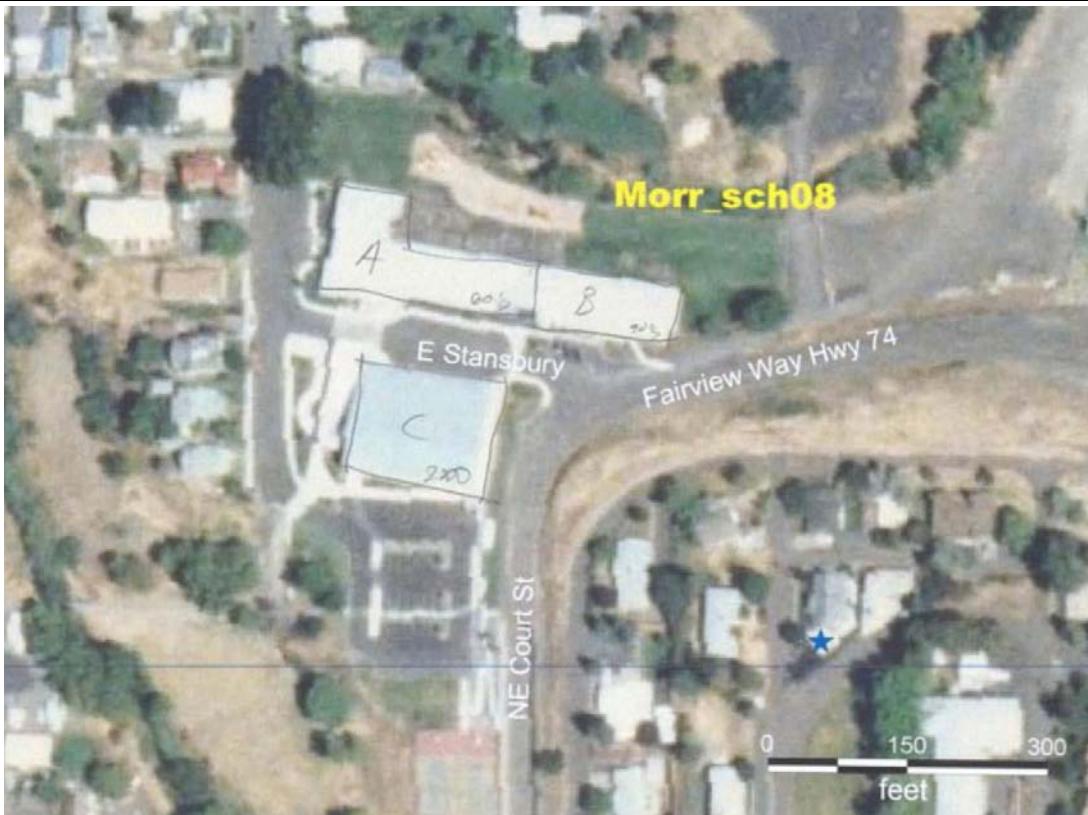
Enrollment 188	Year Built (Field Verified) 1954	Year Built (Alt. Source) 1954	Est. Decade Built 2000
Total Area (square ft) 39318	Number of Stories 1	Basement	Pounding Potential No
Plan Irregularities Reentrant Corners: Other None None		Vertical Irregularities Steps in Elevation View: Single Change Building On Hill or Sloped Site None	
Falling Hazards None None None		Poor Conditions None None None

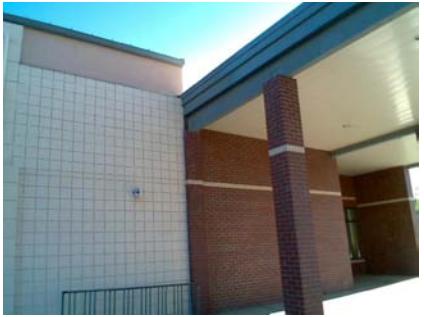
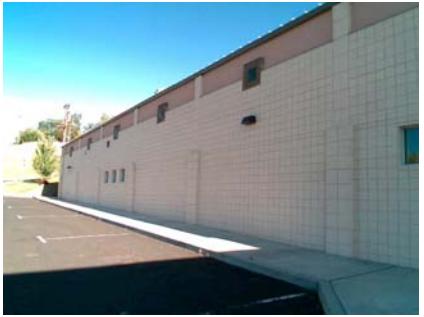
N Vertical Irregularity Primary		N Vertical Irregularity Secondary
