# Multnomah County RFPD 14 Corbett Station #62 Gar

Multnomah County RFPD 14 Aims Station #63

## FEMA 154 Rapid Visual Screening Score Card

Rapid Visual Screening - Senate Bill #2 - Seismic Needs Assessment  
Oregon Department of Geology and Mineral Industries

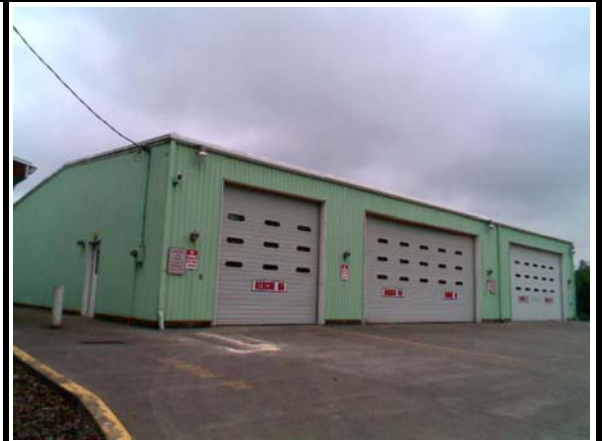
Seismicity Zone: High

| | Type | Basic Score | Vert Irreg | Plan Irreg | Pre-Code | Post-Bench | Soil C | Soil D | Soil E | RVS Score |
|---|---|---|---|---|---|---|---|---|---|---|
| Primary | S3 | 3.2 | 0 | -0.5 | 0 | 0 | -0.4 | 0 | 0 | 2.3 |

FEMA-154 Collapse Potential

Low (<1%)

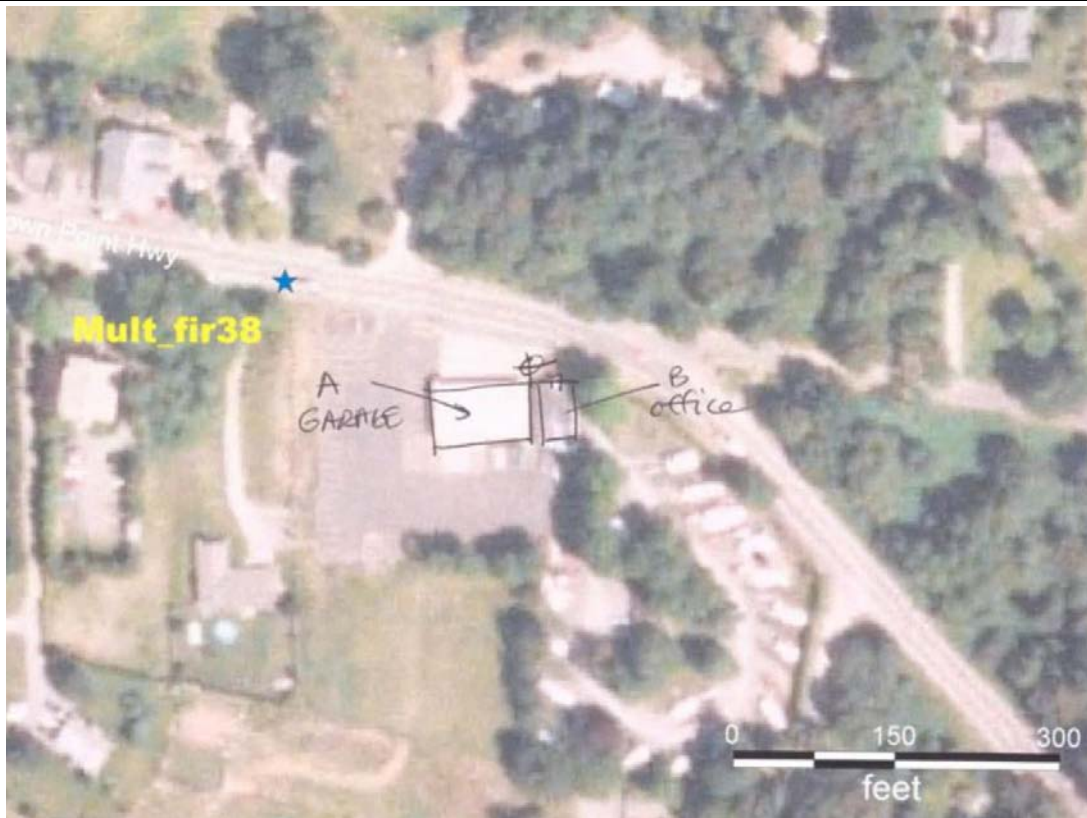
Multnomah County RFPD 14  
Corbett Station #62 Garage

| Torsion: Eccentric Stiffness | None |

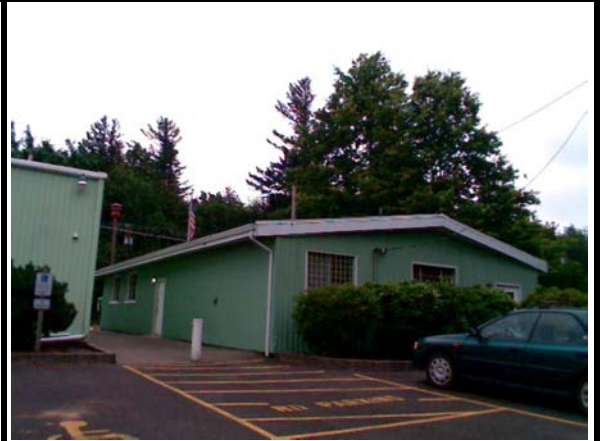
| | Type | Basic Score | Vert Irreg | Plan Irreg | Pre-Code | Post-Bench | Soil C | Soil D | Soil E | RVS Score |
|---|---|---|---|---|---|---|---|---|---|---|
| Primary | S3 | 3.2 | 0 | 0 | 0 | 0 | -0.4 | 0 | 0 | 2.8 |
| Secondary | C2 | 2.8 | 0 | 0 | 0 | 0 | -0.4 | 0 | 0 | 2.4 |

FEMA-154 Collapse Potential

Low (<1%)

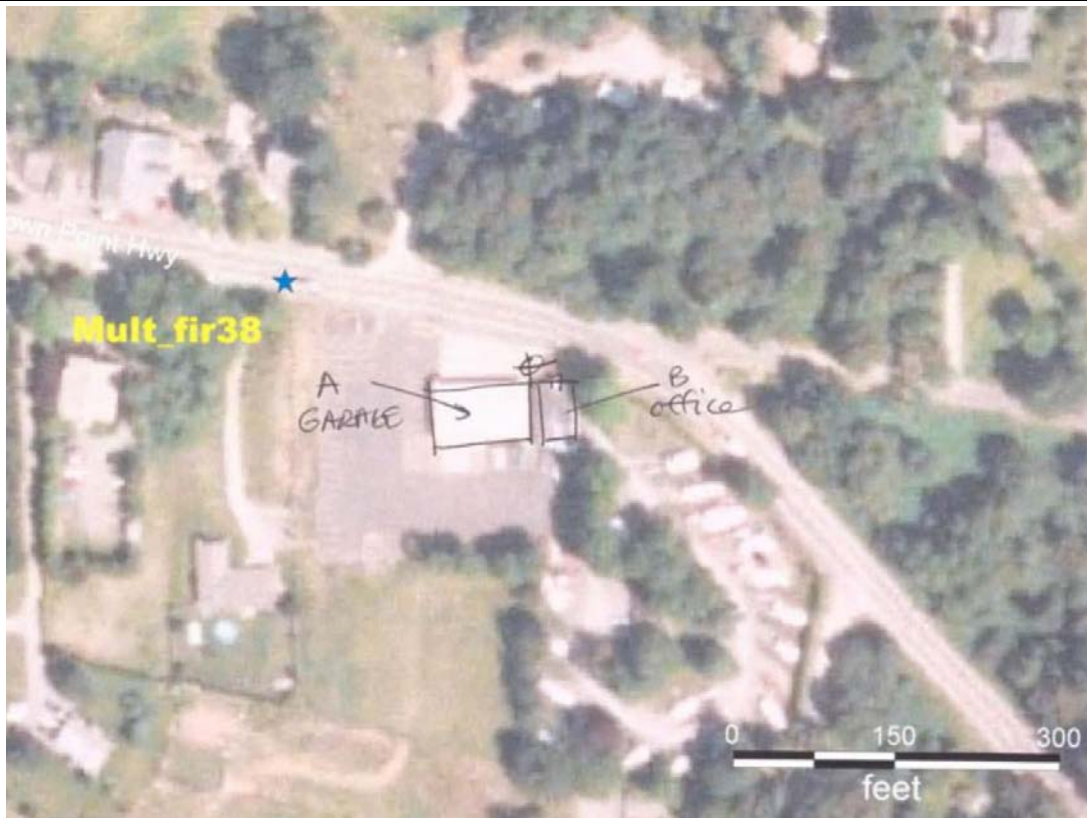
Multnomah County RFPD 14  
Corbett Station #62 Office

| None | None |
