Monmouth Elementary School

Polk_sch04A

FEMA 154 Rapid Visual Screening Score Card

Rapid Visual Screening - Senate Bill #2 - Seismic Needs Assessment
Oregon Department of Geology and Mineral Industries

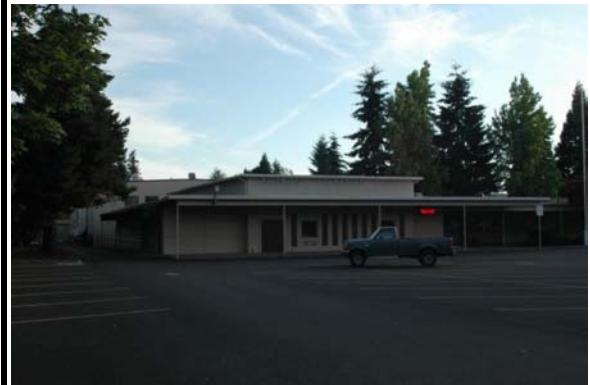
Type	Basic Score	Vert Irreg	Plan Irreg	Pre-Code	Post-Bench	Soil C	Soil D	Soil E	RVS Score
Primary	RM1	2.8	-1	0	0	0	0	-0.6	0	1.2
Secondary		0	0	0	0	0	0	0	0	0
Tertiary		0	0	0	0	0	0	0	0	0

Final Type	Final Score
RM1	1.2

Moderate (>1%)

Enrollment 473	Year Built (Field Verified) 1963	Year Built (Alt. Source) 1963	Est. Decade Built 1960
Total Area (square ft) 36100	Number of Stories 1	Basement	Pounding Potential No
Plan Irregularities		Vertical Irregularities	
Reentrant Corners: Other		Steps in Elevation View: Very Irregular Changes	
Out of Plane Lateral-Force-Resistance Elements		None	
Torsion: Eccentric Stiffness		None	
Falling Hazards		Poor Conditions	
None		None	
None		None	
None		None

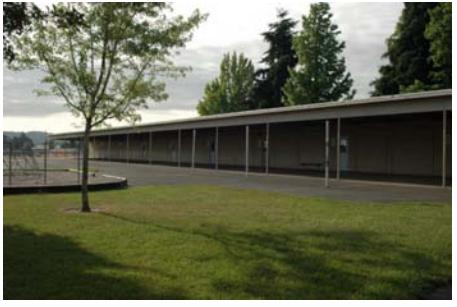
E Other 1963	W Primary Structural Type	NE General Site

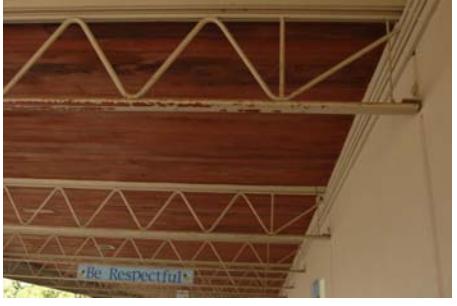
NE General Site connection between A and D	S Falling Hazard concern about how the cover over the walkways is attached.

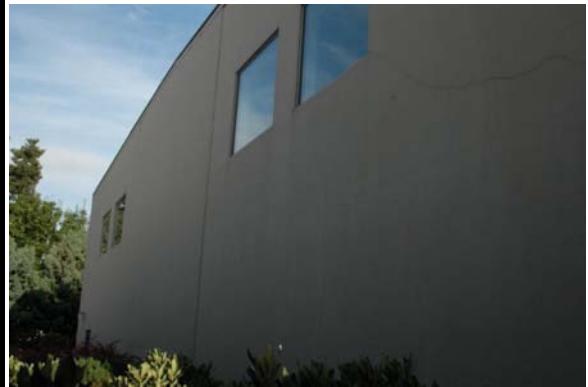
Polk_sch04B

Type	Basic Score	Vert Irreg	Plan Irreg	Pre-Code	Post-Bench	Soil C	Soil D	Soil E	RVS Score
Primary	PC1	2.6	0	0	0	0	0	-0.6	0	2
Secondary		0	0	0	0	0	0	0	0	0
Tertiary		0	0	0	0	0	0	0	0	0

Final Type	Final Score
PC1	2

Moderate (>1%)

Enrollment 473	Year Built (Field Verified) 1963	Year Built (Alt. Source) 1963	Est. Decade Built 1960
Total Area (square ft) 36100	Number of Stories 2	Basement	Pounding Potential No
Plan Irregularities None None None		Vertical Irregularities Internal Discontinuous Diaphragm (large internal opening) Steps in Elevation View: Single Change (Adjacent Building/Entity) None	
Falling Hazards None None None		Poor Conditions None None None

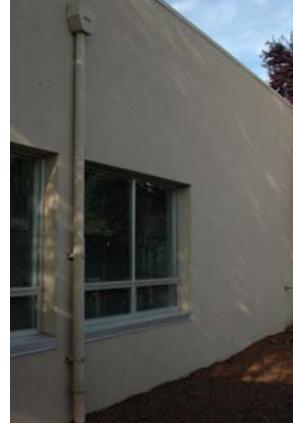
Polk_sch04C

Type	Basic Score	Vert Irreg	Plan Irreg	Pre-Code	Post-Bench	Soil C	Soil D	Soil E	RVS Score
Primary	PC1	2.6	0	0	0	0	0	-0.6	0	2
Secondary		0	0	0	0	0	0	0	0	0
Tertiary		0	0	0	0	0	0	0	0	0

Final Type	Final Score
PC1	2

Moderate (>1%)

Enrollment 473	Year Built (Field Verified) 1963	Year Built (Alt. Source) 1963	Est. Decade Built 1990
Total Area (square ft) 36100	Number of Stories 1	Basement	Pounding Potential No
Plan Irregularities None None None		Vertical Irregularities Steps in Elevation View: Single Change (Adjacent Building/Entity) None None	
Falling Hazards None None None		Poor Conditions None None None

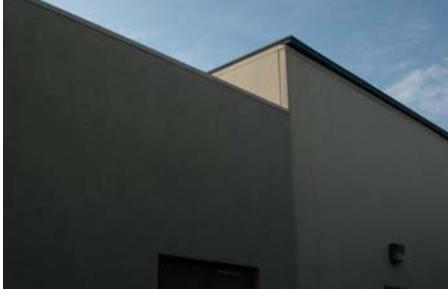
W Vertical Irregularity Primary

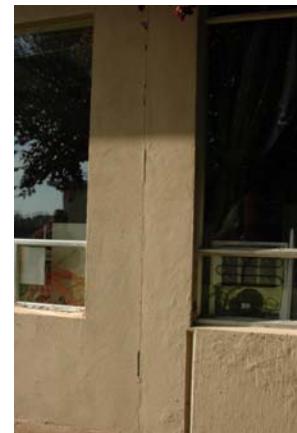
Polk_sch04D

Type	Basic Score	Vert Irreg	Plan Irreg	Pre-Code	Post-Bench	Soil C	Soil D	Soil E	RVS Score
Primary	RM1	2.8	0	-0.5	0	0	0	-0.6	0	1.7
Secondary		0	0	0	0	0	0	0	0	0
Tertiary		0	0	0	0	0	0	0	0	0

Final Type	Final Score
RM1	1.7

Moderate (>1%)

Enrollment 473	Year Built (Field Verified) 1963	Year Built (Alt. Source) 1963	Est. Decade Built 1980
Total Area (square ft) 36100	Number of Stories 1	Basement	Pounding Potential No
Plan Irregularities Torsion: Eccentric Stiffness None None		Vertical Irregularities None None None	
Falling Hazards None None None		Poor Conditions None None None
