## FEMA 154 Rapid Visual Screening Score Card

## Umatilla Hall

Rapid Visual Screening - Senate Bill #2 - Seismic Needs Assessment  
Oregon Department of Geology and Mineral Industries

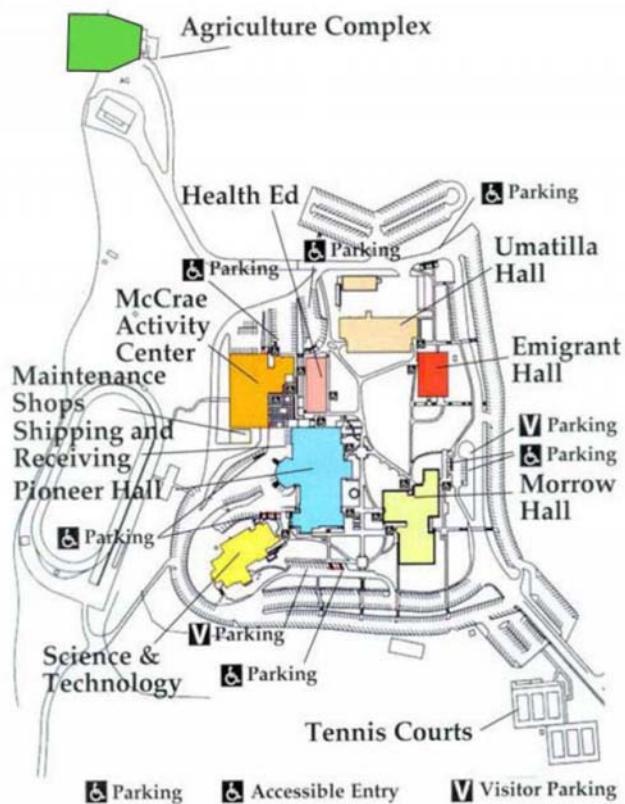
Umat\_coc05A

Enrollment	Year Built (Field Verified)	Year Built (Alt. Source)	Est. Decade Built
	1969	1969	1960
Total Area (square ft)	Number of Stories	Basement	Pounding Potential
34398	2	Yes	No
Plan Irregularities		Vertical Irregularities	
Yes: Unknown		Yes: Unknown	
Falling Hazards		Poor Conditions	
None			
None
