Umatilla RFPD

Building Type Fire - RFPD	County Umatilla	
Street 921 6th St		
City Umatilla	State OR	Zip 97882
Latitude 45.91791	Longitude 119.34201	
Tracking Code RVS in 2006	Inspection Date 8/15/2006

FEMA 154 Rapid Visual Screening Score Card

Rapid Visual Screening - Senate Bill #2 - Seismic Needs Assessment
Oregon Department of Geology and Mineral Industries

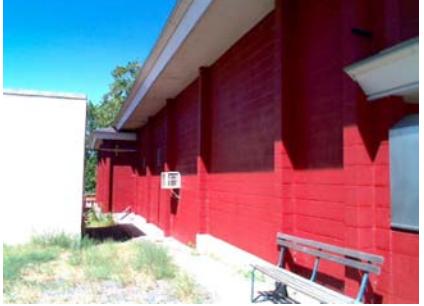
W Elevation View

Enrollment	Year Built (Field Verified)	Year Built (Alt. Source)	Est. Decade Built
		1980	1960
Total Area (square ft)	Number of Stories	Basement	Pounding Potential
3782	1	No	No
Plan Irregularities		Vertical Irregularities	
Torsion: Eccentric Stiffness		None	
Reentrant Corners: L Shaped		None	
None		None	
Falling Hazards		Poor Conditions	
None		None	
None		None	
None		None
