# Umatilla RFPD

## FEMA 154 Rapid Visual Screening Score Card

Rapid Visual Screening - Senate Bill #2 - Seismic Needs Assessment  
Oregon Department of Geology and Mineral Industries

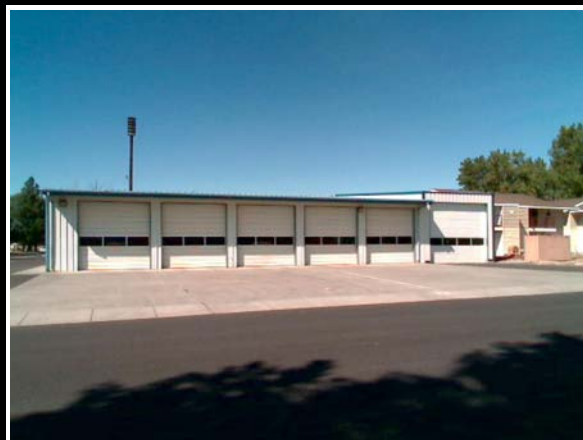
| | Type | Basic Score | Vert Irreg | Plan Irreg | Pre-Code | Post-Bench | Soil C | Soil D | Soil E | RVS Score |
| Primary | S3 | 3.8 | 0 | -0.5 | 0 | 0 | 0 | -1 | 0 | 2.3 |

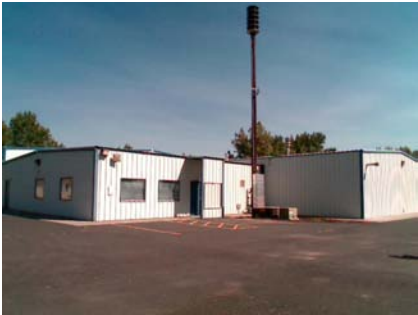
NW Elevation View

| Reentrant Corners: Other | Steps in Elevation View: 2 to 3 Changes |
| Torsion: Eccentric Stiffness | None |
