Building Type		County	
EOC-Public Safety Answering P		Umatilla	
Street			
4700 Nw Pioneer Pl			
City	State	Zip	
Pendleton	OR	97801	
Latitude	Longitude		
45.67366	118.84322		
Tracking Code	Inspection Date		
RVS in 2006	8/1/2006

## FEMA 154 Rapid Visual Screening Score Card

Umatilla County Sheriff's Dept

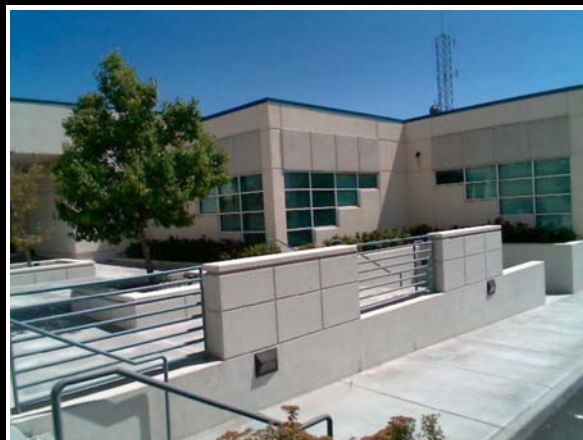
Plan Irregularities	Vertical Irregularities
Reentrant Corners: Other	Building On Hill or Sloped Site
None	Steps in Elevation View: 2 to 3 Changes
None	None

Falling Hazards	Poor Conditions
None	None
None	None
None	None

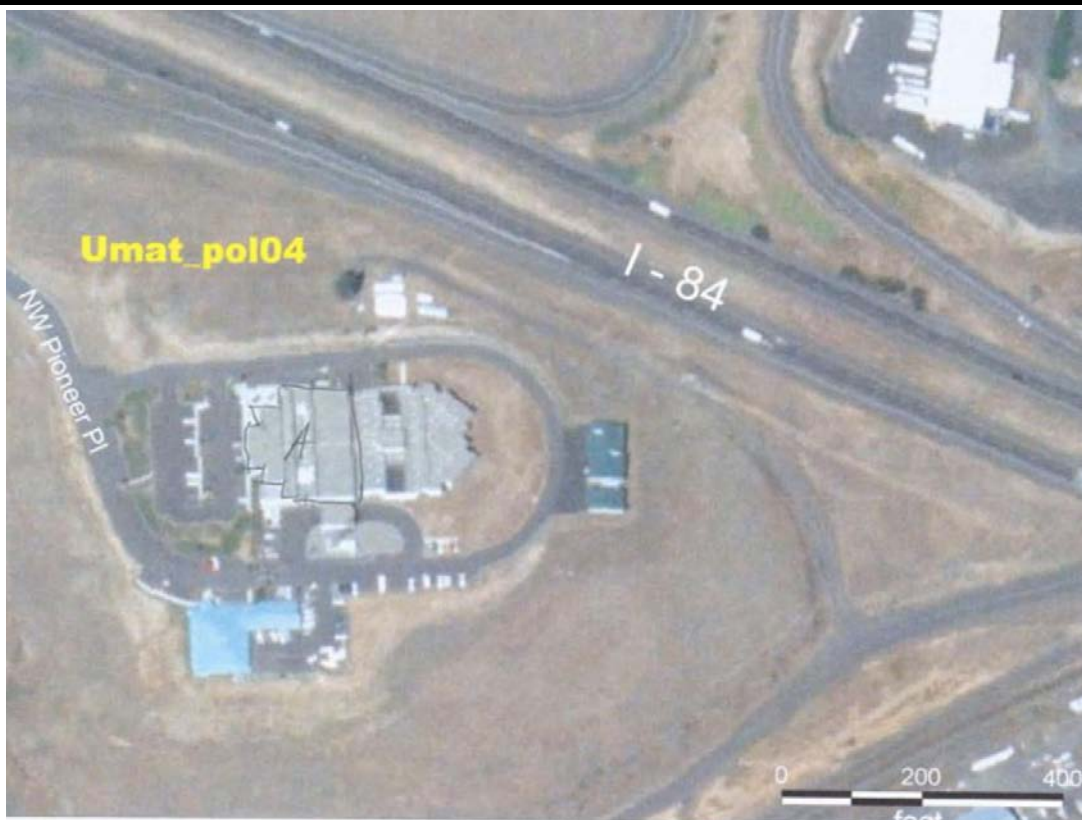
Enrollment	Year Built (Field Verified)	Year Built (Alt. Source)	Est. Decade Built
	1992	1992	1990
Total Area (square ft)	Number of Stories	Basement	Pounding Potential
5500	2	No	No

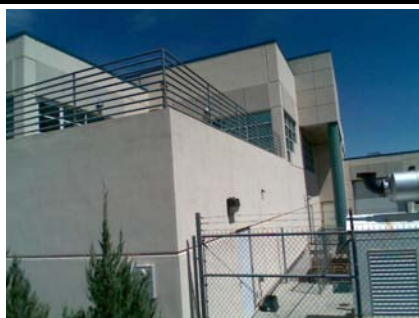
S Vertical Irregularity Secondary
