Oregon State Police

Building Type	County
Police - State	Umatilla
Street	
700 Se Emigrant Ave	
City	State Zip
Pendleton	OR 97801
Latitude	Longitude
45.67261	118.7791
Tracking Code	Inspection Date
RVS in 2006	8/1/2006

FEMA 154 Rapid Visual Screening Score Card

Rapid Visual Screening - Senate Bill #2 - Seismic Needs Assessment
Oregon Department of Geology and Mineral Industries

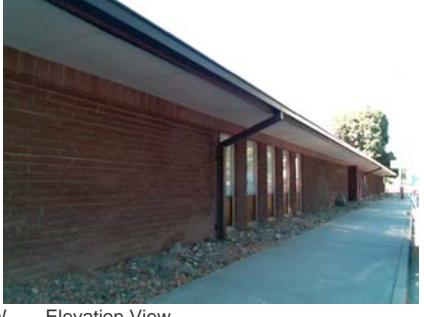
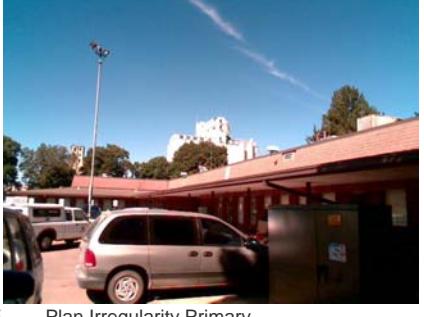
Enrollment	Year Built (Field Verified)	Year Built (Alt. Source)	Est. Decade Built
	1963	1963	1960
Total Area (square ft)	Number of Stories	Basement	Pounding Potential
13486	1	No	No
Plan Irregularities		Vertical Irregularities	
Reentrant Corners: L Shaped		None	
None		None	
None		None	
Falling Hazards		Poor Conditions	
None		None	
None		None	
None		None

W	Elevation View	E	Plan Irregularity Primary
