Pilot Rock Police Dept

Umat_pol09A

FEMA 154 Rapid Visual Screening Score Card

Rapid Visual Screening - Senate Bill #2 - Seismic Needs Assessment
Oregon Department of Geology and Mineral Industries

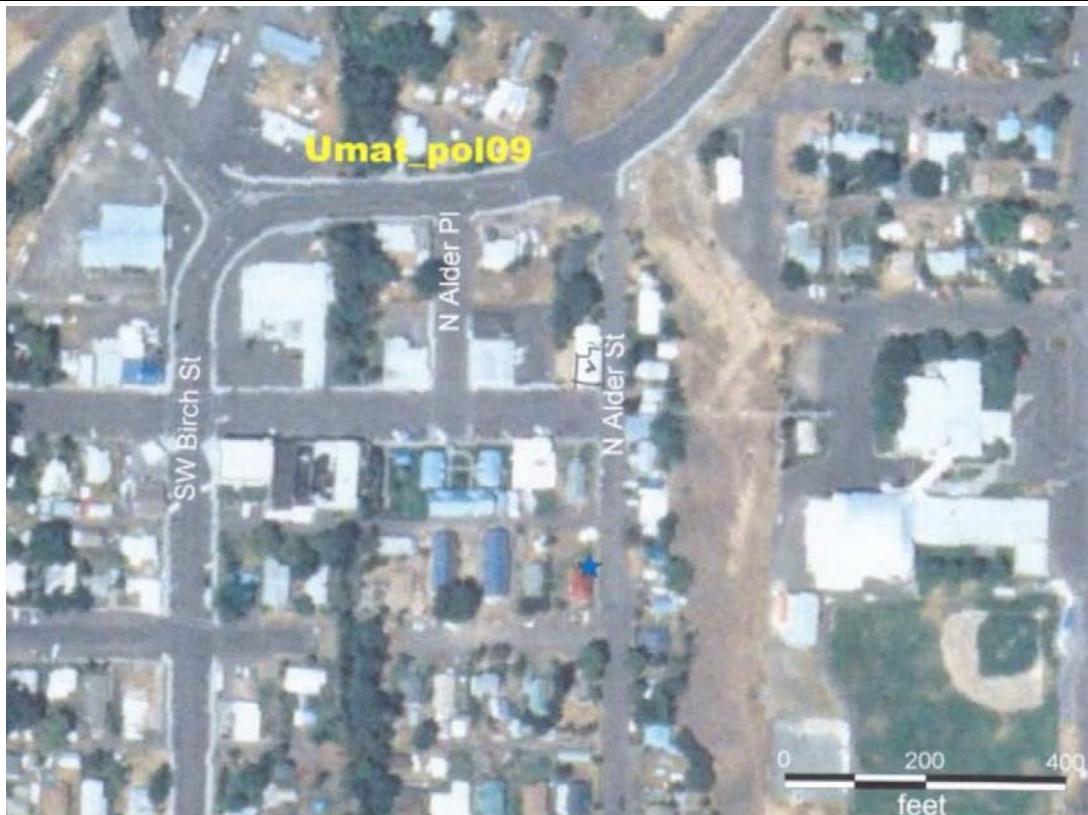
Building Type Police - City	County Umatilla	
Street 144 N Alder Pl		
City Pilot Rock	State OR	Zip 97868
Latitude 45.48289	Longitude 118.83293	
Tracking Code RVS in 2006	Inspection Date 8/1/2006

Type	Basic Score	Vert Irreg	Plan Irreg	Pre-Code	Post-Bench	Soil C	Soil D	Soil E	RVS Score
Primary	RM1	3.6	-2	-0.5	0	0	-0.8	0	0	0.3
Secondary		0	0	0	0	0	0	0	0	0
Tertiary		0	0	0	0	0	0	0	0	0

Final Type	Final Score
RM1	0.3

High (>10%)

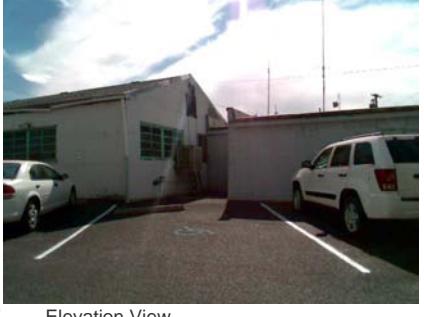
E Elevation View

Enrollment	Year Built (Field Verified)	Year Built (Alt. Source)	Est. Decade Built
		1930	1950
Total Area (square ft)	Number of Stories	Basement	Pounding Potential
2278	1	No	No
Plan Irregularities		Vertical Irregularities	
Reentrant Corners: L Shaped		Steps in Elevation View: Single Change (Adjacent Building/Entity)	
Reentrant Corners: Other		None	
None		None	
Falling Hazards		Poor Conditions	
None		None	
None		None	
None		None
