# Sunset Elementary School

Umat\_sch05A

Building Type		County	
School		Umatilla	
Street			
300 E Catherine Ave			
City	State	Zip	
Hermiston	OR	97838	
Latitude		Longitude	
45.84421		119.28714	
Tracking Code		Inspection Date	
RVS in 2006		8/16/2006

Rapid Visual Screening - Senate Bill #2 - Seismic Needs Assessment  
Oregon Department of Geology and Mineral Industries

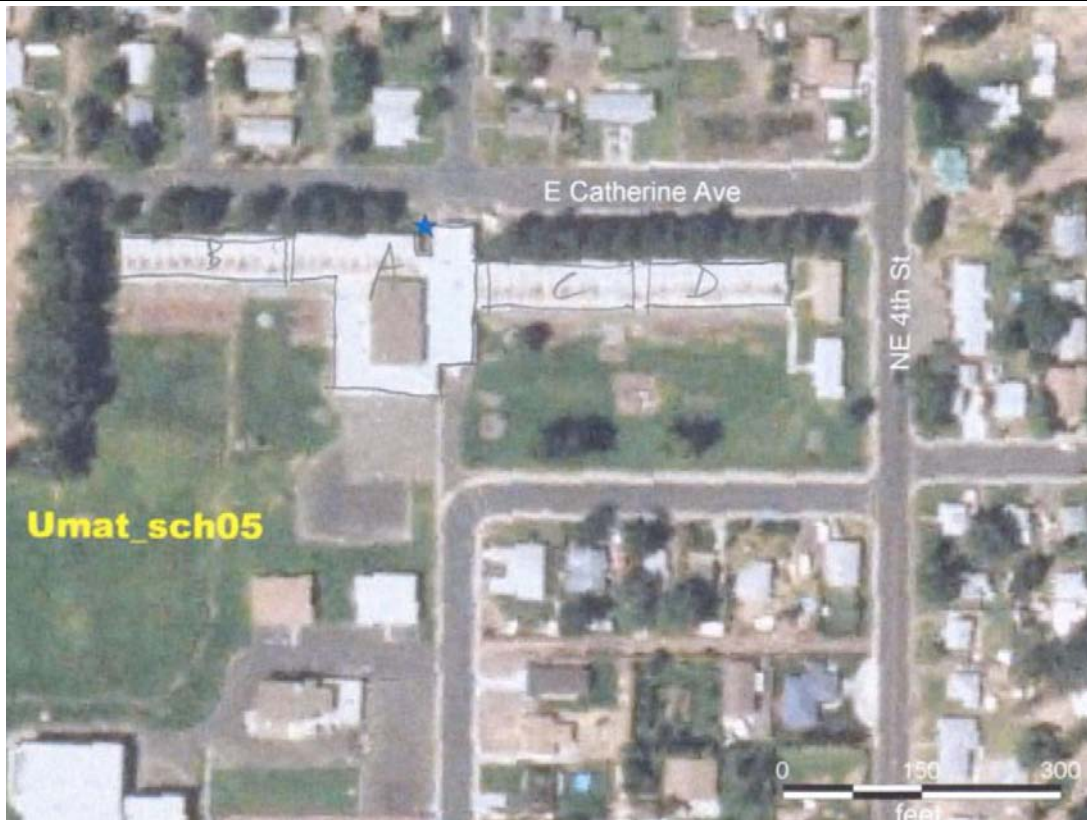
Type	Basic Score	Vert Irreg	Plan Irreg	Pre-Code	Post-Bench	Soil C	Soil D	Soil E	RVS Score
Primary	C2	3.6	-2	-0.5	0	0	-0.8	0	0	0.3
Secondary	PC1	3.2	0	-0.5	0	0	-0.6	0	0	2.1
Tertiary		0	0	0	0	0	0	0	0	0

C2

0.3

FEMA-154 Collapse Potential

High (>10%)

Plan Irregularities	Vertical Irregularities
Reentrant Corners: Other	Steps in Elevation View: Single Change
None	None
None	None

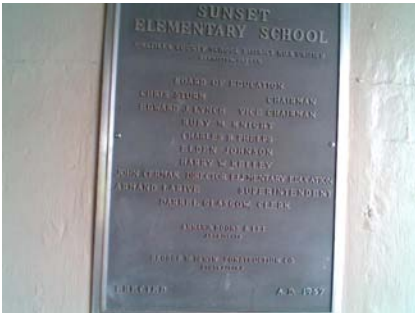
E Field Verified Year Built

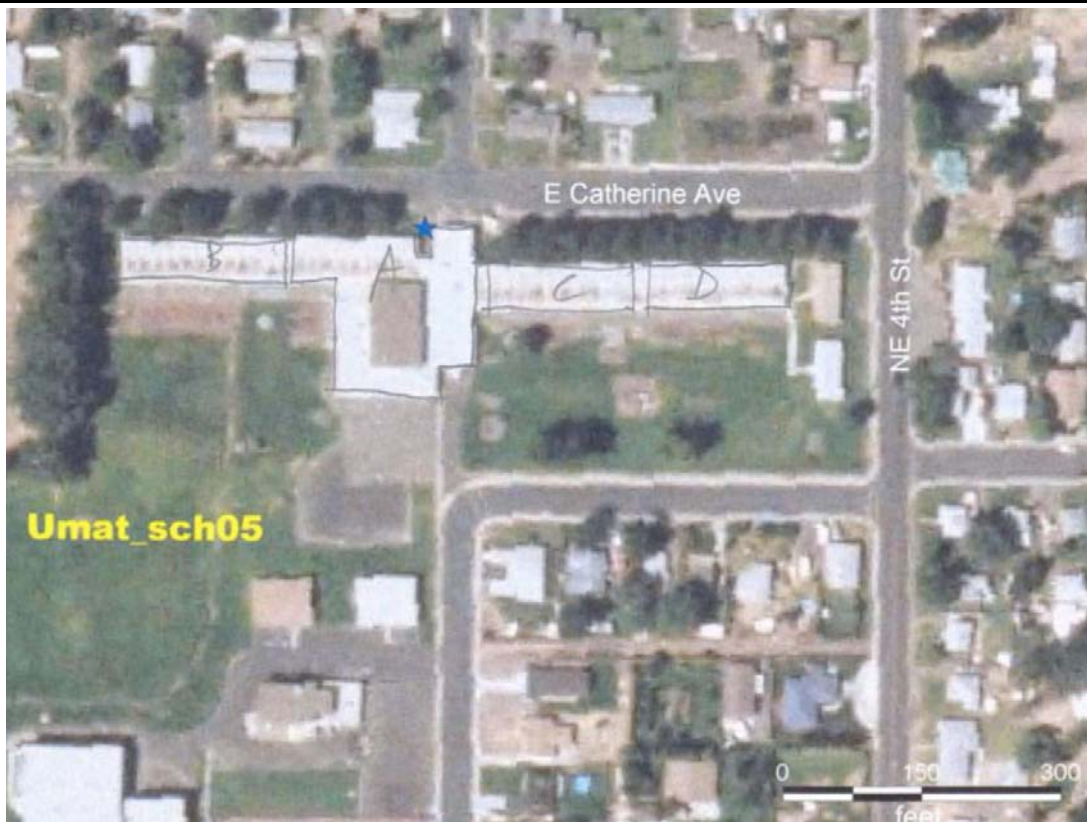
Type	Basic Score	Vert Irreg	Plan Irreg	Pre-Code	Post-Bench	Soil C	Soil D	Soil E	RVS Score
Primary	C2	3.6	0	0	0	0	-0.8	0	0	2.8
Secondary	PC1	3.2	0	0	0	0	-0.6	0	0	2.6
Tertiary		0	0	0	0	0	0	0	0	0

PC1

2.6

FEMA-154 Collapse Potential

Low (<1%)
