# Stanfield Secondary School

Umat\_sch18A

## FEMA 154 Rapid Visual Screening Score Card

Rapid Visual Screening - Senate Bill #2 - Seismic Needs Assessment  
Oregon Department of Geology and Mineral Industries

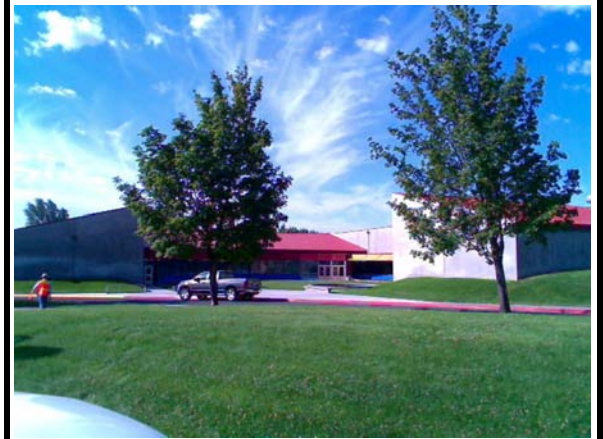
Seismicity Zone: Moderate

| | Type | Basic Score | Vert Irreg | Plan Irreg | Pre-Code | Post-Bench | Soil C | Soil D | Soil E | RVS Score |
|---|---|---|---|---|---|---|---|---|---|---|
| Primary | PC1 | 3.2 | 0 | -0.5 | 0 | 0 | 0 | 0 | 0 | 2.7 |

2.7

Low (<1%)
