Pilot Rock Elementary School

Umat_sch21A

FEMA 154 Rapid Visual Screening Score Card

Rapid Visual Screening - Senate Bill #2 - Seismic Needs Assessment
Oregon Department of Geology and Mineral Industries

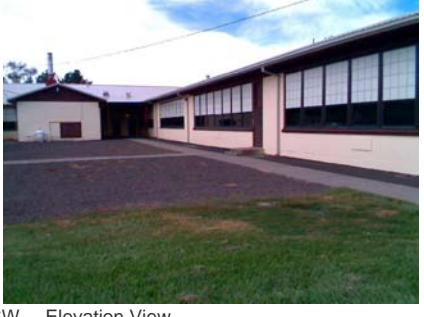
| Plan Irregularities Reentrant Corners: L Shaped None None | | Vertical Irregularities None None None | |
| SW Elevation View attach w/building b | | N Elevation View | |

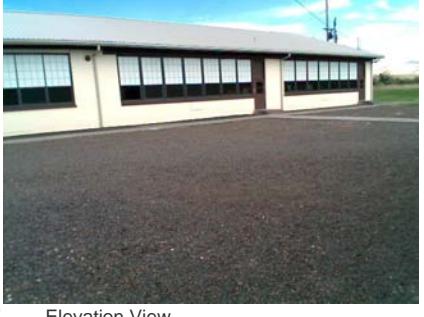
| E Elevation View | | | |

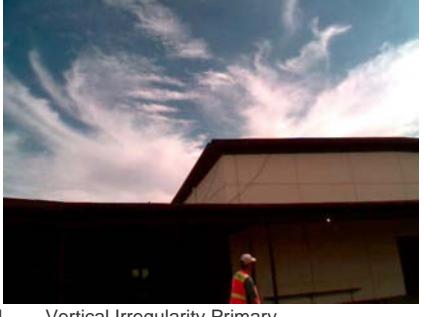
| Plan Irregularities Reentrant Corners: L Shaped None None | | Vertical Irregularities Steps in Elevation View: Single Change (Adjacent Building/Entity) None None | |
| N Vertical Irregularity Primary | | | |

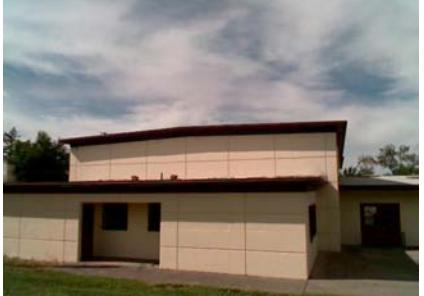
| Plan Irregularities Reentrant Corners:L shaped (Adjacent Build/Entity) Reentrant Corners: T shaped None | | Vertical Irregularities Steps in Elevation View: Single Change (Adjacent Building/Entity) Steps in Elevation View: Single Change None | |
| S Elevation View | | | |
