Echo School

Umat_sch22A

FEMA 154 Rapid Visual Screening Score Card

Rapid Visual Screening - Senate Bill #2 - Seismic Needs Assessment
Oregon Department of Geology and Mineral Industries

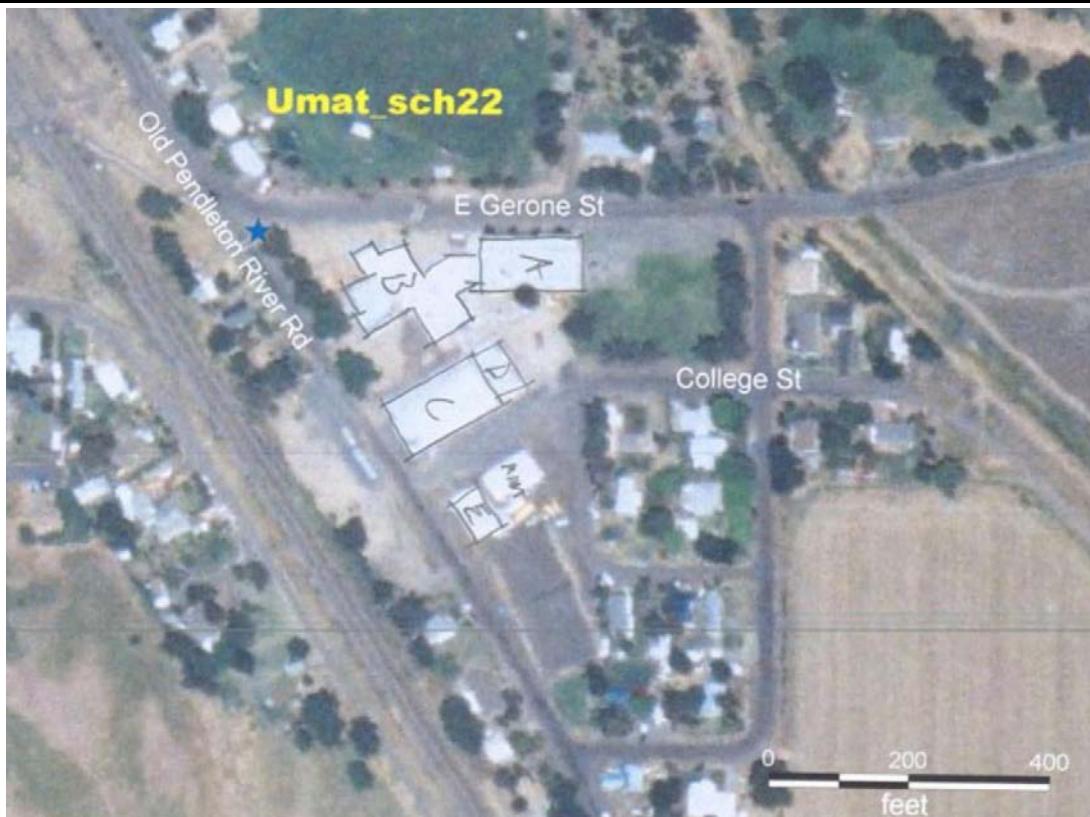
Type	Basic Score	Vert Irreg	Plan Irreg	Pre-Code	Post-Bench	Soil C	Soil D	Soil E	RVS Score
Primary	C2	3.6	-2	-0.5	0	0	-0.8	0	0	0.3
Secondary	RM1	3.6	-2	-0.5	0	0	-0.8	0	0	0.3
Tertiary		0	0	0	0	0	0	0	0	0

Final Type	Final Score
C2	0.3

High (>10%)

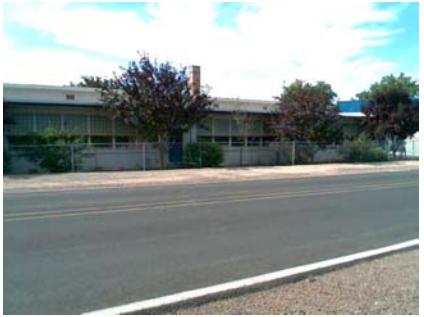
N Elevation View		SE Elevation View	E Falling Hazard

Enrollment 267	Year Built (Field Verified) 1953	Year Built (Alt. Source) 1953	Est. Decade Built 1940
Total Area (square ft) 52298	Number of Stories 1	Basement	Pounding Potential No
Plan Irregularities Reentrant Corners: L Shaped Reentrant Corners: Other None		Vertical Irregularities Steps in Elevation View: Single Change Steps in Elevation View: Single Change (Adjacent Building/Entity) None	
Falling Hazards None None None		Poor Conditions None None None

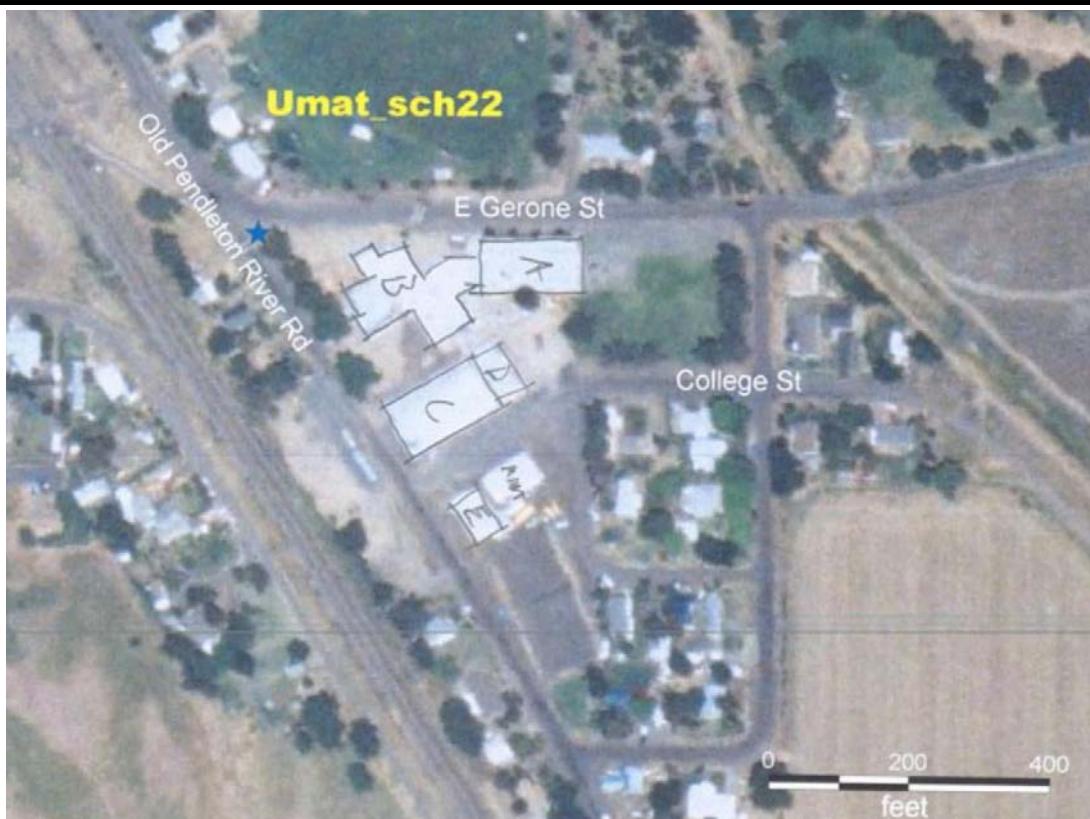
Umat_sch22B

Type	Basic Score	Vert Irreg	Plan Irreg	Pre-Code	Post-Bench	Soil C	Soil D	Soil E	RVS Score
Primary	C2	3.6	-2	0	0	0	-0.8	0	0	0.8
Secondary		0	0	0	0	0	0	0	0	0
Tertiary		0	0	0	0	0	0	0	0	0

Final Type	Final Score
C2	0.8

High (>10%)

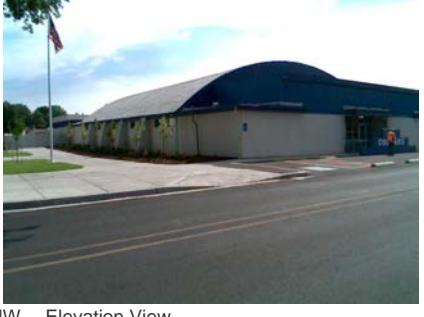
NW Elevation View

Enrollment 267	Year Built (Field Verified) 1953	Year Built (Alt. Source) 1953	Est. Decade Built 1940
Total Area (square ft) 52298	Number of Stories 1	Basement	Pounding Potential No
Plan Irregularities None None None		Vertical Irregularities Steps in Elevation View: Single Change Steps in Elevation View: 2 to 3 Changes (Adjacent Building/Entity) None	
Falling Hazards None None None		Poor Conditions None None None

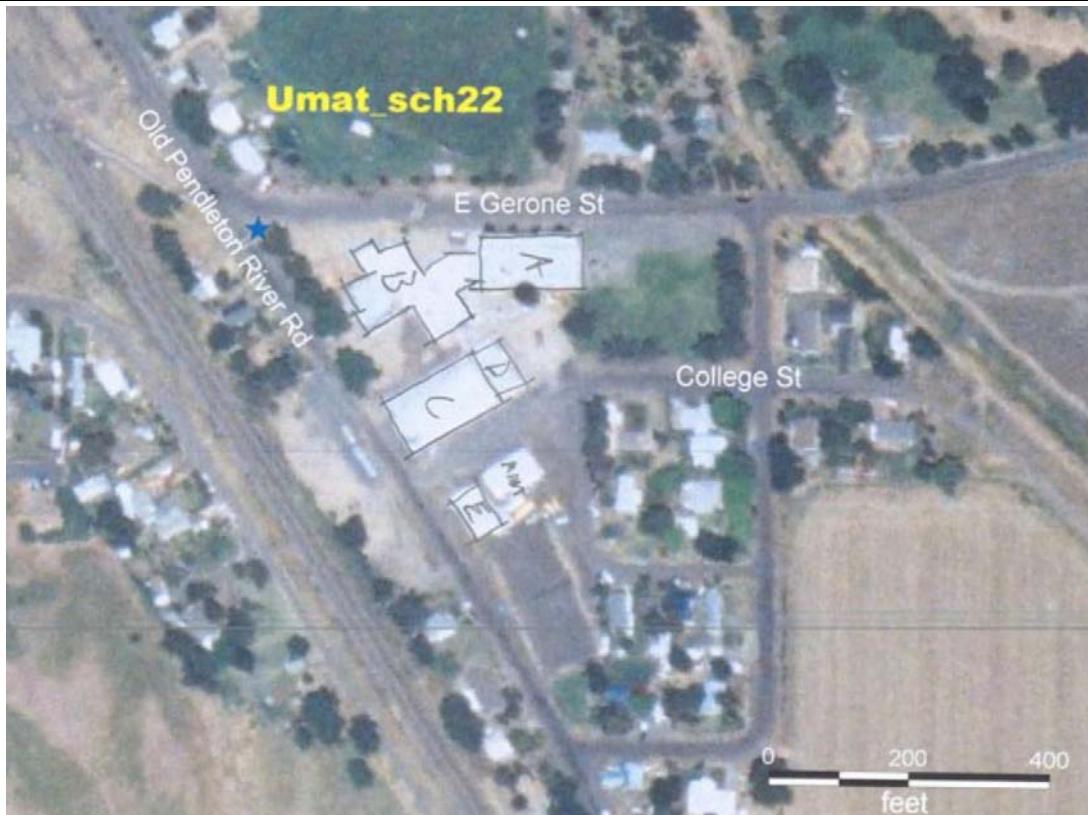
Umat_sch22C

Type	Basic Score	Vert Irreg	Plan Irreg	Pre-Code	Post-Bench	Soil C	Soil D	Soil E	RVS Score
Primary	W2	4.8	-3	-0.5	0	1.6	-0.8	0	0	2.1
Secondary	RM1	3.6	-2	-0.5	0	0	-0.8	0	0	0.3
Tertiary		0	0	0	0	0	0	0	0	0

Final Type	Final Score
RM1	0.3

High (>10%)

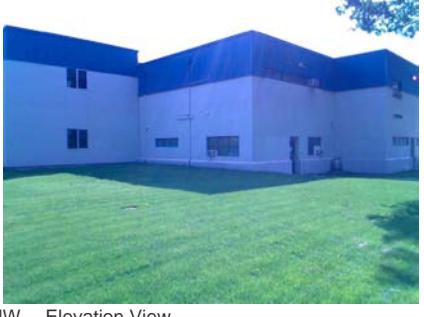
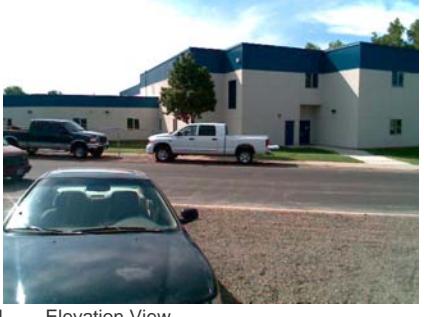
NW Elevation View		N Elevation View

Enrollment 267	Year Built (Field Verified) 1953	Year Built (Alt. Source) 1953	Est. Decade Built 1980
Total Area (square ft) 52298	Number of Stories 2	Basement	Pounding Potential No
Plan Irregularities Reentrant Corners: Other Reentrant Corners: Other None		Vertical Irregularities Steps in Elevation View: Very Irregular Changes Steps in Elevation View: Single Change (Adjacent Building/Entity) None	
Falling Hazards None None None		Poor Conditions None None None

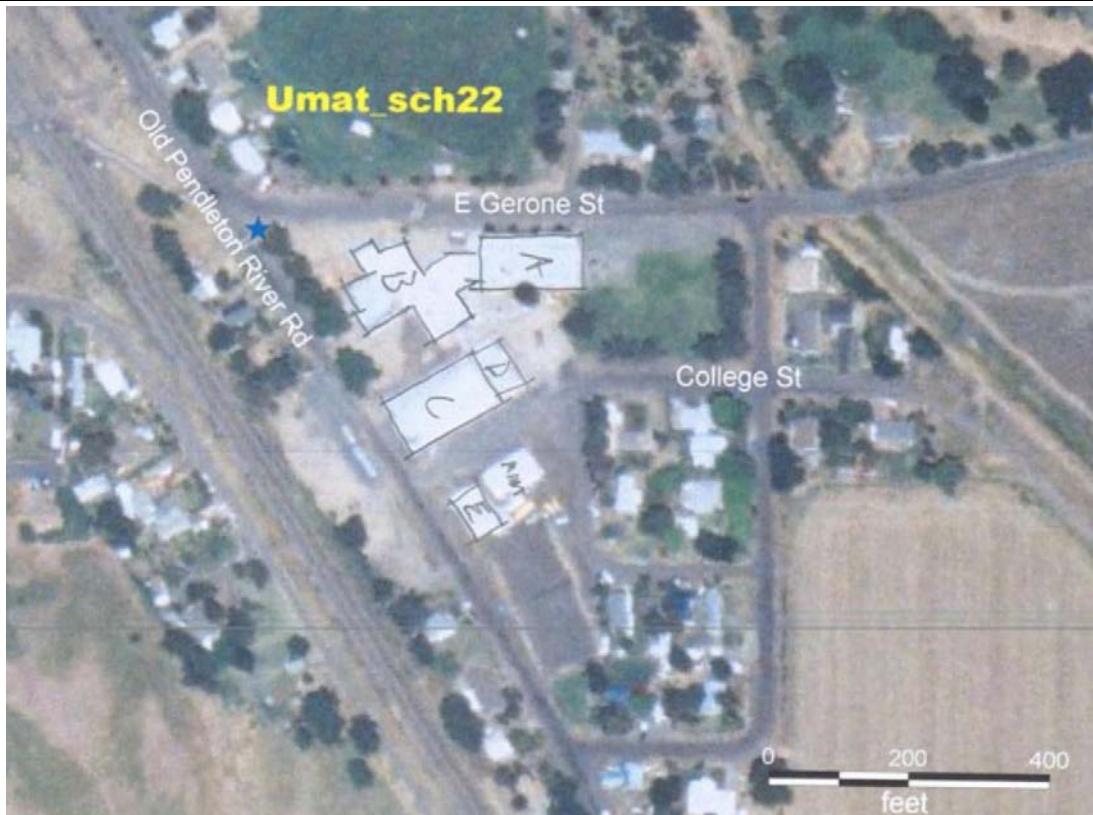
Umat_sch22D

Type	Basic Score	Vert Irreg	Plan Irreg	Pre-Code	Post-Bench	Soil C	Soil D	Soil E	RVS Score
Primary	W2	4.8	-3	-0.5	0	1.6	-0.8	0	0	2.1
Secondary	RM1	3.6	-2	-0.5	0	0	-0.8	0	0	0.3
Tertiary		0	0	0	0	0	0	0	0	0

Final Type	Final Score
RM1	0.3

High (>10%)

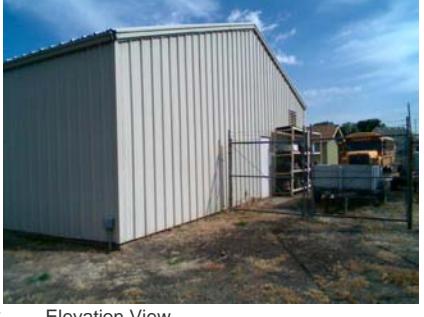
S Elevation View

Enrollment 267	Year Built (Field Verified) 1953	Year Built (Alt. Source) 1953	Est. Decade Built 1970
Total Area (square ft) 52298	Number of Stories 1	Basement	Pounding Potential No
Plan Irregularities None None None		Vertical Irregularities None None None	
Falling Hazards None None None		Poor Conditions None None None
