McLoughlin High School

Umat_sch25A

FEMA 154 Rapid Visual Screening Score Card

Rapid Visual Screening - Senate Bill #2 - Seismic Needs Assessment
Oregon Department of Geology and Mineral Industries

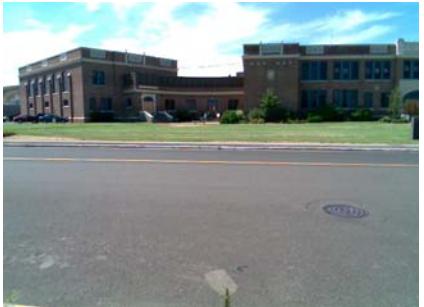
W Elevation View		W Field Verified Year Built

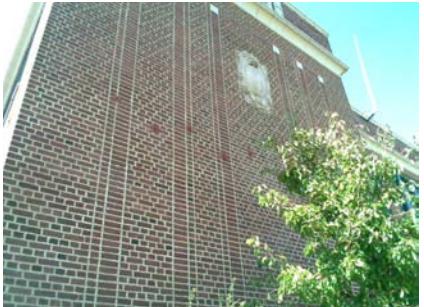
W Seismic Upgrade

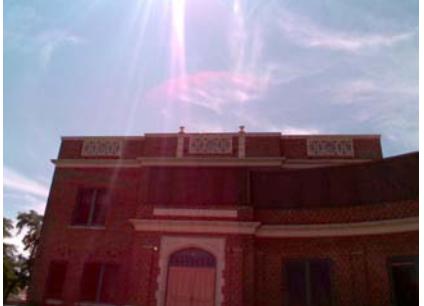
Enrollment 508	Year Built (Field Verified) 1921	Year Built (Alt. Source) 1921	Est. Decade Built 1920
Total Area (square ft) 80312	Number of Stories 2	Basement	Pounding Potential Yes
Plan Irregularities Reentrant Corners: Other None None		Vertical Irregularities Steps in Elevation View: 2 to 3 Changes None None	
Falling Hazards Parapets: Unreinforced Around Entire Building None None		Poor Conditions None None None

NW Falling Hazard		S Elevation View Original w/back block additions

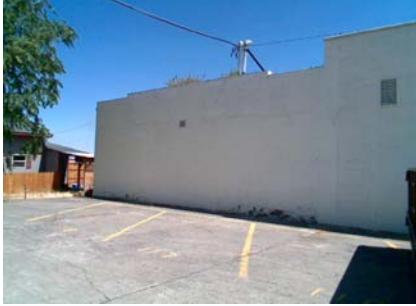
E Elevation View

Enrollment 508	Year Built (Field Verified) 1921	Year Built (Alt. Source) 1921	Est. Decade Built 1940
Total Area (square ft) 80312	Number of Stories 1	Basement	Pounding Potential No
Plan Irregularities None None None		Vertical Irregularities Steps in Elevation View: Single Change (Adjacent Building/Entity) None None	
Falling Hazards None None None		Poor Conditions None None None

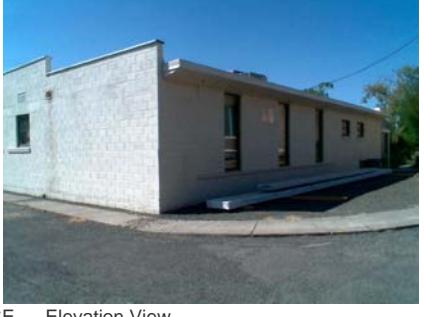
SE Elevation View

Enrollment 508	Year Built (Field Verified) 1921	Year Built (Alt. Source) 1921	Est. Decade Built 1940
Total Area (square ft) 80312	Number of Stories 1	Basement	Pounding Potential No
Plan Irregularities None None None		Vertical Irregularities Steps in Elevation View: Single Change (Adjacent Building/Entity) None None	
Falling Hazards None None None		Poor Conditions None None None

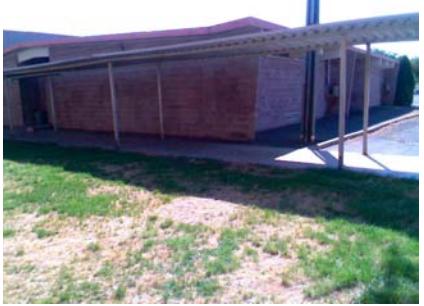
NE Elevation View

Enrollment 508	Year Built (Field Verified) 1921	Year Built (Alt. Source) 1921	Est. Decade Built 1940
Total Area (square ft) 80312	Number of Stories 1	Basement	Pounding Potential No
Plan Irregularities None None None		Vertical Irregularities None None None	
Falling Hazards None None None		Poor Conditions None None None

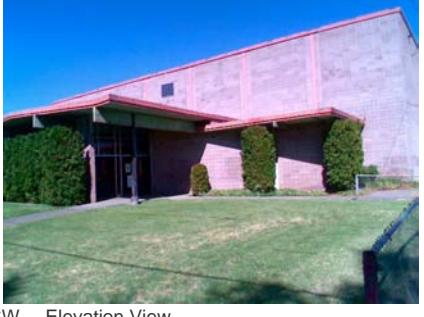
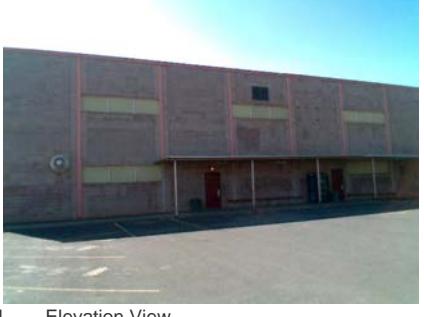
SW Elevation View		N Elevation View

Enrollment 508	Year Built (Field Verified) 1946	Year Built (Alt. Source) 1921	Est. Decade Built 1940
Total Area (square ft) 80312	Number of Stories 1	Basement	Pounding Potential No
Plan Irregularities Reentrant Corners: T shaped None None		Vertical Irregularities Steps in Elevation View: Single Change None None	
Falling Hazards None None None		Poor Conditions None None None

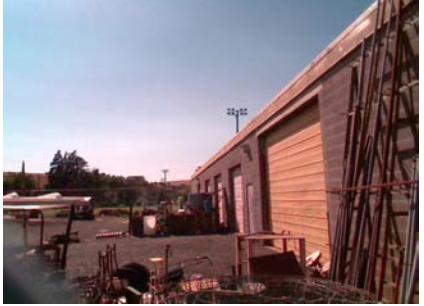
S Elevation View

Enrollment 508	Year Built (Field Verified) 1921	Year Built (Alt. Source) 1921	Est. Decade Built 1980
Total Area (square ft) 80312	Number of Stories 1	Basement	Pounding Potential No
Plan Irregularities Reentrant Corners: T shaped Torsion: Eccentric Stiffness None		Vertical Irregularities None None None	
Falling Hazards None None None		Poor Conditions None None None
