Clara Brownell Middle School

Umat_sch27A

FEMA 154 Rapid Visual Screening Score Card

Rapid Visual Screening - Senate Bill #2 - Seismic Needs Assessment
Oregon Department of Geology and Mineral Industries

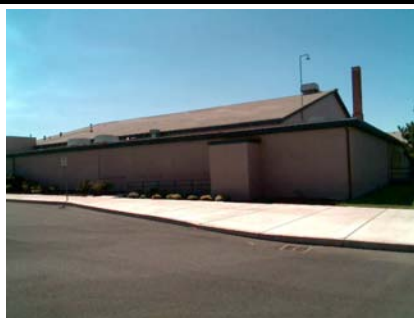
NE Elevation View

Plan Irregularities	Vertical Irregularities
Reentrant Corners: Other	Steps in Elevation View: 2 to 3 Changes
Reentrant Corners: Other	Steps in Elevation View: 2 to 3 Changes (Adjacent Building/Entity)
None	None

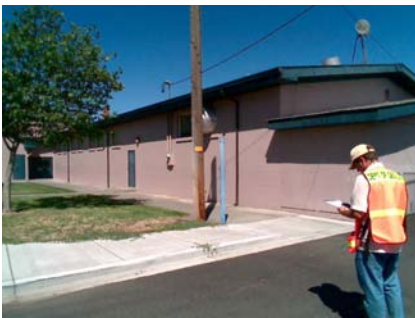
SW Elevation View

Plan Irregularities	Vertical Irregularities
Reentrant Corners: Other (Adjacent Build/Entity)	Steps in Elevation View: Single Change (Adjacent Building/Entity)
Reentrant Corners: Other	None
None	None
