# West Hills Intermediate

Umat\_sch28A

FEMA 154 Rapid Visual Screening Score Card

Rapid Visual Screening - Senate Bill #2 - Seismic Needs Assessment  
Oregon Department of Geology and Mineral Industries

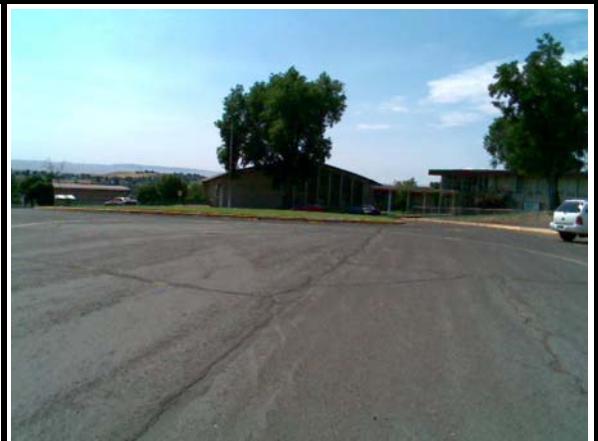
Type	Basic Score	Vert Irreg	Plan Irreg	Pre-Code	Post-Bench	Soil C	Soil D	Soil E	RVS Score
Primary	RM1	3.6	-2	-0.5	0	0	-0.8	0	0	0.3
Secondary		0	0	0	0	0	0	0	0	0
Tertiary		0	0	0	0	0	0	0	0	0

Final Type	Final Score
RM1	0.3

High (>10%)
-------------

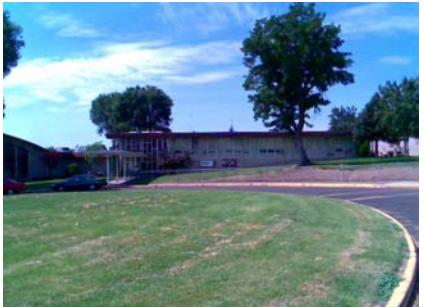
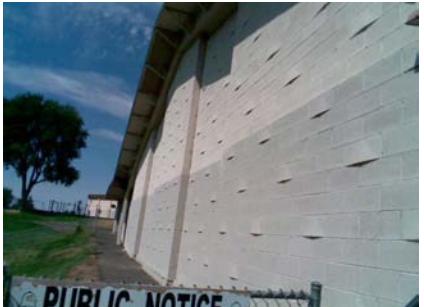
SE Elevation View		SE Elevation View

Enrollment 182	Year Built (Field Verified) 1958	Year Built (Alt. Source) 1958	Est. Decade Built 1950
Total Area (square ft) 21259	Number of Stories 1	Basement	Pounding Potential No
Plan Irregularities Reentrant Corners: Other None None		Vertical Irregularities Steps in Elevation View: 2 to 3 Changes Building On Hill or Sloped Site None	
Falling Hazards None None None		Poor Conditions None None None

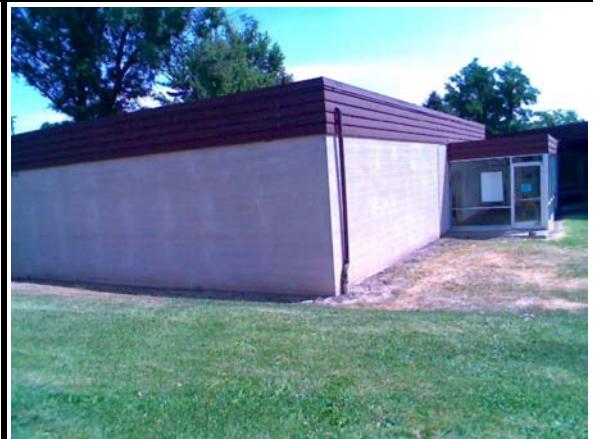
Type	Basic Score	Vert Irreg	Plan Irreg	Pre-Code	Post-Bench	Soil C	Soil D	Soil E	RVS Score
Primary	RM1	3.6	0	0	0	0	-0.8	0	0	2.8
Secondary		0	0	0	0	0	0	0	0	0
Tertiary		0	0	0	0	0	0	0	0	0

Final Type	Final Score
RM1	2.8

Low (<1%)

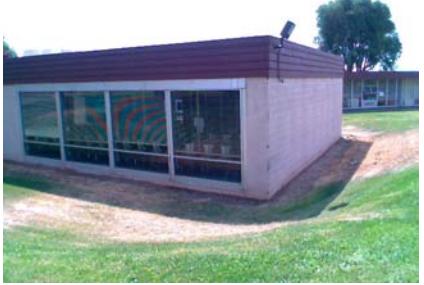
N Elevation View

Enrollment 182	Year Built (Field Verified) 1958	Year Built (Alt. Source) 1958	Est. Decade Built 1970
Total Area (square ft)	Number of Stories 1	Basement	Pounding Potential No
Plan Irregularities None None None		Vertical Irregularities None None None	
Falling Hazards None None None		Poor Conditions None None None

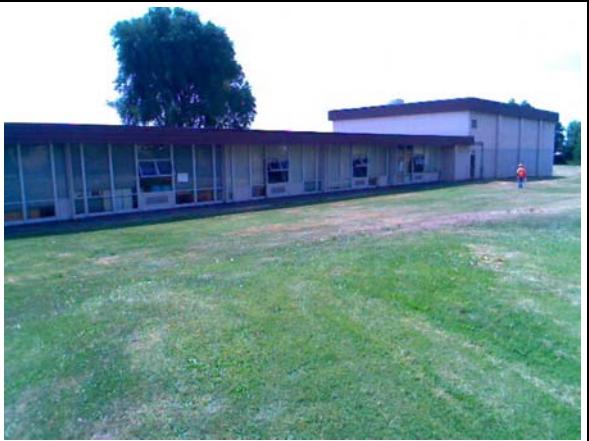
Type	Basic Score	Vert Irreg	Plan Irreg	Pre-Code	Post-Bench	Soil C	Soil D	Soil E	RVS Score
Primary	RM1	3.6	-2	-0.5	0	0	0	0	0	1.1
Secondary		0	0	0	0	0	0	0	0	0
Tertiary		0	0	0	0	0	0	0	0	0

Final Type	Final Score
RM1	1.1

Moderate (>1%)
----------------
