Imbler RFPD

Unio_fir04A

Building Type Fire - RFPD	County Union	
Street 310 Patton St		
City Summerville	State OR	Zip 97876
Latitude 45.48941	Longitude 118.00381	
Tracking Code RVS in 2006	Inspection Date 8/4/2006

Rapid Visual Screening - Senate Bill #2 - Seismic Needs Assessment
Oregon Department of Geology and Mineral Industries

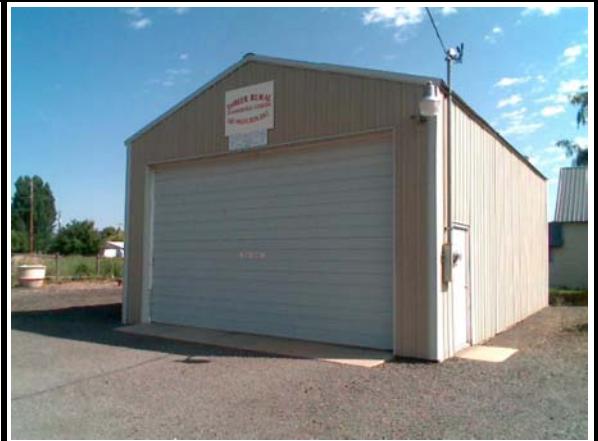
Seismicity Zone: Moderate

Type	Basic Score	Vert Irreg	Plan Irreg	Pre-Code	Post-Bench	Soil C	Soil D	Soil E	RVS Score
Primary	S3	3.8	0	-0.5	0	0	0	-1	0	2.3
Secondary		0	0	0	0	0	0	0	0	0
Tertiary		0	0	0	0	0	0	0	0	0

Final Type	Final Score
S3	2.3

Low (<1%)

Enrollment	Year Built (Field Verified)	Year Built (Alt. Source)	Est. Decade Built
			1990
Total Area (square ft)	Number of Stories	Basement	Pounding Potential
	1	No	No
Plan Irregularities		Vertical Irregularities	
Torsion: Eccentric Stiffness		None	
None		None	
None		None	
Falling Hazards		Poor Conditions	
None		None	
None		None	
None		None
