# OSP - La Grande Patrol

Oregon State Police

## FEMA 154 Rapid Visual Screening Score Card

Rapid Visual Screening - Senate Bill #2 - Seismic Needs Assessment  
Oregon Department of Geology and Mineral Industries

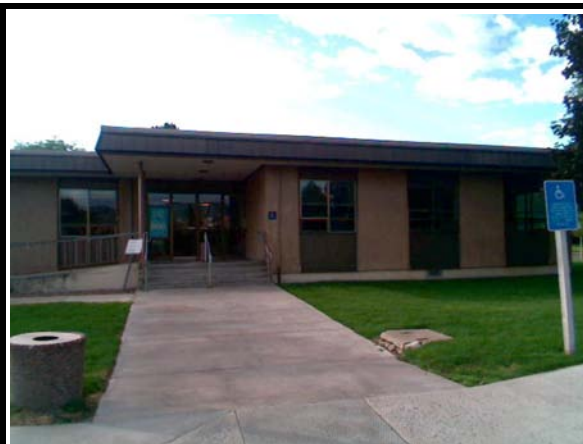
Seismicity Zone: Moderate

| | Type | Basic Score | Vert Irreg | Plan Irreg | Pre-Code | Post-Bench | Soil C | Soil D | Soil E | RVS Score |
| Primary | W2 | 4.8 | 0 | -0.5 | 0 | 0 | -0.8 | 0 | 0 | 3.5 |
