Union Elementary School

Unio_sch04A

FEMA 154 Rapid Visual Screening Score Card

Rapid Visual Screening - Senate Bill #2 - Seismic Needs Assessment
Oregon Department of Geology and Mineral Industries

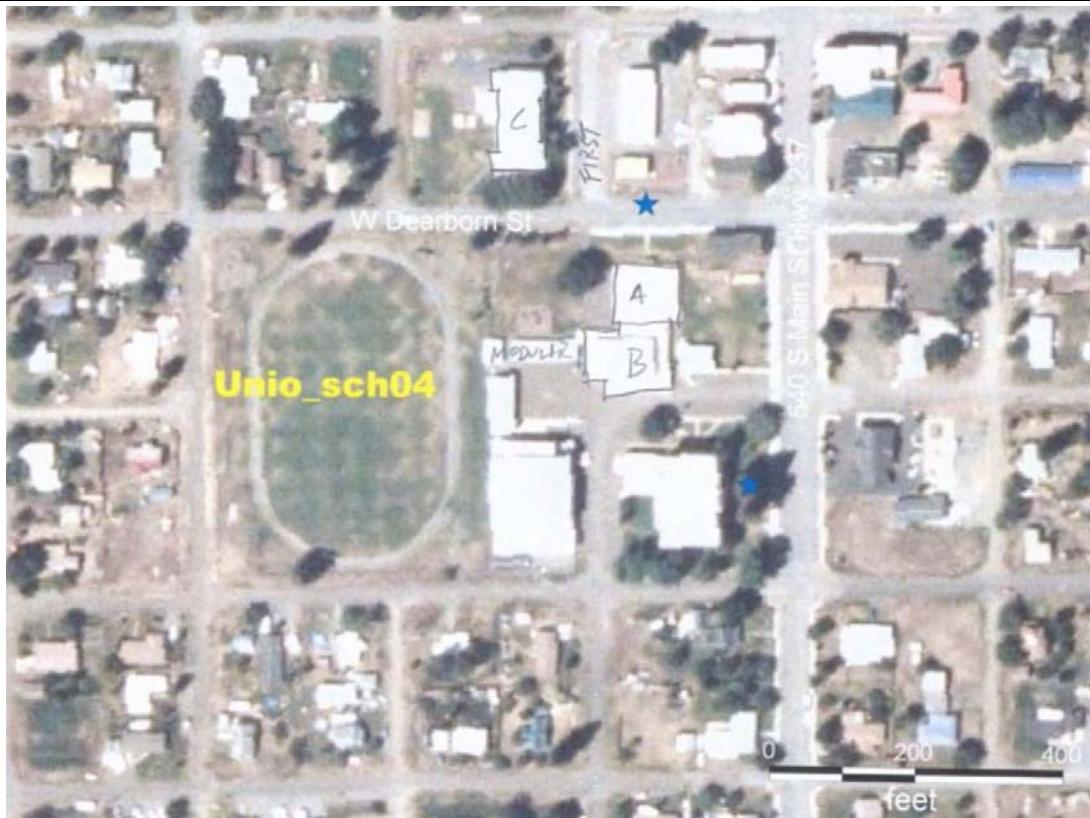
Type	Basic Score	Vert Irreg	Plan Irreg	Pre-Code	Post-Bench	Soil C	Soil D	Soil E	RVS Score
Primary	W2	4.8	-3	-0.5	0	0	-0.8	0	0	0.5
Secondary		0	0	0	0	0	0	0	0	0
Tertiary		0	0	0	0	0	0	0	0	0

Final Type	Final Score
W2	0.5

High (>10%)

Enrollment 240	Year Built (Field Verified) 1929	Year Built (Alt. Source) 1929	Est. Decade Built 1950
Total Area (square ft) 48303	Number of Stories 1	Basement	Pounding Potential No
Plan Irregularities Reentrant Corners:L shaped (Adjacent Build/Entity) None None		Vertical Irregularities Steps in Elevation View: Single Change (Adjacent Building/Entity) None None	
Falling Hazards None None None		Poor Conditions None None None

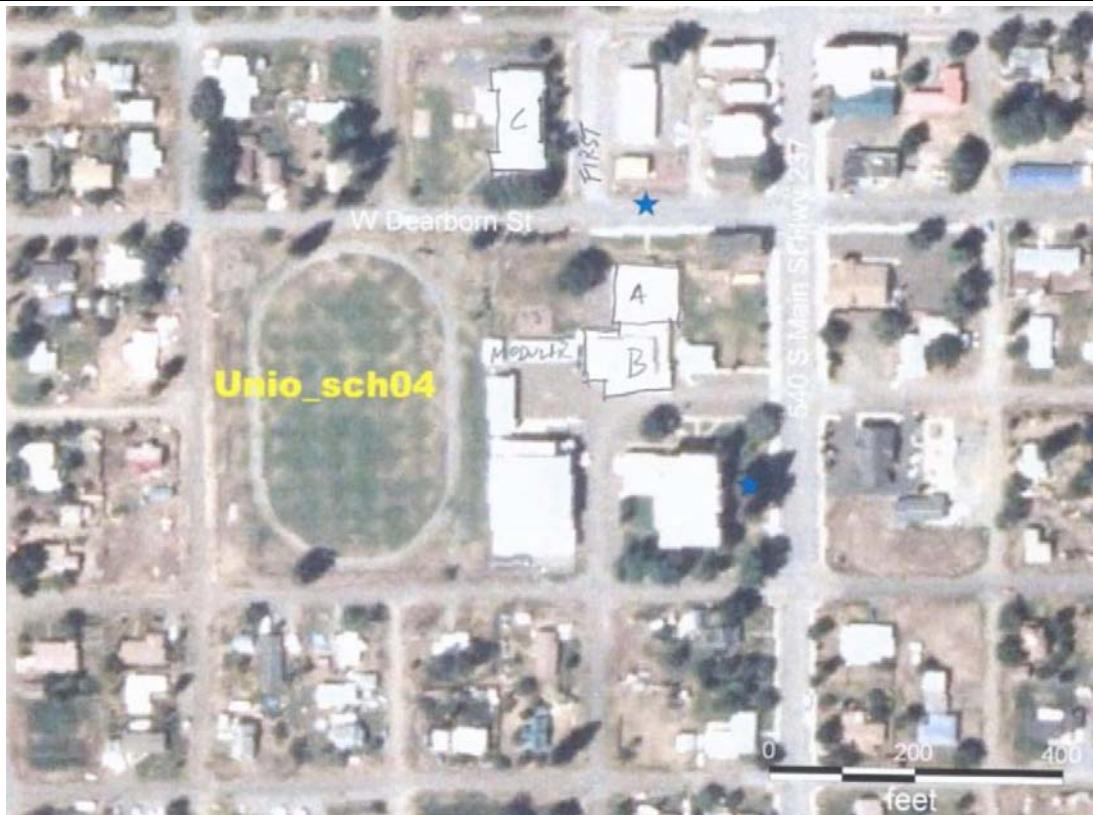
Unio_sch04B

Type	Basic Score	Vert Irreg	Plan Irreg	Pre-Code	Post-Bench	Soil C	Soil D	Soil E	RVS Score
Primary	RM1	3.6	-2	-0.5	0	0	-0.8	0	0	0.3
Secondary	W2	4.8	-3	-0.5	0	0	-0.8	0	0	0.5
Tertiary		0	0	0	0	0	0	0	0	0

Final Type	Final Score
RM1	0.3

High (>10%)

Enrollment 240	Year Built (Field Verified) 1929	Year Built (Alt. Source) 1929	Est. Decade Built 1960
Total Area (square ft)	Number of Stories 1	Basement	Pounding Potential No
Plan Irregularities Reentrant Corners:L shaped (Adjacent Build/Entity) None None		Vertical Irregularities Vertical Change in Structural Type (Soft over Stiff) Steps in Elevation View: Single Change Steps in Elevation View: Single Change (Adjacent Building/Entity)	
Falling Hazards Other: Smokestack None None		Poor Conditions None None None

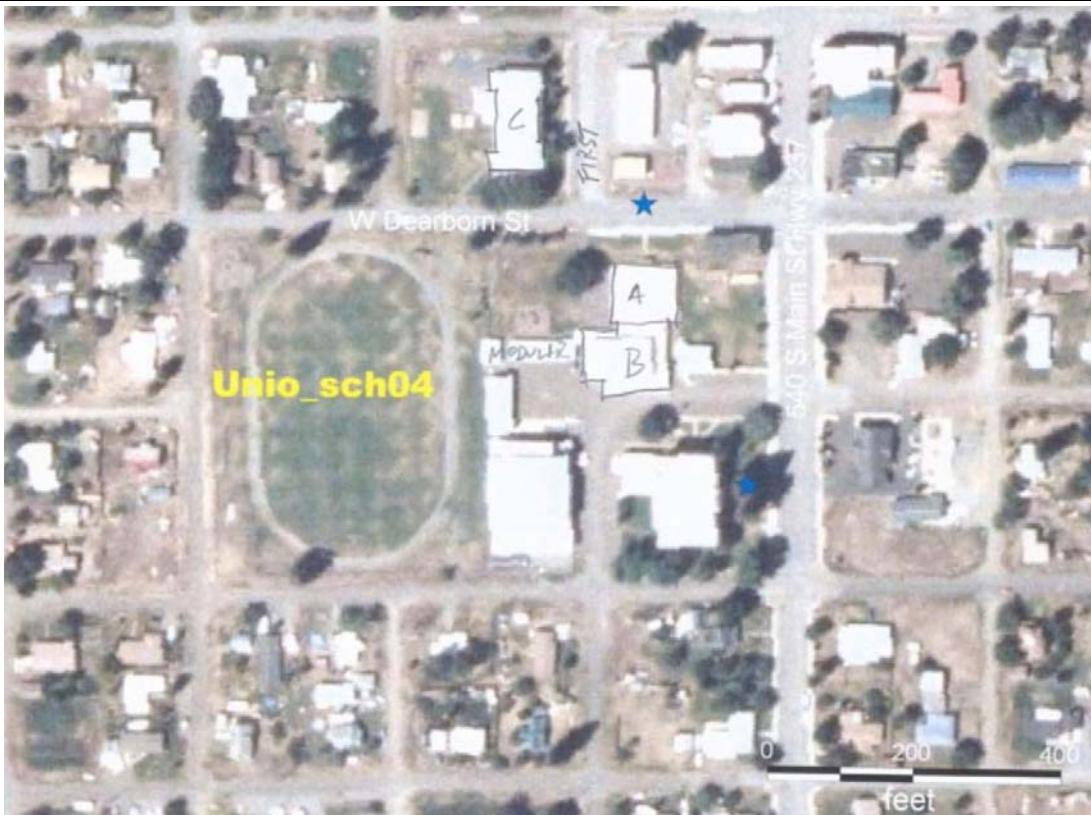
Unio_sch04C

Type	Basic Score	Vert Irreg	Plan Irreg	Pre-Code	Post-Bench	Soil C	Soil D	Soil E	RVS Score
Primary	C2	3.6	0	-0.5	-0.4	0	-0.8	0	0	1.9
Secondary	URM	3.4	0	-0.5	-0.4	0	-0.4	0	0	2.1
Tertiary		0	0	0	0	0	0	0	0	0

Final Type	Final Score
C2	1.9

Moderate (>1%)

Enrollment 240	Year Built (Field Verified) 1929	Year Built (Alt. Source) 1929	Est. Decade Built 1930
Total Area (square ft)	Number of Stories 1	Basement	Pounding Potential No
Plan Irregularities Out of Plane Lateral-Force-Resistance Elements None None		Vertical Irregularities None None None	
Falling Hazards Unreinforced Chimneys None None		Poor Conditions None None None
