TVF & R - North Division Office

Building Type Fire - RFPD	County Washington	
Street 14480 SW Jenkins Rd		
City Beaverton	State OR	Zip 97005
Latitude 45.50343	Longitude 122.82619	
Tracking Code RVS in 2006	Inspection Date 6/27/2006

FEMA 154 Rapid Visual Screening Score Card

Rapid Visual Screening - Senate Bill #2 - Seismic Needs Assessment
Oregon Department of Geology and Mineral Industries

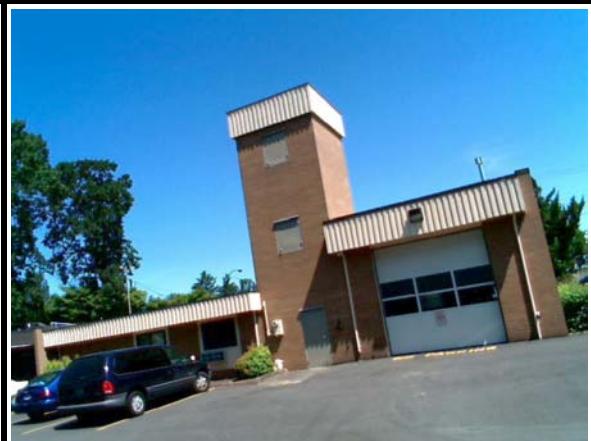
Seismicity Zone: High

Type	Basic Score	Vert Irreg	Plan Irreg	Pre-Code	Post-Bench	Soil C	Soil D	Soil E	RVS Score
Primary	RM1	2.8	-1	-0.5	0	0	-0.4	0	0	0.9
Secondary		0	0	0	0	0	0	0	0	0
Tertiary		0	0	0	0	0	0	0	0	0

Final Type	Final Score
RM1	0.9

High (>10%)

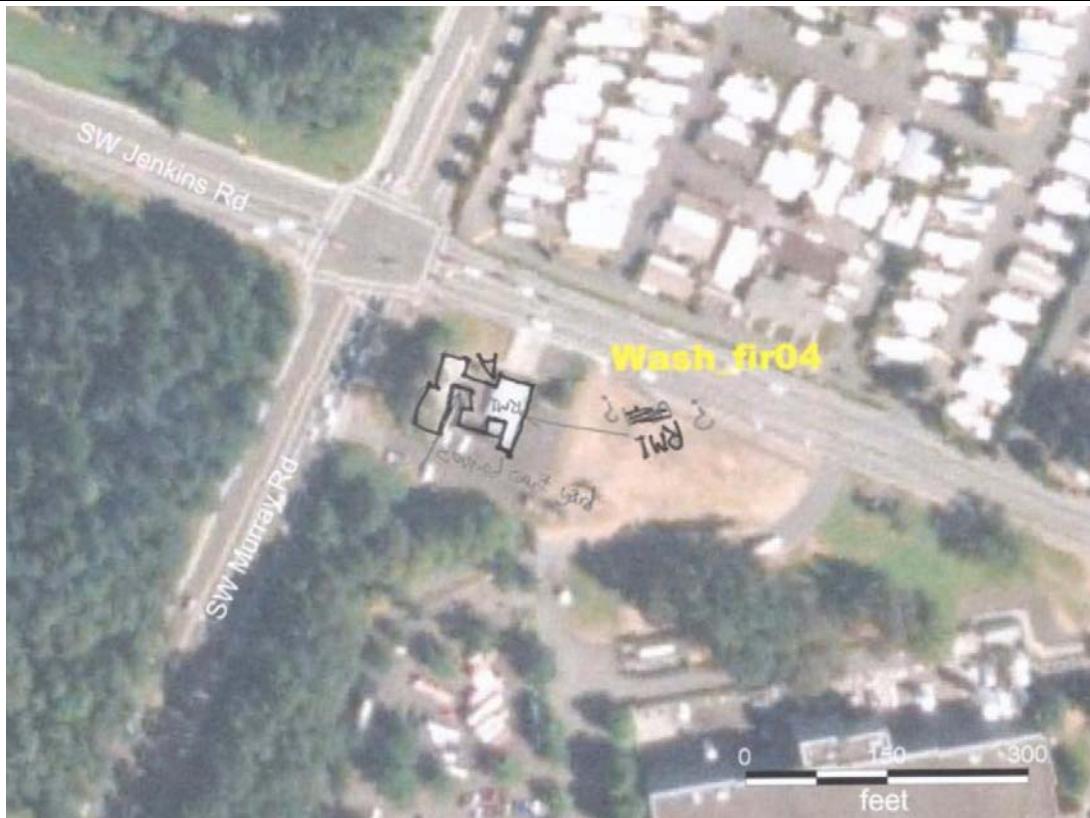
Enrollment	Year Built (Field Verified)	Year Built (Alt. Source)	Est. Decade Built
		1968	1970
Total Area (square ft)	Number of Stories	Basement	Pounding Potential
	1	No	No
Plan Irregularities		Vertical Irregularities	
Reentrant Corners: Other		Steps in Elevation View: 2 to 3 Changes (Adjacent Building/Entity)	
Lateral-Force-Resistance in One Direction Only		None	
None		None	
Falling Hazards		Poor Conditions	
Other: General		None	
None		None	
None		None

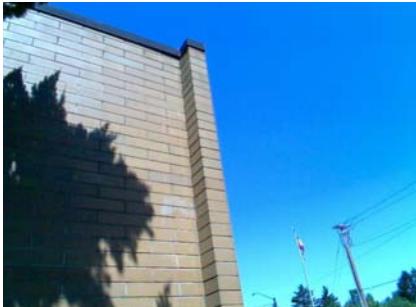
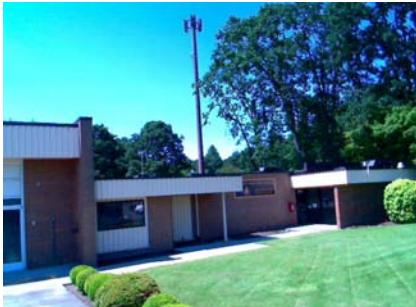
E	Primary Structural Type	N	Plan Irregularity Primary

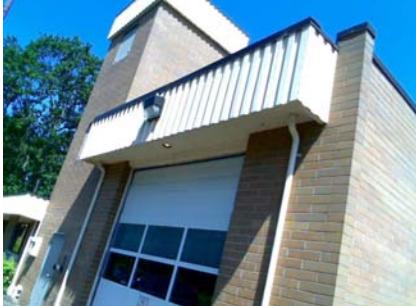
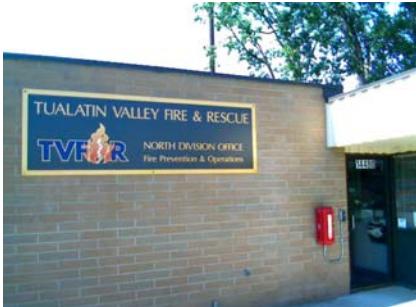
S	Falling Hazard	N	Building Name
