West Tualatin View Elementary School

Beaverton SD 48J

FEMA 154 Rapid Visual Screening Score Card

Rapid Visual Screening - Senate Bill #2 - Seismic Needs Assessment
Oregon Department of Geology and Mineral Industries

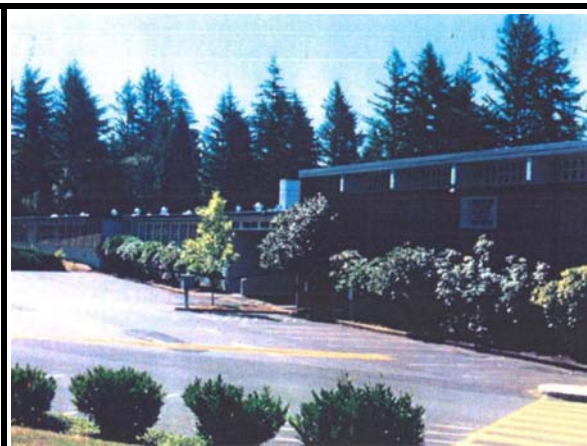
Type	Basic Score	Vert Irreg	Plan Irreg	Pre-Code	Post-Bench	Soil C	Soil D	Soil E	RVS Score
Primary	C2	2.8	-1	-0.5	0	0	-0.4	0	0	0.9
Secondary		0	0	0	0	0	0	0	0	0
Tertiary		0	0	0	0	0	0	0	0	0

C2

0.9

FEMA-154 Collapse Potential

Moderate (>1%)

Enrollment	Year Built (Field Verified)	Year Built (Alt. Source)	Est. Decade Built
346		1955	
Total Area (square ft)	Number of Stories	Basement	Pounding Potential
42228	1	No	No
