# Mountain View Middle School

## FEMA 154 Rapid Visual Screening Score Card

Rapid Visual Screening - Senate Bill #2 - Seismic Needs Assessment  
Oregon Department of Geology and Mineral Industries

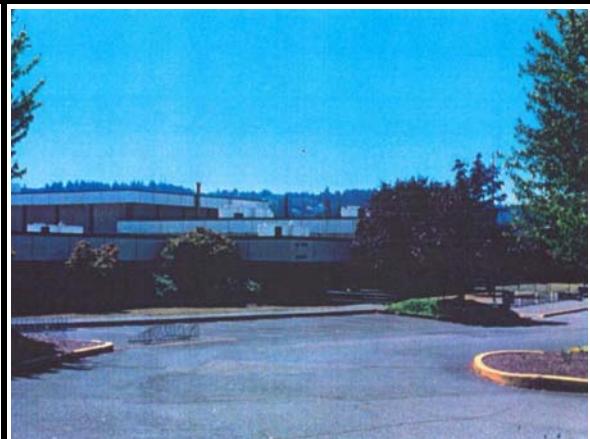
Type	Basic Score	Vert Irreg	Plan Irreg	Pre-Code	Post-Bench	Soil C	Soil D	Soil E	RVS Score
Primary	S1	2.8	-1	-0.5	0	0	-0.4	0	0	0.9
Secondary	RM2	2.8	-1	-0.5	0	0	-0.4	0	0	0.9
Tertiary		0	0	0	0	0	0	0	0	0

Final Type	Final Score
S1	0.9

High (>10%)

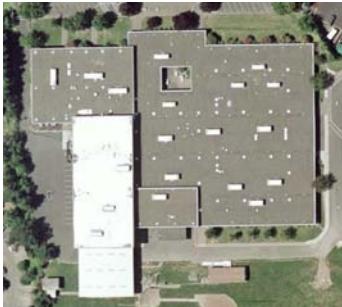
S General Site

Enrollment 1046	Year Built (Field Verified) 1968	Year Built (Alt. Source) 1968	Est. Decade Built 1960
Total Area (square ft) 136296	Number of Stories 1	Basement	Pounding Potential No
Plan Irregularities Reentrant Corners:L shaped Large Diaphragm or Central Opening		Vertical Irregularities Steps in Elevation View: Single Change	
Falling Hazards None None None		Poor Conditions None None None
