Sexton Mountain Elementary School

Beaverton SD 48J

FEMA 154 Rapid Visual Screening Score Card

Rapid Visual Screening - Senate Bill #2 - Seismic Needs Assessment
Oregon Department of Geology and Mineral Industries

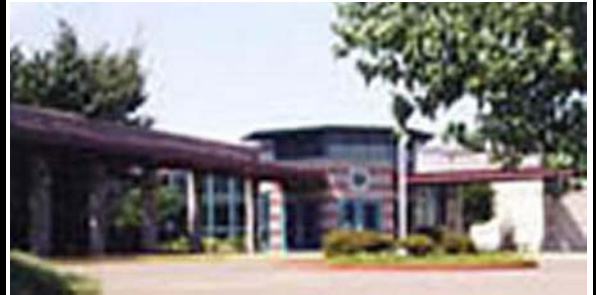
Type	Basic Score	Vert Irreg	Plan Irreg	Pre-Code	Post-Bench	Soil C	Soil D	Soil E	RVS Score
Primary	RM1	2.8	-1	-0.5	0	0	-0.4	0	0	0.9
Secondary		0	0	0	0	0	0	0	0	0
Tertiary		0	0	0	0	0	0	0	0	0

FEMA-154 Collapse Potential

High (>10%)
