Spray School

Whee_sch01A

FEMA 154 Rapid Visual Screening Score Card

Rapid Visual Screening - Senate Bill #2 - Seismic Needs Assessment
Oregon Department of Geology and Mineral Industries

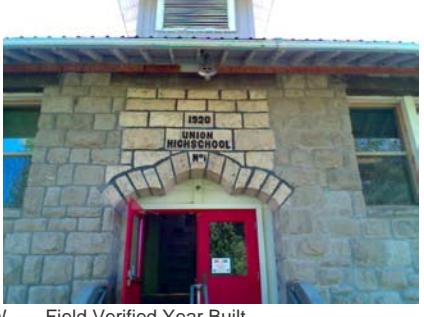
W	Field Verified Year Built	W	Seismic Upgrade

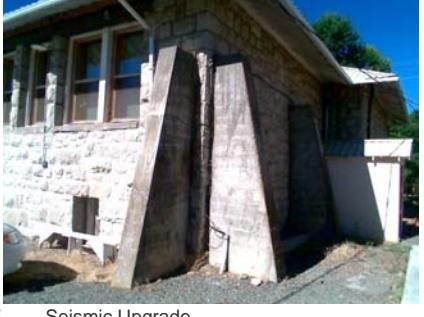
Enrollment	Year Built (Field Verified)	Year Built (Alt. Source)	Est. Decade Built
66	1920	1955	1920
Total Area (square ft)	Number of Stories	Basement	Pounding Potential
3026	1	Yes	No
Plan Irregularities		Vertical Irregularities	
Reentrant Corners: T shaped		Steps in Elevation View: Single Change	
None		None	
None		None	
Falling Hazards		Poor Conditions	
None		None	
None		None	
None		None

E	Seismic Upgrade	E	Plan Irregularity Primary

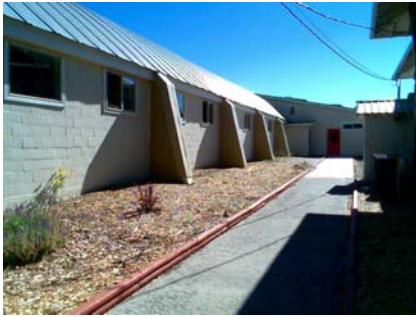
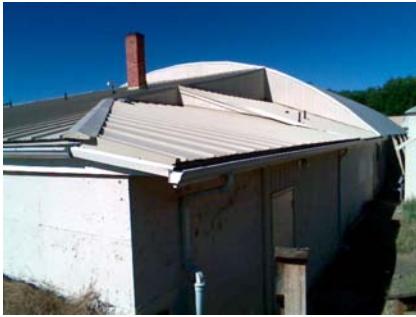
Enrollment 66	Year Built (Field Verified) 1955	Year Built (Alt. Source) 1950	Est. Decade Built 1950
Total Area (square ft) 3026	Number of Stories 1	Basement	Pounding Potential No
Plan Irregularities Reentrant Corners: L Shaped None None		Vertical Irregularities Steps in Elevation View: 2 to 3 Changes Building On Hill or Sloped Site None	
Falling Hazards None None None		Poor Conditions None None None

SE Plan Irregularity Primary		E Vertical Irregularity Primary

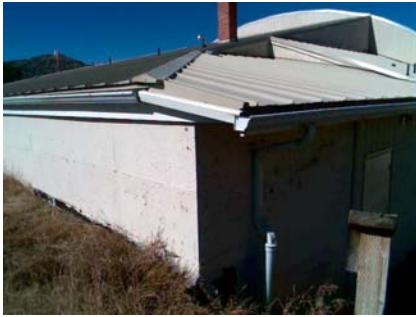
NE Tertiary Structural Type

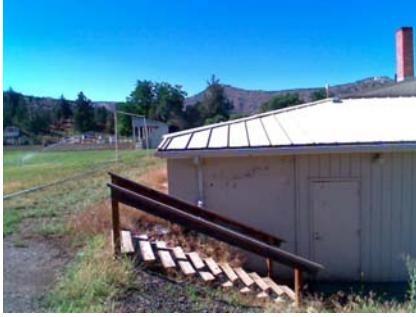
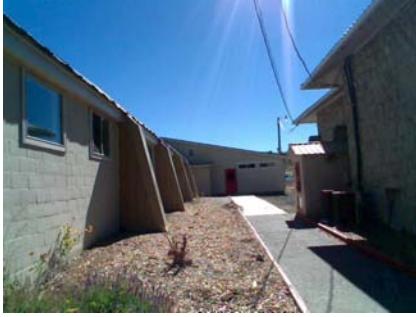
N Vertical Irregularity Secondary		W Secondary Structural Type

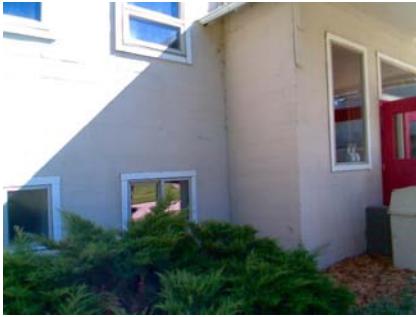
Enrollment 66	Year Built (Field Verified) 1955	Year Built (Alt. Source) 1950	Est. Decade Built 1950
Total Area (square ft) 3026	Number of Stories 2	Basement	Pounding Potential No
Plan Irregularities Out of Plane Lateral-Force-Resistance Elements None None		Vertical Irregularities Internal Discontinuous Diaphragm (large internal opening) None None	
Falling Hazards None None None		Poor Conditions None None None

SW Plan Irregularity Primary

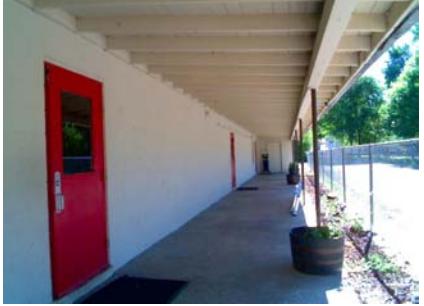
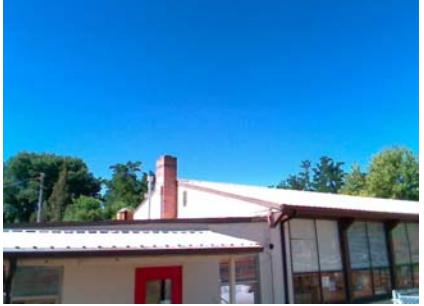
Enrollment 66	Year Built (Field Verified) 1955	Year Built (Alt. Source) 1955	Est. Decade Built 1960
Total Area (square ft) 3026	Number of Stories 1	Basement	Pounding Potential No
Plan Irregularities None None None		Vertical Irregularities Steps in Elevation View: Single Change None None	
Falling Hazards None None None		Poor Conditions None None None

W Plan Irregularity Primary		NE Vertical Irregularity Primary
