Mitchell School

Whee_sch02A

FEMA 154 Rapid Visual Screening Score Card

Rapid Visual Screening - Senate Bill #2 - Seismic Needs Assessment
Oregon Department of Geology and Mineral Industries

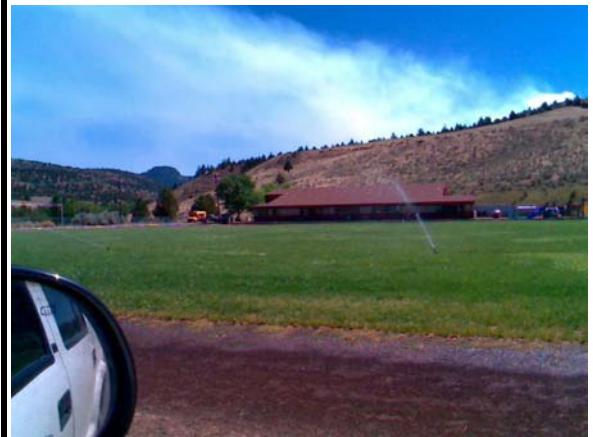
| | Type | Basic Score | Vert Irreg | Plan Irreg | Pre-Code | Post-Bench | Soil C | Soil D | Soil E | RVS Score |
|---|---|---|---|---|---|---|---|---|---|---|
| Primary | W2 | 4.8 | -3 | -0.5 | 0 | 1.6 | -0.8 | 0 | 0 | 2.1 |
| Secondary | RM1 | 3.6 | -2 | -0.5 | 0 | 0 | -0.8 | 0 | 0 | 0.3 |

| Final Type | Final Score |
|---|---|
| RM1 | 0.3 |

High (>10%)

| Plan Irregularities Reentrant Corners: Other None None | | Vertical Irregularities Steps in Elevation View: 2 to 3 Changes None None | |

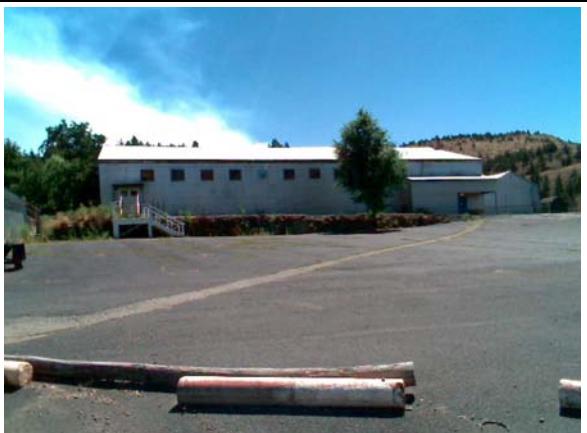
Whee_sch02B

| | Type | Basic Score | Vert Irreg | Plan Irreg | Pre-Code | Post-Bench | Soil C | Soil D | Soil E | RVS Score |
|---|---|---|---|---|---|---|---|---|---|---|
| Primary | W2 | 4.8 | 0 | 0 | 0 | 0 | -0.8 | 0 | 0 | 4 |

| Final Type | Final Score |
|---|---|
| W2 | 4 |

Low (<1%)

| Falling Hazards Unreinforced Chimneys None None | | Poor Conditions Other None None | |

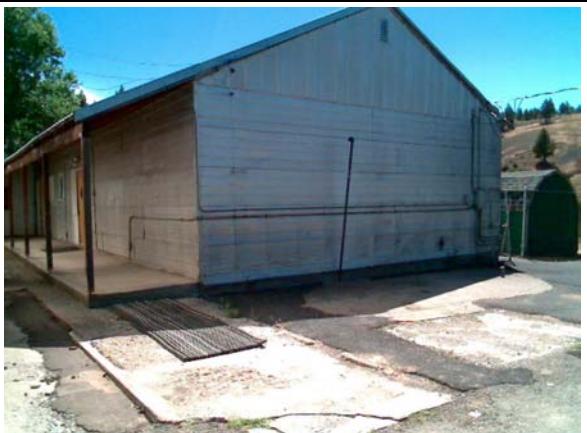
Whee_sch02C

| Falling Hazards None None None | | Poor Conditions Other None None | |
