Building Type Police-City	County Yamhill
Street 205 N Maple St	
City Yamhill	State OR
Latitude 45.34059	Longitude 123.18753
Tracking Code RVS in 2006	Inspection Date 8/21/2006

## FEMA 154 Rapid Visual Screening Score Card

# Yamhill Police Dept

Rapid Visual Screening - Senate Bill #2 - Seismic Needs Assessment  
Oregon Department of Geology and Mineral Industries

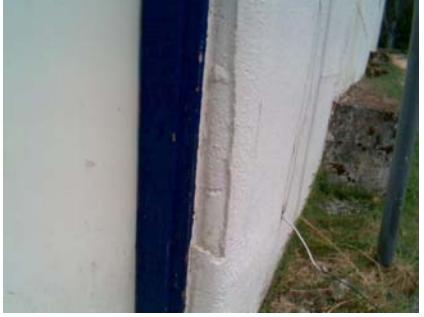
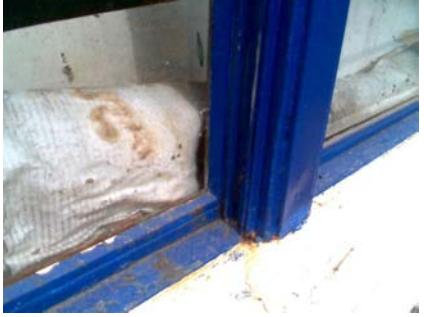
S Primary Structural Type		S Primary Structural Type

Type	Basic Score	Vert Irreg	Plan Irreg	Pre-Code	Post-Bench	Soil C	Soil D	Soil E	RVS Score
Primary	RM1	2.8	0	0	-1	0	-0.4	0	0	1.4
Secondary		0	0	0	0	0	0	0	0	0
Tertiary		0	0	0	0	0	0	0	0	0

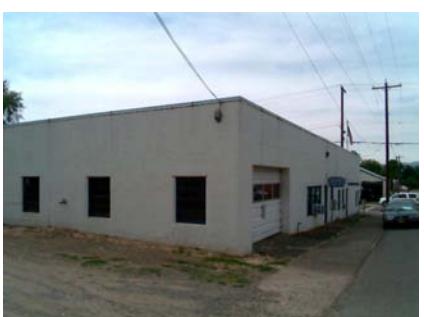
SE General Site		SE Falling Hazard

Enrollment	Year Built (Field Verified)	Year Built (Alt. Source)	Est. Decade Built
			1940
Total Area (square ft)	Number of Stories	Basement	Pounding Potential
	1	No	No
Plan Irregularities		Vertical Irregularities	
None		Building On Hill or Sloped Site	
None		None	
None		None	
Falling Hazards		Poor Conditions	
Unreinforced Chimneys		None	
Parapets: General		None	
None		None
