Yamhill-Carlton High School

Yamh_sch18A

Rapid Visual Screening - Senate Bill #2 - Seismic Needs Assessment
Oregon Department of Geology and Mineral Industries

Yamh_sch18B

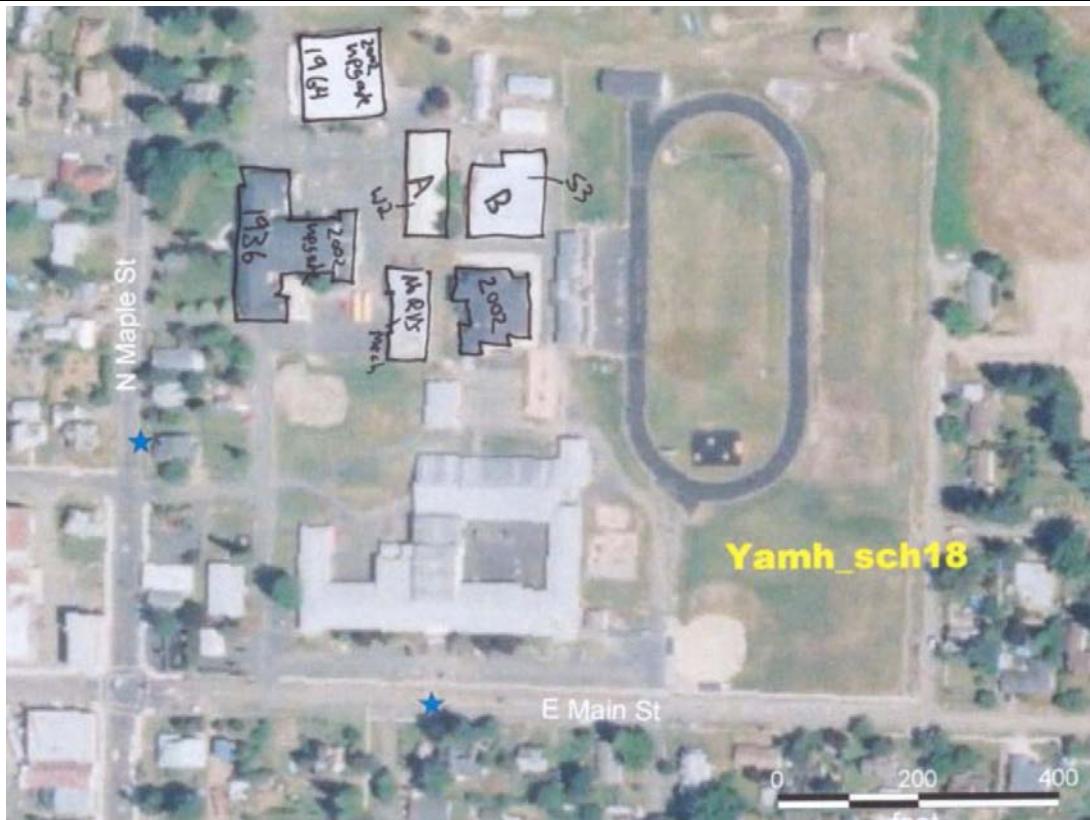
Enrollment 438	Year Built (Field Verified) 1935	Year Built (Alt. Source) 1935	Est. Decade Built 1950
Total Area (square ft) 64037	Number of Stories 1	Basement	Pounding Potential No
Plan Irregularities None None None		Vertical Irregularities None None None	
Falling Hazards None None None		Poor Conditions None None None

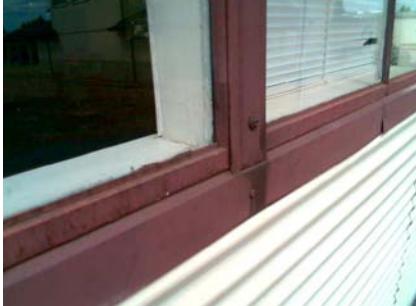
S Primary Structural Type Wood inside window. Shop teacher said the walls are wood framed with steel truss roof.

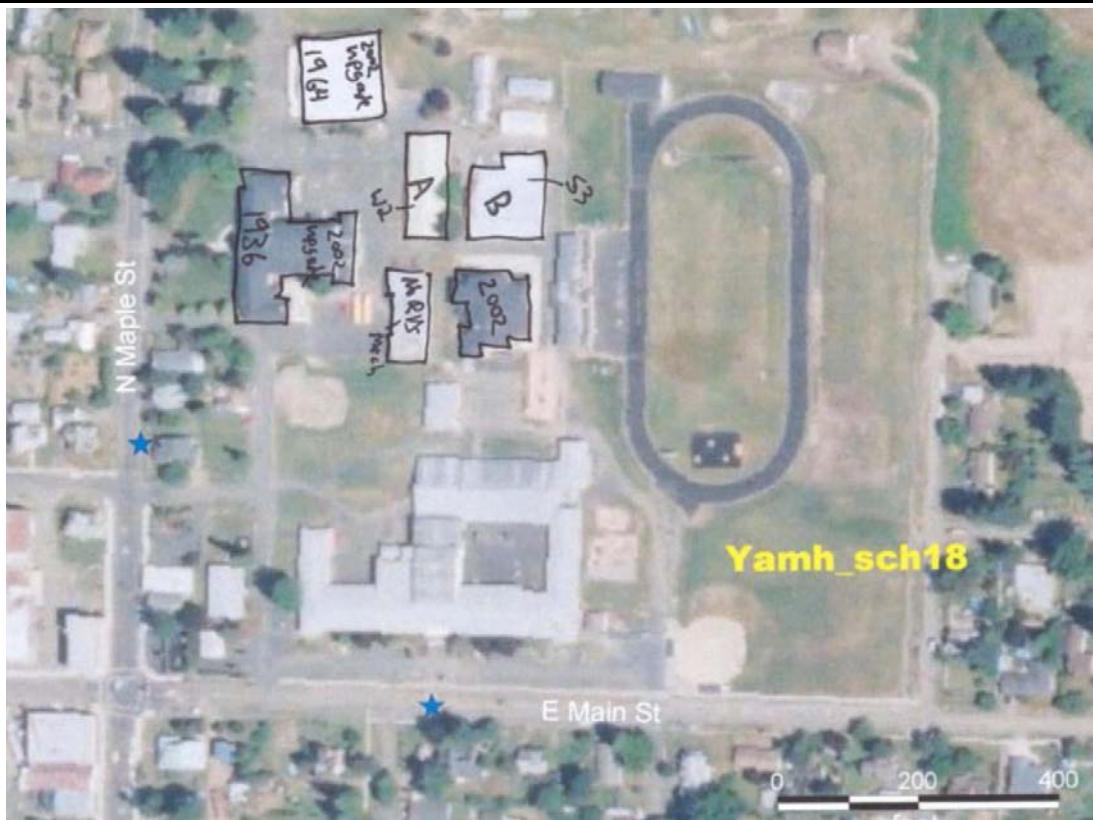
Enrollment 438	Year Built (Field Verified) 1935	Year Built (Alt. Source) 1935	Est. Decade Built 1970
Total Area (square ft) 64037	Number of Stories 1	Basement	Pounding Potential No
Plan Irregularities Reentrant Corners: L Shaped None None		Vertical Irregularities None None None	
Falling Hazards None None None		Poor Conditions None None None
