EXHIBIT J
WETLANDS
OAR 345-021-0010(1)(j)

- J-1 Wetlands and Waters Phase 2 Design Scenario A: Detailed View
- J-2 Wetlands and Waters Phase 2 Design Scenario B: Detailed View
- J-3 Wetlands and Waters Phase 2 Design Scenario C: Detailed View
- J-4 Wetlands and Waters Survey Coverage

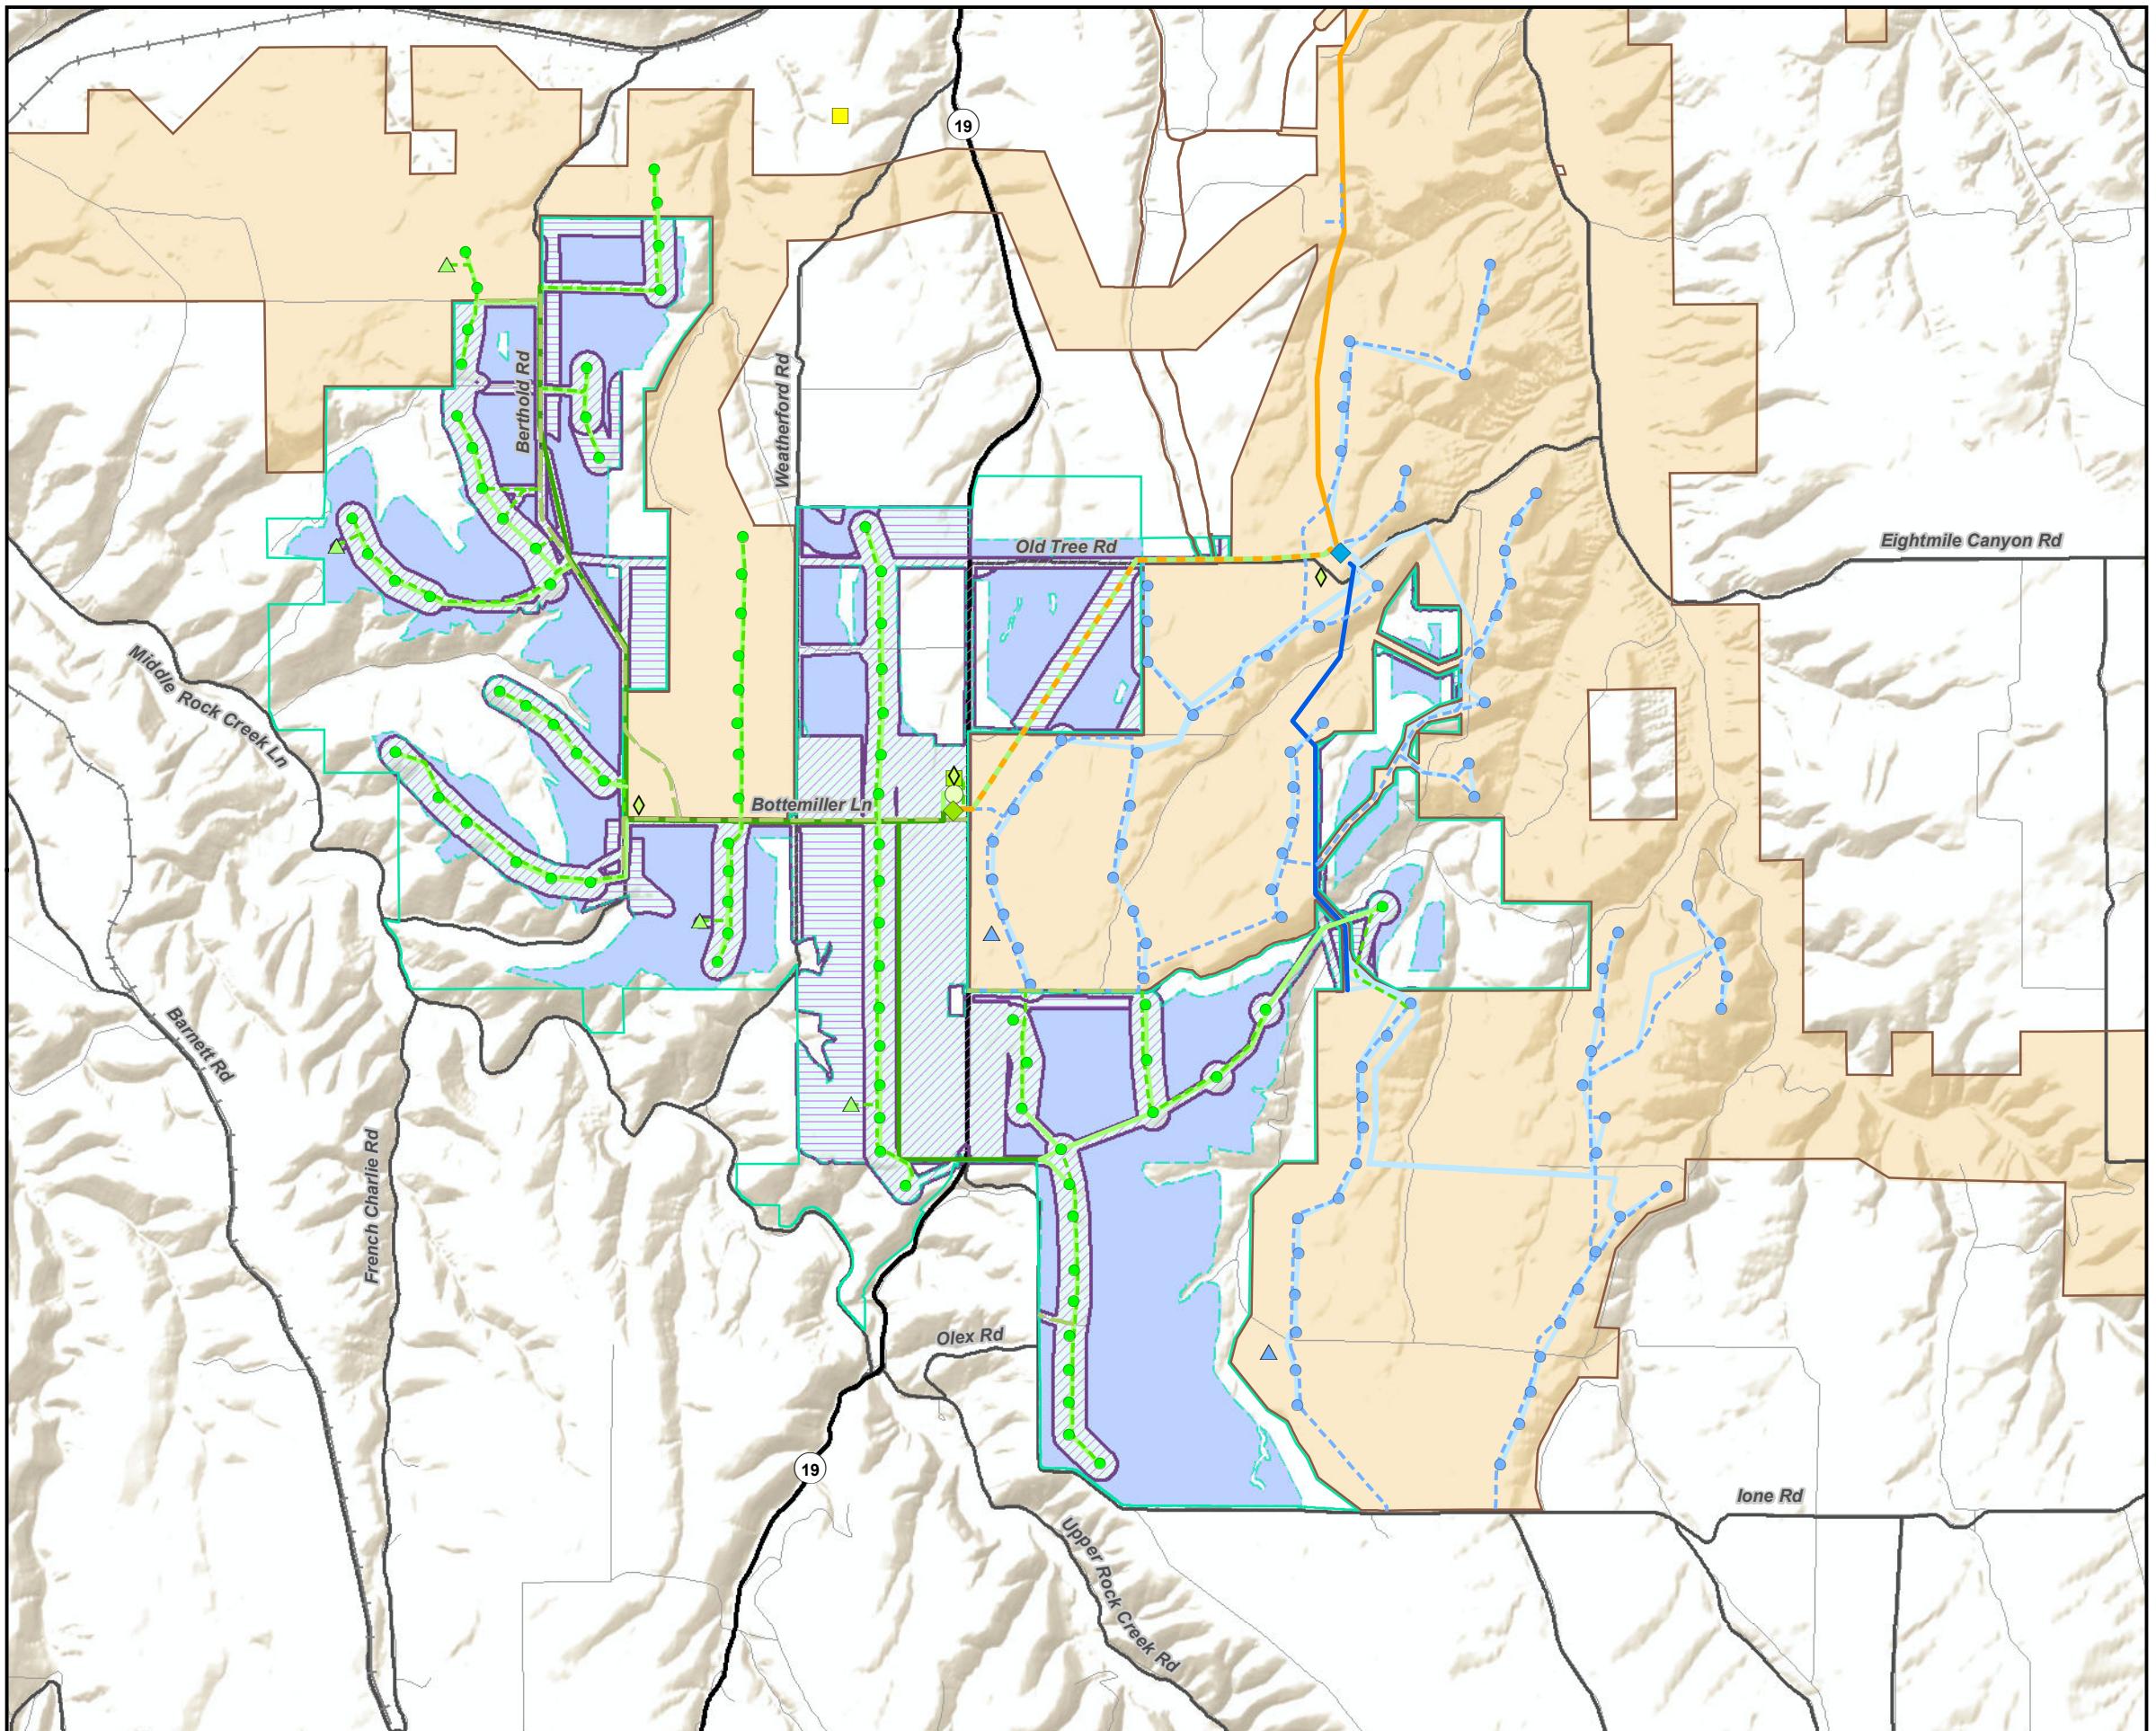
Figure J-4
Wetlands and Waters
Survey Coverage
Montague Wind Power Facility

- Approved Site Boundary
- Approved Micrositing Corridor
- Proposed Expanded Site Boundary
- Proposed Expanded Micrositing Corridor
- 2017 Wetland Survey Corridor
- 2018 Wetland Survey Corridor
- Previously Surveyed for Wetlands
- Existing Shared LJIB O&M Building

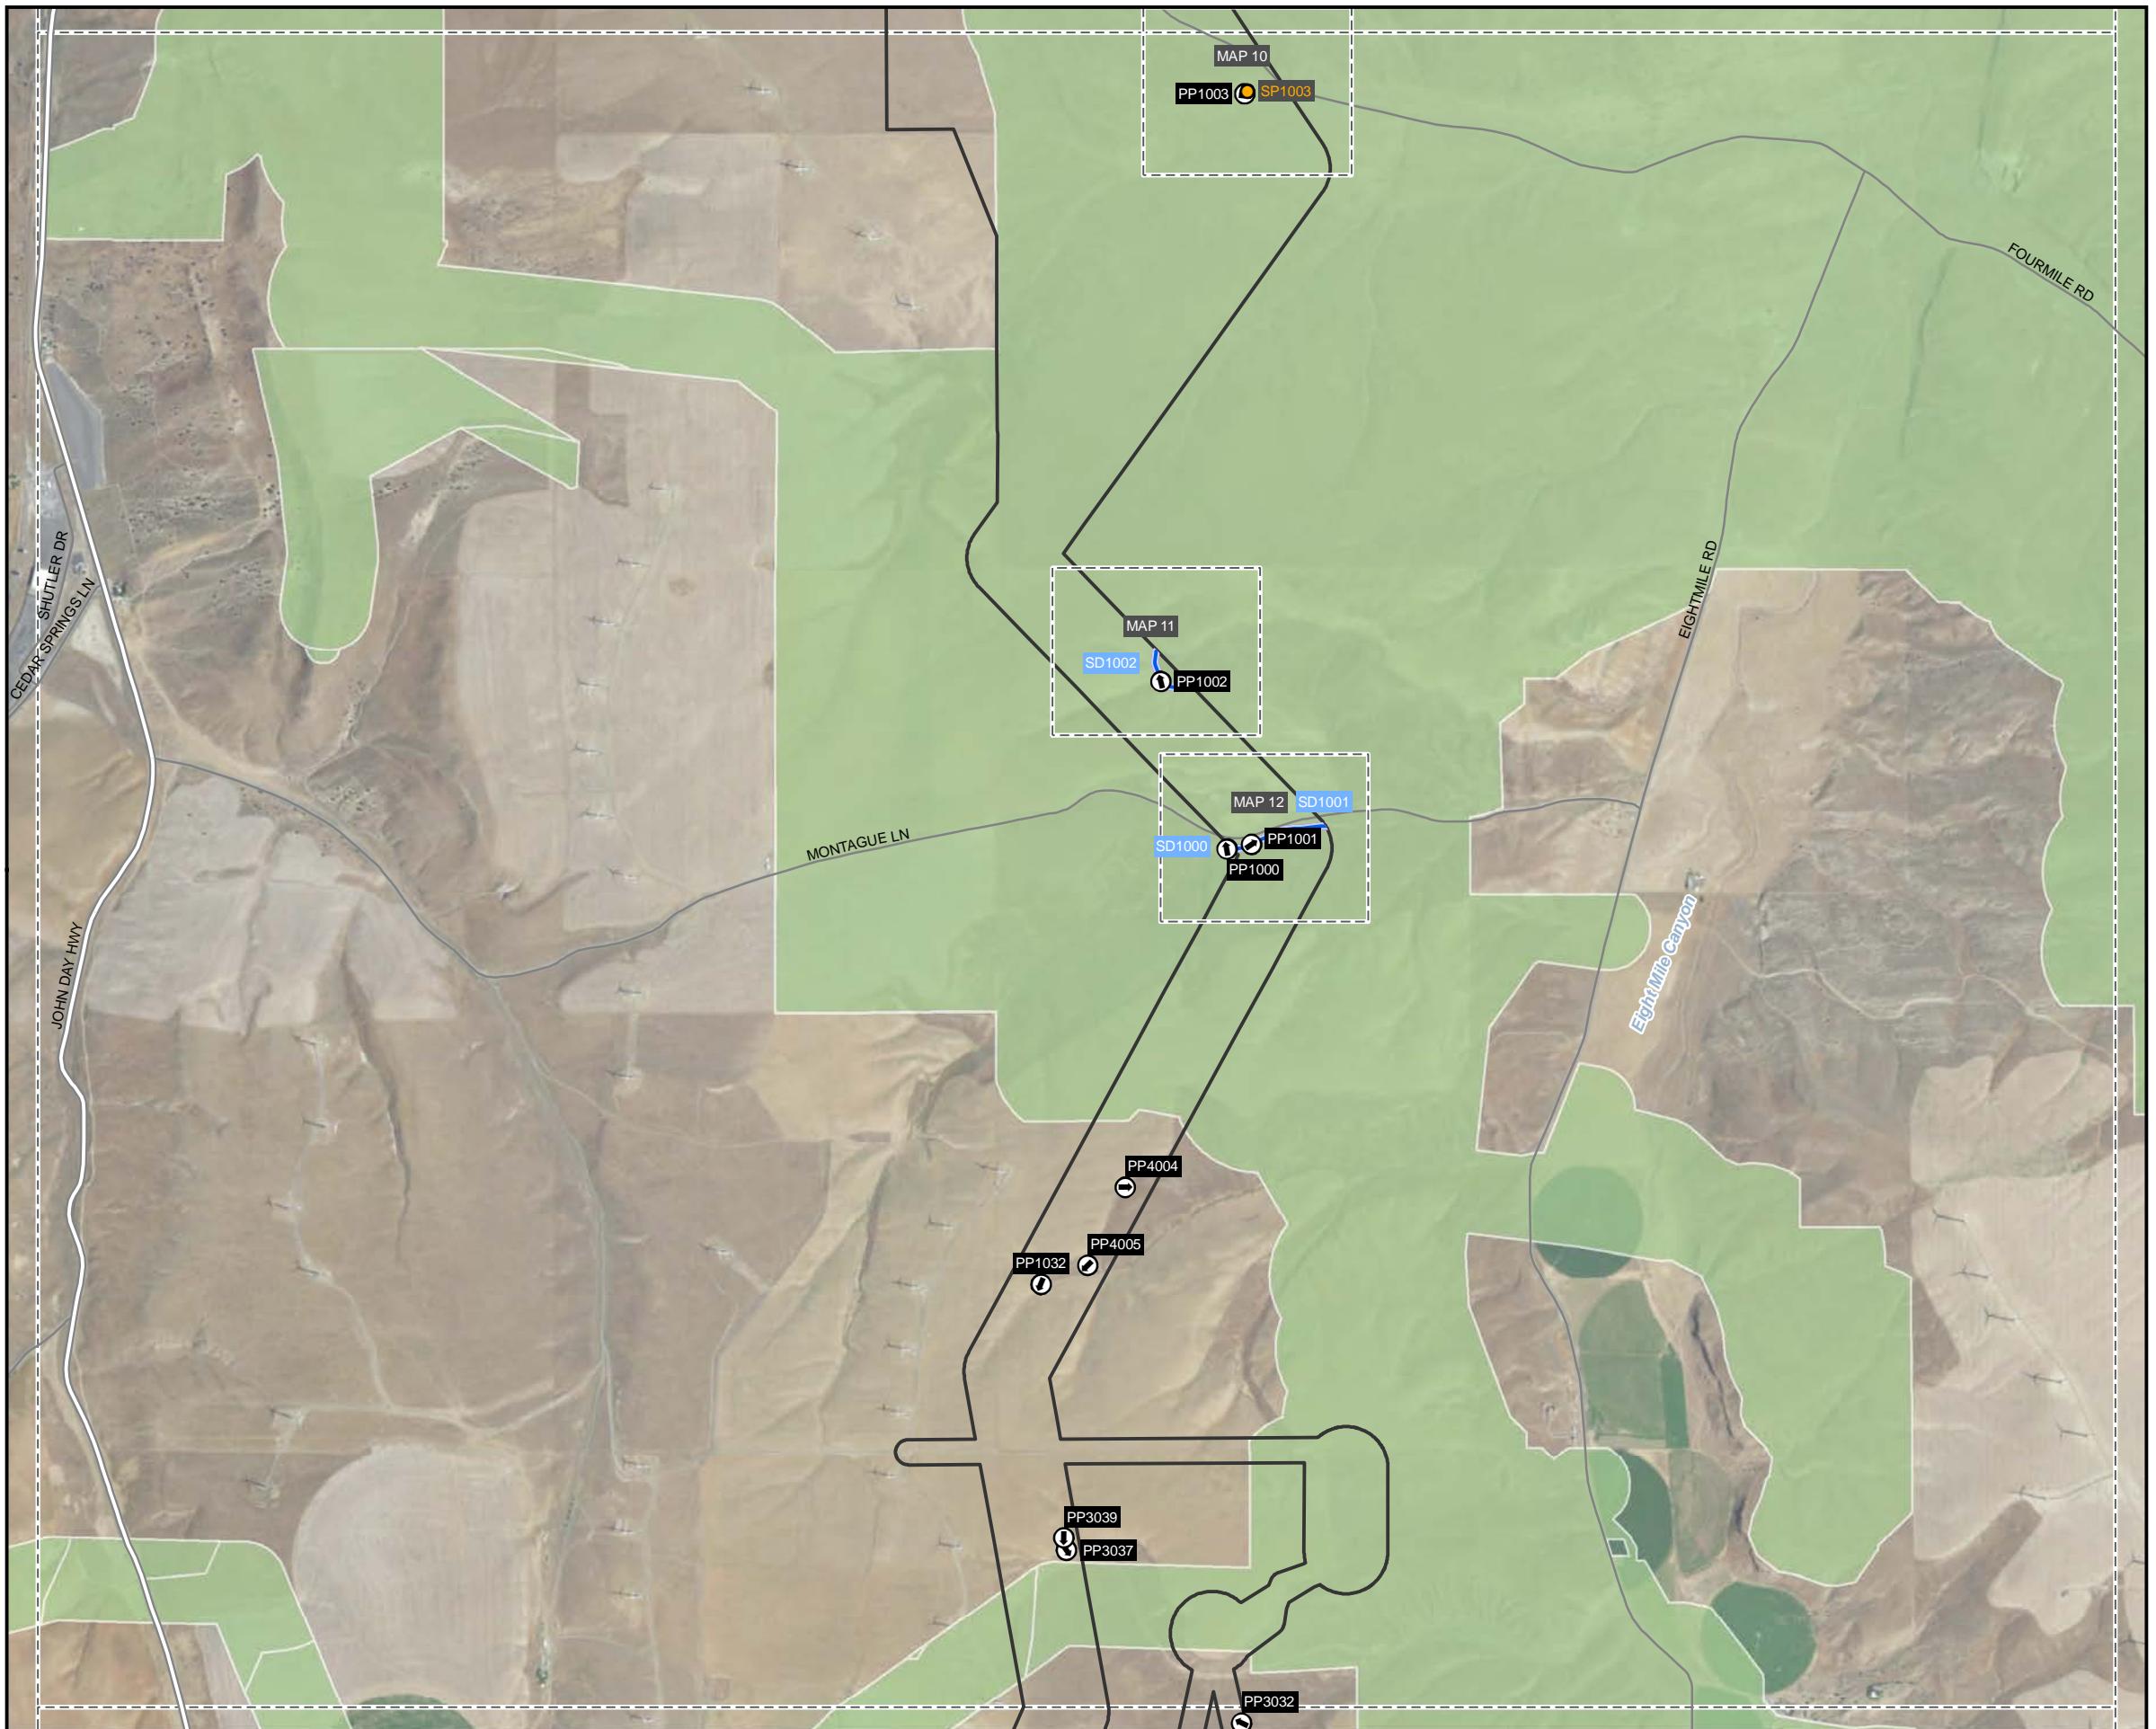
Figure 5.2
Wetland Survey
Wetland and Waterways
Survey Detail Map 2
Montague Wind Power Facility

* Previously surveyed wetland and ordinary high water delineated and concurred with as part of WD# 2010-0083.
 Wetland data was mapped using a resource grade EOS Arrow 100 GPS with mapping accuracy of 50 cm (1.64 ft).

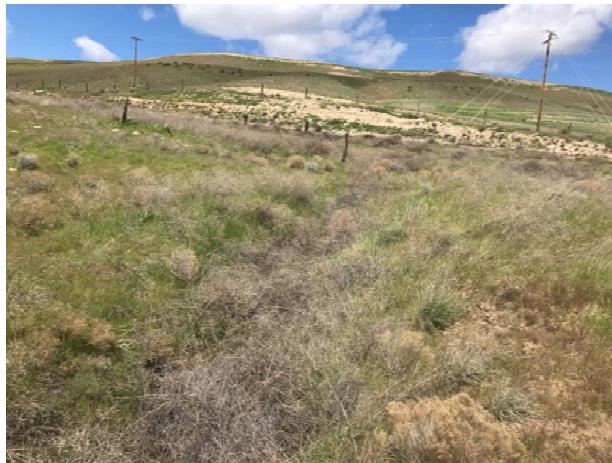
PP1000: Waterway (SD1000) looking N

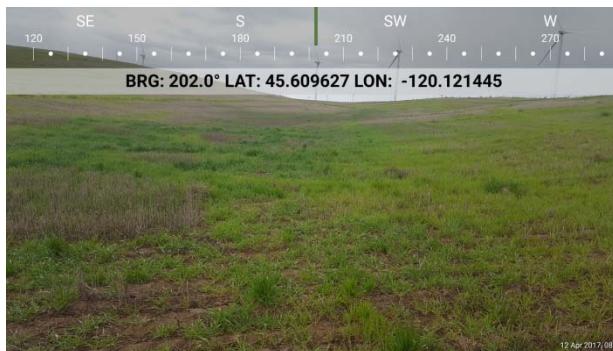
PP1032: NHD mapped waterway looking SW. No waterway observed.

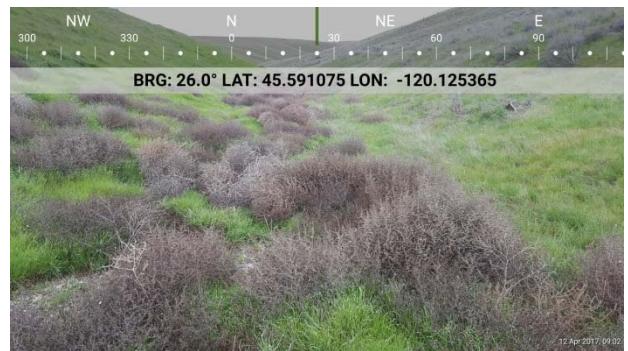
PP1034: SP1034 and NHD mapped waterway looking N. No waterway present.
