EXHIBIT J
WETLANDS
OAR 345-021-0010(1)(j)

Archway Solar Energy LLC (Applicant) proposes to construct the Archway Solar Energy Facility (Facility) in Lake County, Oregon, with generating capacity of up to 400 megawatts (MW). The Facility may also contain a battery energy component with storage capacity of up to 400 MW and discharge capacity of up to 1,600 megawatt-hours. This Exhibit J provides wetland information and analysis as required by Oregon Administrative Rules (OAR) 345-021-0010(j).

A wetland and other waters delineation, consisting of a literature review and field study, was conducted to identify potentially jurisdictional wetlands and other waters. The delineation was performed in accordance with the Oregon Removal-Fill Law and Section 404 of the Clean Water Act. The delineation report was completed in March 2020 (*Wetlands and Nonwetland Waters Delineation Report for the Archway Solar Energy Project*) (Jacobs, 2020) and updated in August 2020 (*Responses to Questions and Comments from the Oregon Department of State Lands on the Wetlands and Nonwetland Waters Delineation Report WD2020-0127*) and September 2020 (*Second Set of Responses to Questions and Comments from the

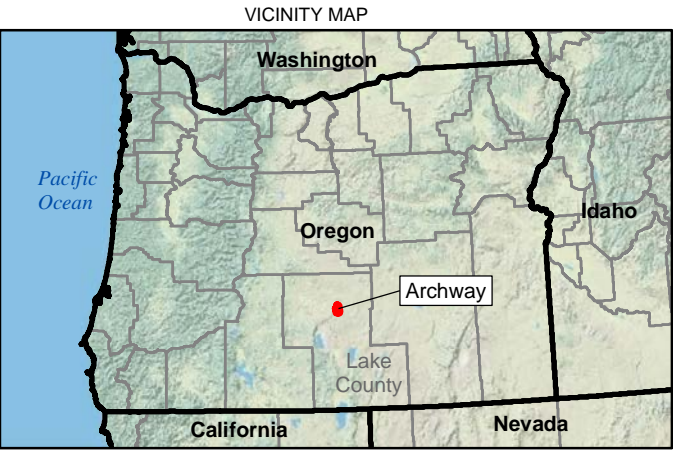
Figure 3a
NWI and NHD Map
Archway Solar Energy Project
Lake County, Oregon

- NWI Wetland Type**
- Freshwater Emergent Wetland
 - Freshwater Pond
- NHD Waterbody**
- Lake
 - Playa
- Other Symbols**
- No Access
 - Archway Project Study Area
 - Highway
 - Road

Figure 3 in Appendix A shows potential waters identified within the Project study area by the NWI and NHD. The locations of the wetlands and waters mapped by NWI and NHD within the Project study area are somewhat different than what Jacobs delineated in the Project study area. The NWI mapped seven features in the Project study area that are classified as palustrine unconsolidated shoreline, intermittently flooded (PUSJ). Jacobs delineated and mapped 20 playas, some of which are in the general location mapped by NWI. The NWI notes the water regimes definition for the PUSJ as substrate that is usually exposed, but surface water is present for variable periods without detectable seasonal periodicity. Weeks, months, or even years may intervene between periods of inundation. The dominant plant communities under this water regime may change as soil moisture conditions change. Some areas exhibiting this water regime do not fall within the definition of wetland because they do not have hydric soils or support hydrophytes. This water regime is generally limited to the arid West (FGDC 2013).

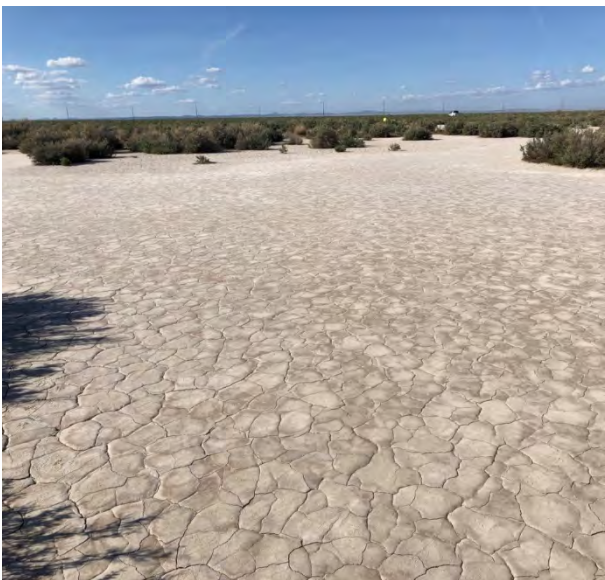
Photo ID: Photo 1

Playa ID: Playa 1

Comment: Viewpoint facing northeast.

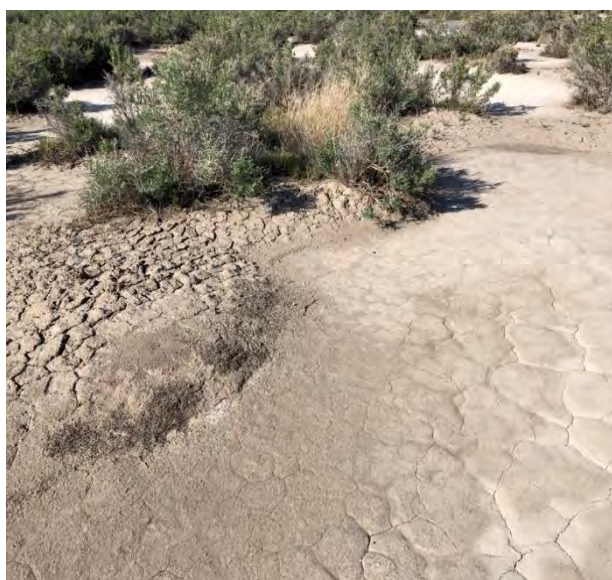
Photo ID: Photo 2

Playa ID: Playa 1

Comment: Driftlines adjacent to upland margin.

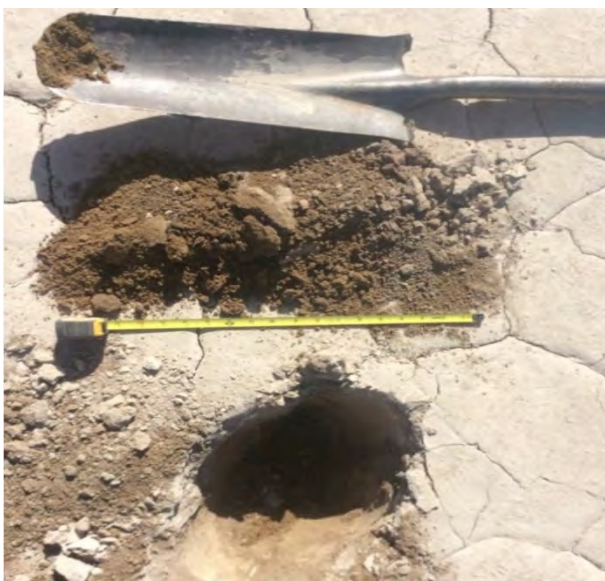
Photo ID: Photo 3

ID: Sample plot SP1-OW-P1

Comment: Soil profile within playa.

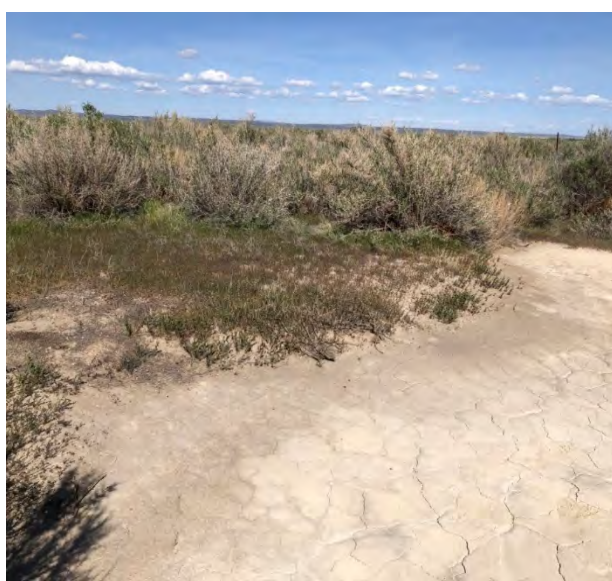
Photo ID: Photo 4

Playa ID: Playa 2

Comment: Viewpoint facing north. Slight elevation shift from upland edge to playa. Ordinary high water mark (OHWM) of receding water marks along upland margin.

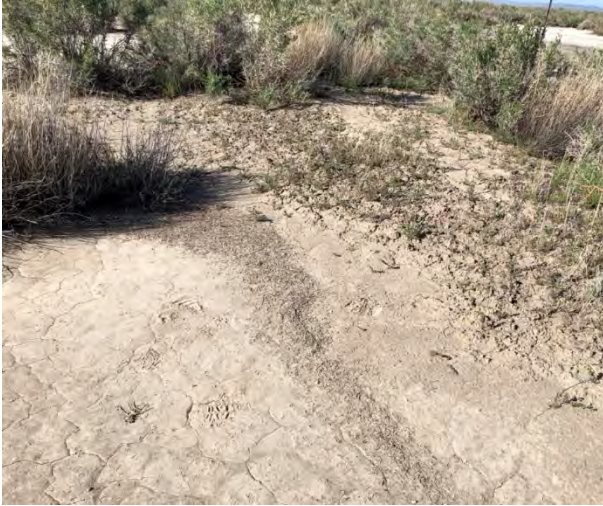
Photo ID: Photo 5
Playa ID: Playa 3
Comment: Viewpoint facing playa upland margin. Driftlines present.

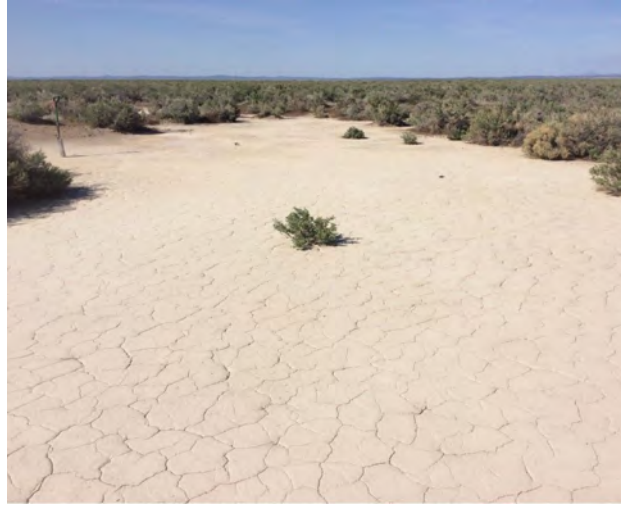
Photo ID: Photo 6
Playa ID: Playa 3
Comment: Viewpoint facing east. Slight elevation shift from upland edge to playa. Driftlines present as seen in Photo 2.

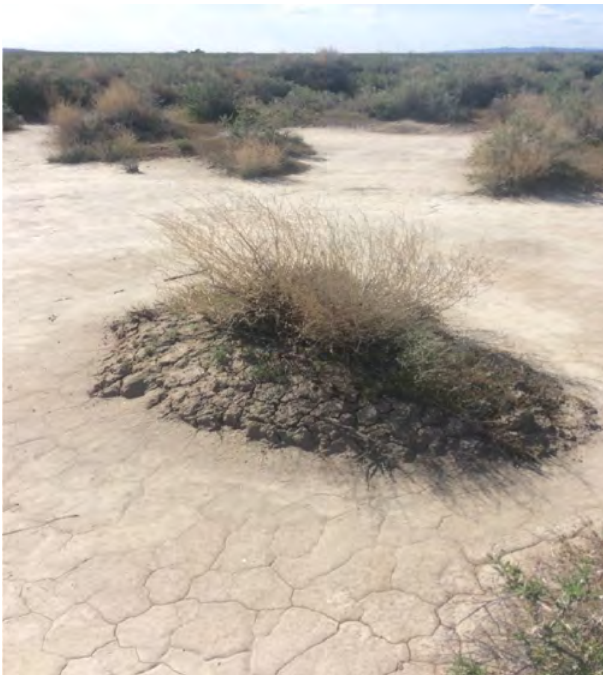
Photo ID: Photo 7
Playa ID: Playa Mosaic 4
Comment: Viewpoint facing north. Upland mound within playa. Driftlines around mounds.

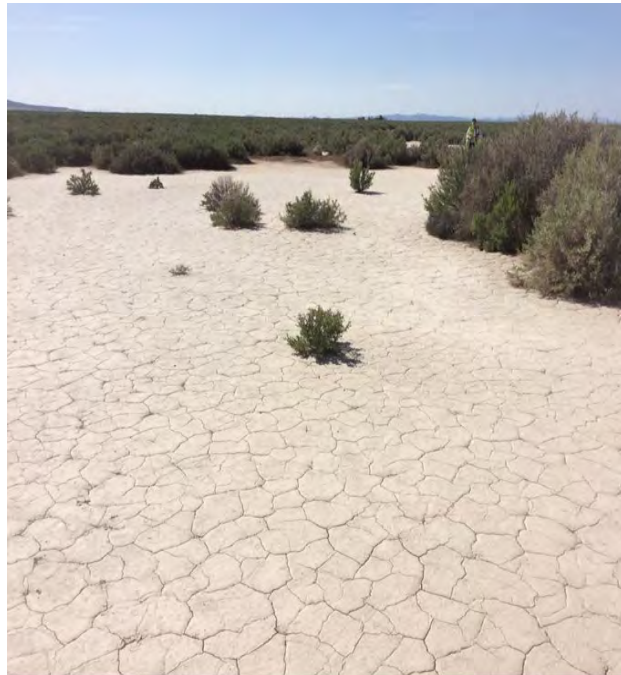
Photo ID: Photo 8
Playa ID: Playa 5
Comment: Viewpoint facing west. Same OHW indicators as in Playa 3; slight elevation shift from upland edge to playa. Driftlines present.

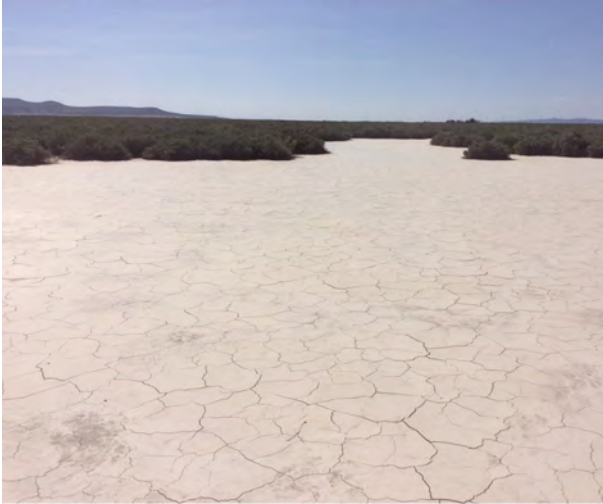
Photo ID: Photo 9
Playa ID: Playa Mosaic 6
Comment: Viewpoint facing West; Slight elevation shift from upland edge to playa. Driftlines present similar as in Playas 2 and 3.

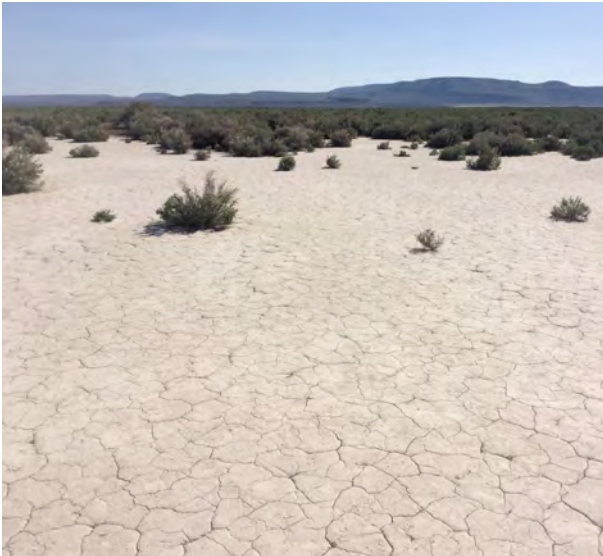
Photo ID: Photo 10
Playa ID: Playa 6
Comment: Pronounced soil cracks with surface curls.

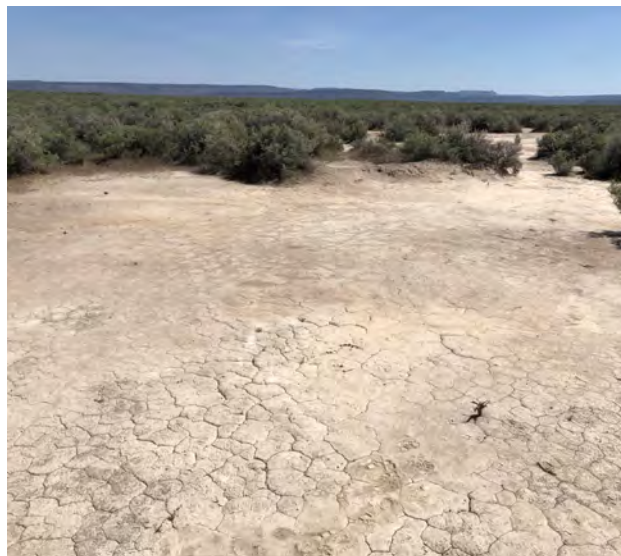
Photo ID: Photo 11
Playa ID: Playa 7
Comment: Viewpoint facing south, southeast. More typical of Playas 9 to 13. OHW indicators less distinct along playa margins. Less elevation shift if any.

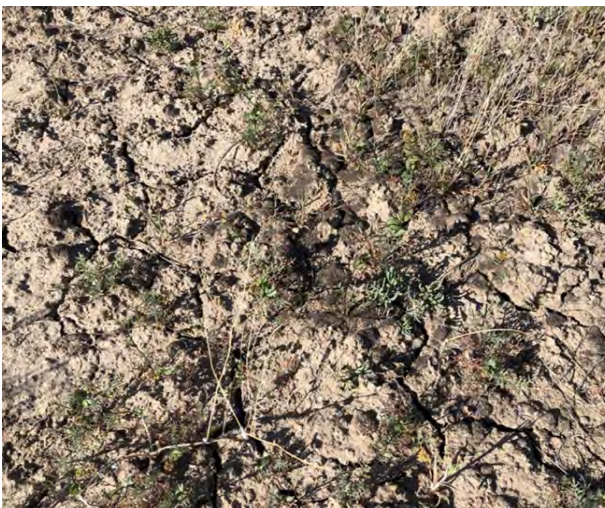
Photo ID: Photo 12
Playa ID: Playa 8
Comment: Viewpoint facing south, southeast. Slight elevation shift from upland edge to playa. Driftlines present, as well as upward curl of mud along cracks.

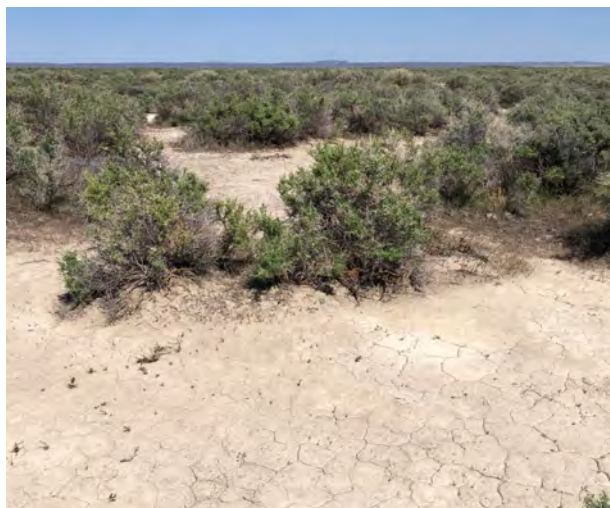
Photo ID: Photo 13

Comment: Viewpoint looking down. Typical herbaceous upland vegetation area adjacent to greasewood. Note biotic crusts and vegetation

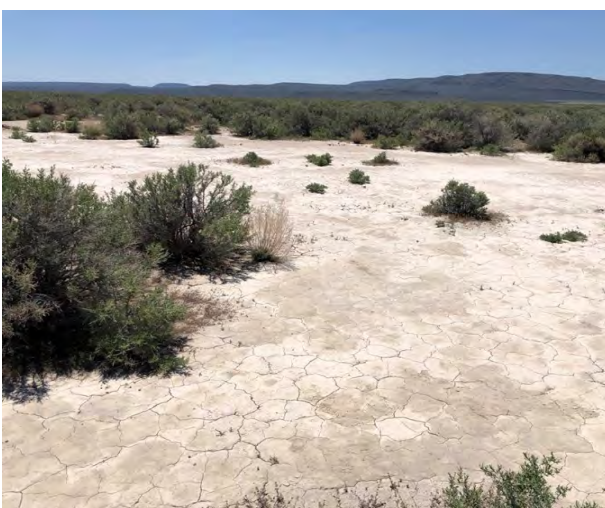
Photo ID: Photo 13

Comment: Viewpoint facing West. Typical upland area: note soil cracking but no other OHWM observed. Some herbaceous upland vegetation growing in area with cracked soil.

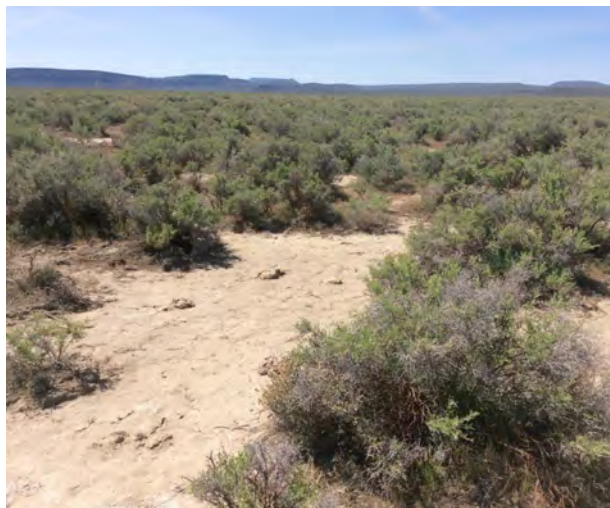
Photo ID: Photo 14

Comment: Viewpoint facing east. Example of typical upland area; note soil cracking with herbaceous upland vegetation. No distinct elevation shift around margins or other OHWM.

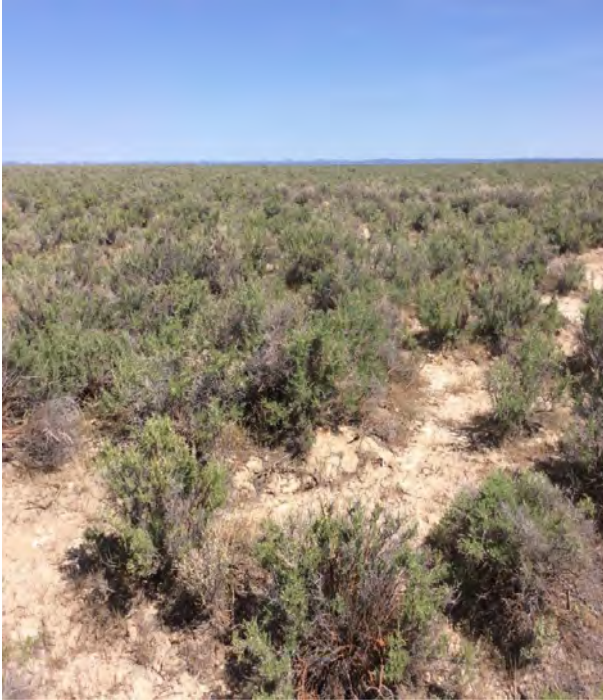
Photo ID: Photo 15

Comment: Viewpoint facing east. Upland area. Typical greasewood community north section of Project area.

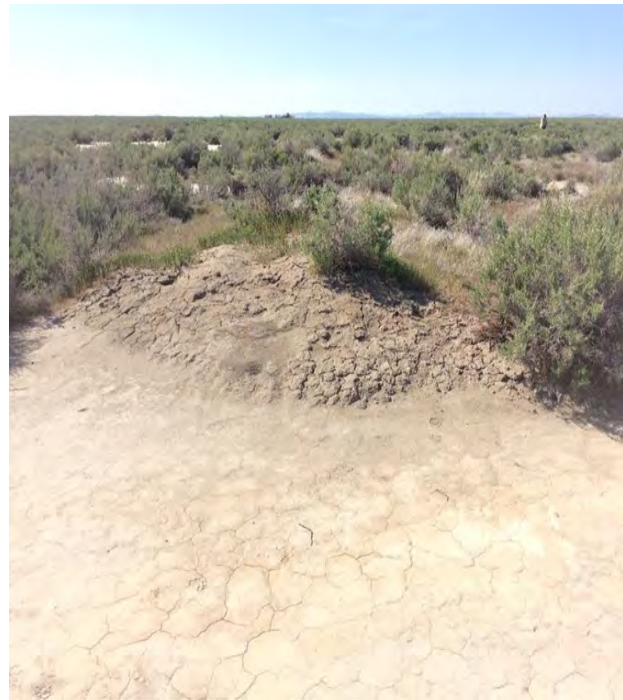
Photo ID: Photo 16

Comment: Viewpoint facing north. Typical upland greasewood community midsection of Project area

RESPONSE: During the original wetland delineation field survey, the entire project area was walked in transects by teams of both wetland and wildlife biologists. No photos were originally taken for these areas you reference because no OHW indicators were observed and vegetation was typical of the greasewood community found in this area. These areas were revisited in July 2020 and photos taken (see photos 60-62 in Attachment 3 to this memo and updated Figures 6-C and 6-E in Attachment 1). No additional playas with OHW marks were observed. Many of these scattered, open areas have a biotic crust within the open areas which was only observed in upland areas where playas had been identified. Also, ant mounds were observed on the open areas which also had been seen only in upland areas. These same conditions were observed in the areas west of photo 16 (see photo 63 in Attachment 3 to this memo and Figure 6-G in Attachment 1).

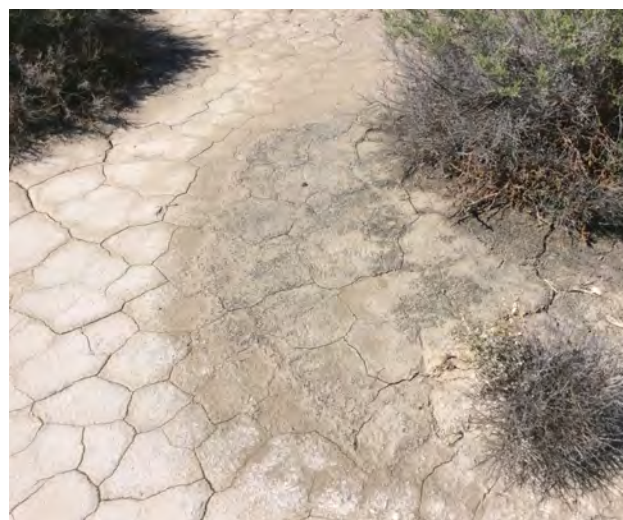
Comment: pH test strip indicating a soil pH of 9.0.

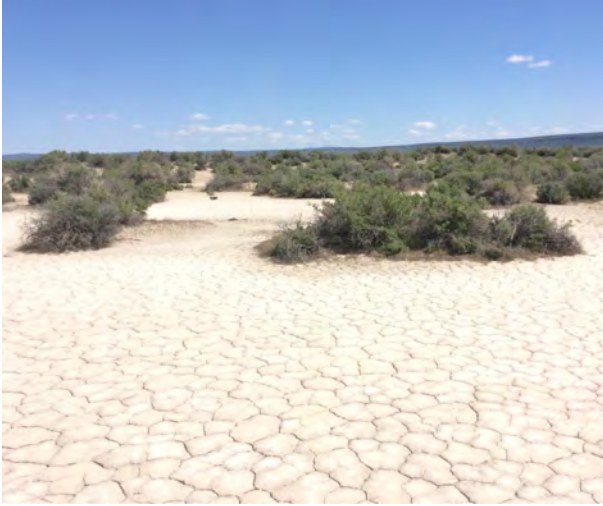
Comment: Viewpoint facing along margin of playa. Slight shift in elevation of playa to more depressional. OWHM observed next to biotic crust found in upland area.

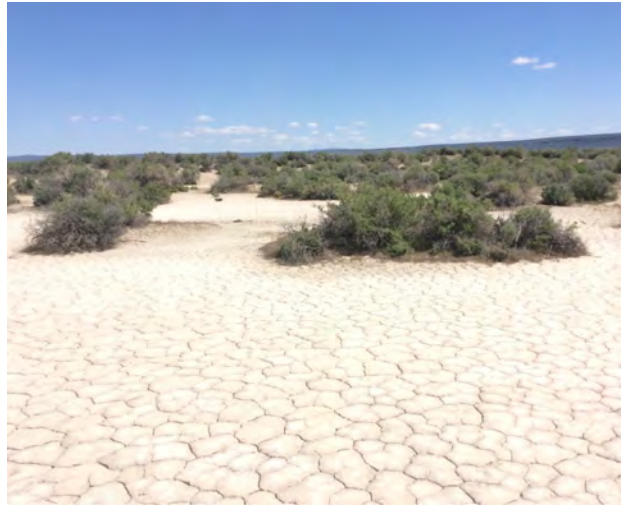
Comment: Viewpoint facing east; Slight shift in elevation of playa to more depressional. OHWM observed next to biotic crust which was always found on upland area.

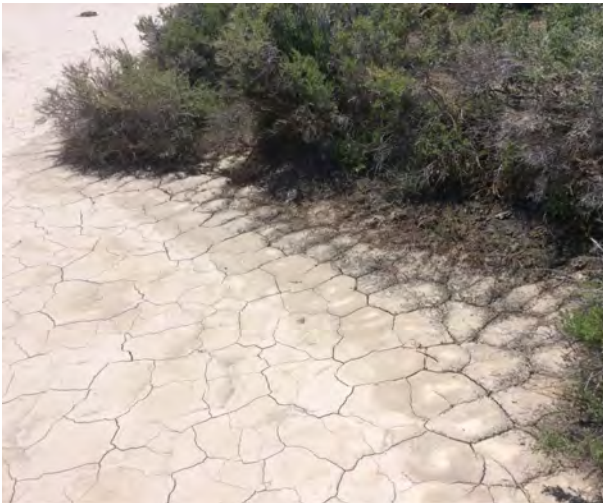
Photo ID: Photo 19

Comment: Viewpoint facing south east. Typical of Playas 14 and 15.

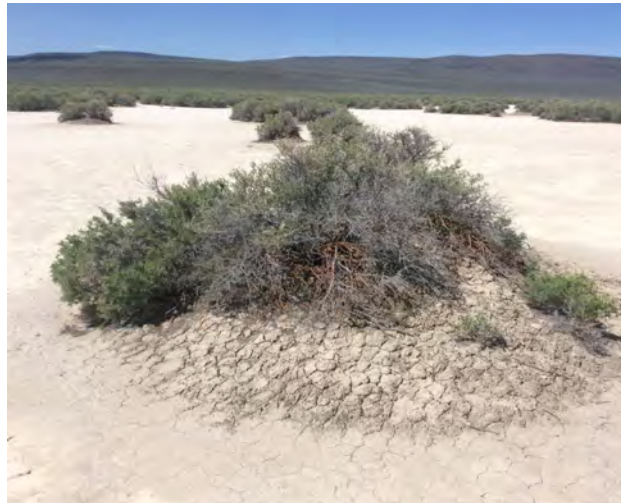
Photo ID: Photo 19

Comment: Viewpoint playa/upland margin. Water mark adjacent to biotic crust on upland.

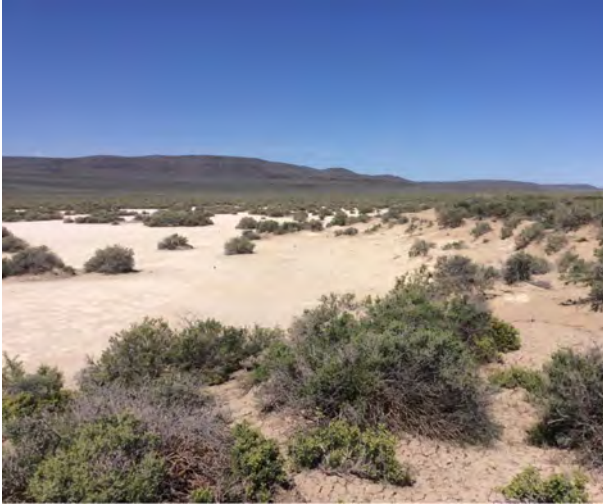
Photo ID: Photo 20

Comment: Viewpoint facing west. Large isolated mounds with waterlines around base. Mounds likely relic dunes.

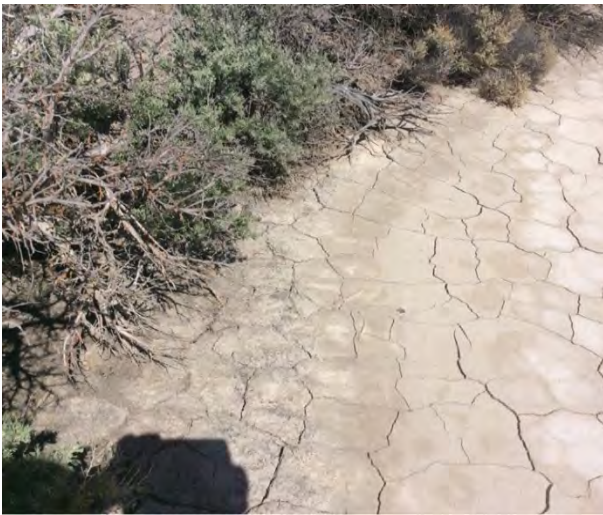
Photo ID: Photo 22
Playa ID: Playa Mosaic 17
Comment: Viewpoint facing west. Cracks large 10 x 12 inches. OHWM subtler. See Photo 23.

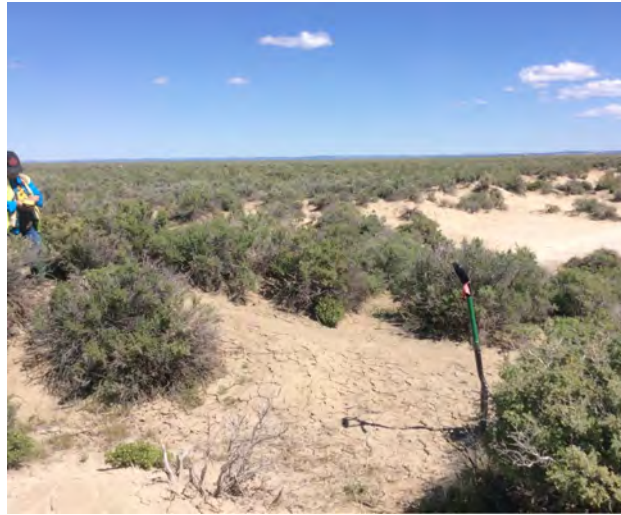
Photo ID: Photo 23
Playa ID: Playa Mosaic 17
Comment: View of upland edge and playa margin. Waterline extends to edge of biotic crust.

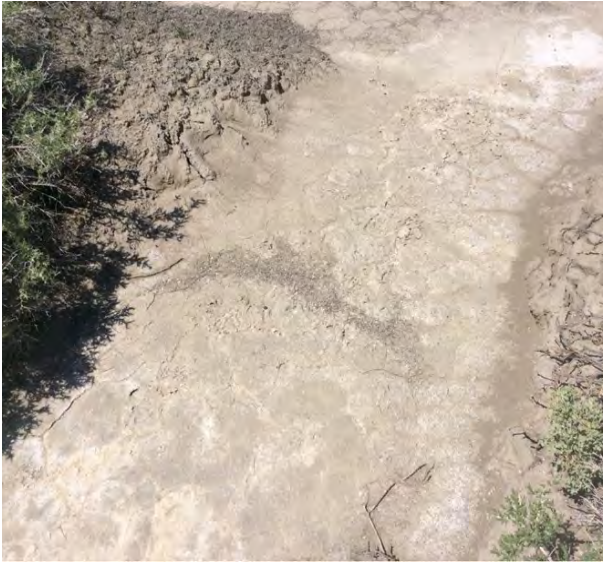
Photo ID: Photo 24
Comment: Viewpoint facing east, northeast. The start of dunes and relic lunettes that extend east and south of the Project area. No OHWM observed in area below dunes.

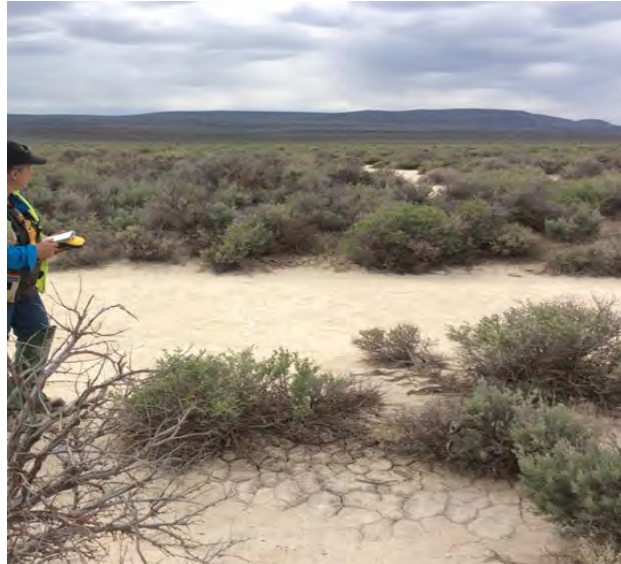
Comment: Viewpoint facing down. This is a large playa mosaic complex that extends to the north. OHWM consist of waterlines adjacent to the upland biotic crust.

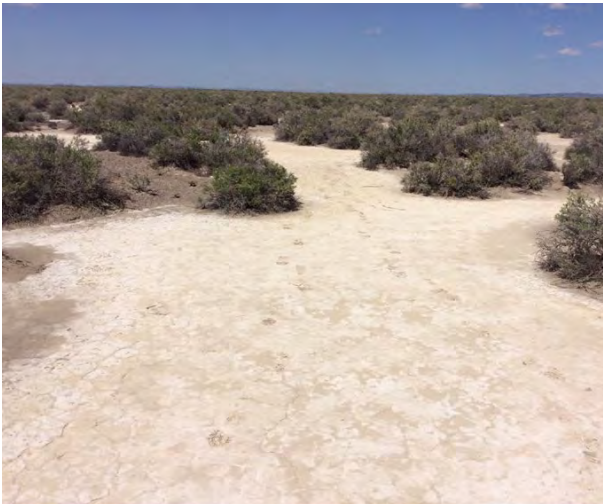
Photo ID: Photo 26

Comment: Viewpoint facing south. Upland south of Playa Mosaic 18. Vegetation denser and no OHW indicators observed.

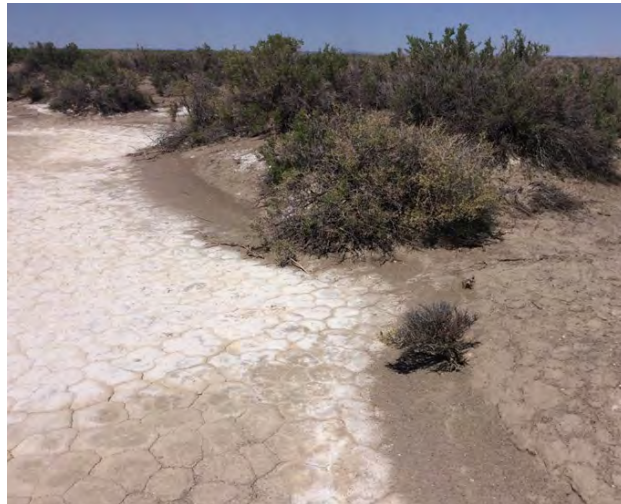
Comment: Viewpoint facing north. Driftline along playa edge.

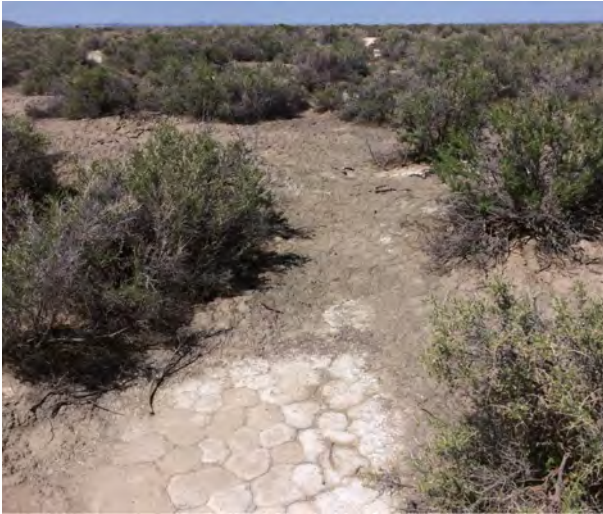
Photo ID: Photo 28

Comment: Viewpoint facing west. OHWM includes clear shift in elevation and driftlines.

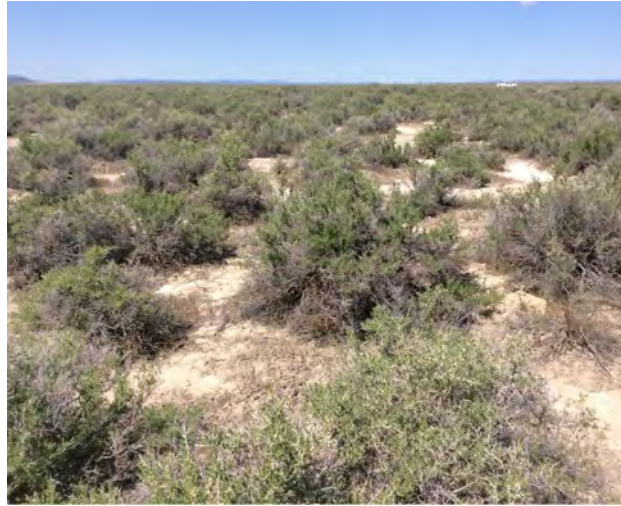
Photo ID: Photo 29

Comment: Viewpoint facing north at edge of playa looking outside of limit to nonwater areas.

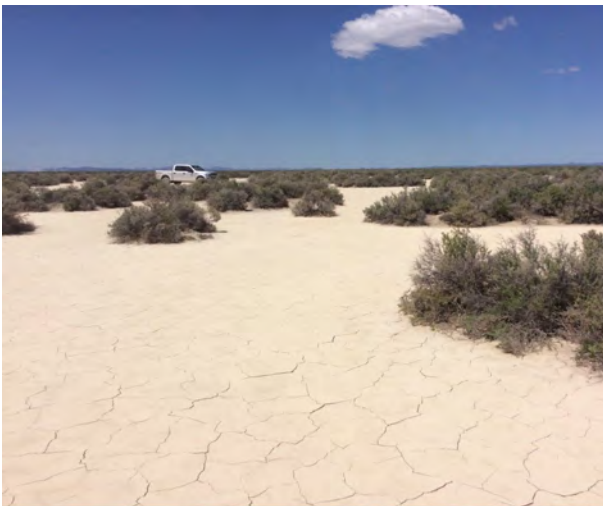
Comment: Viewpoint facing north. Typical vegetated upland of greasewood, sage community.

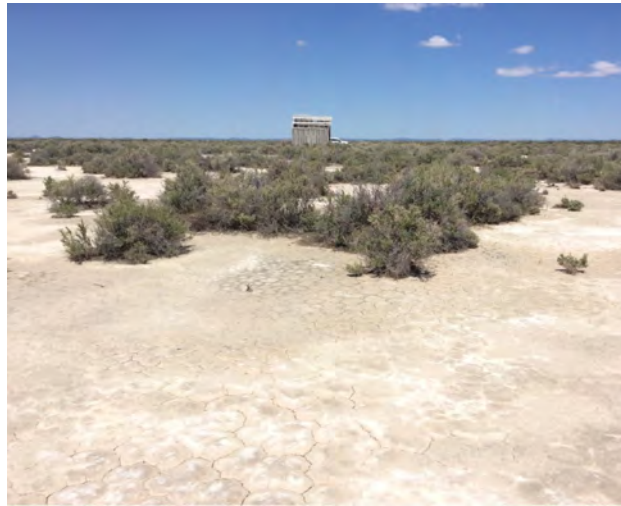
Photo ID: Photo 31

Comment: Viewpoint facing north. Typical unvegetated area with cracked soils. No OHW indicators observed.

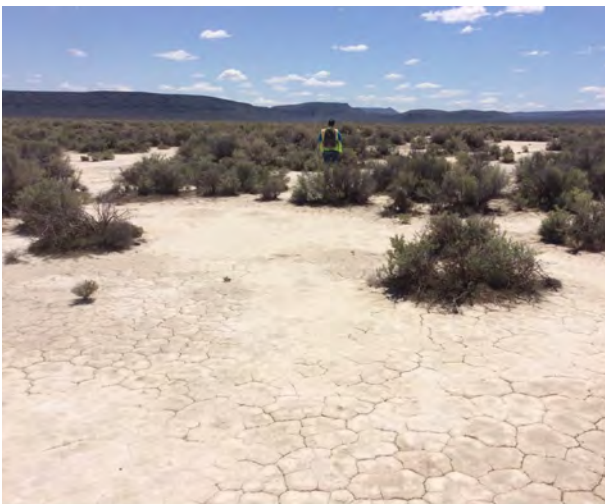
Photo ID: Photo 32

Comment: Viewpoint facing north. No OHW indicators observed.

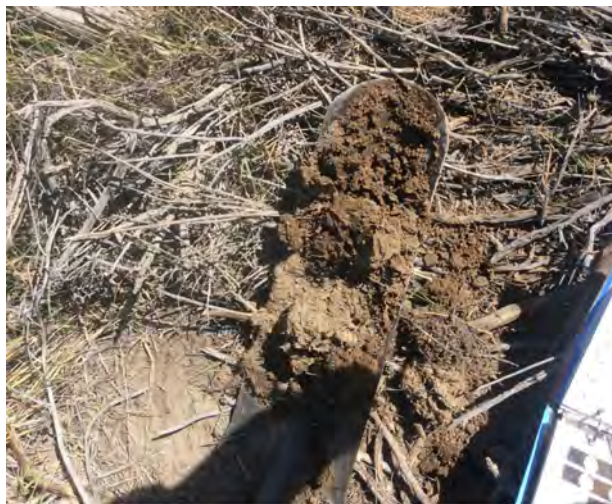
Photo ID: Photo 32

Comment: Viewpoint facing south. No OHW indicators observed.

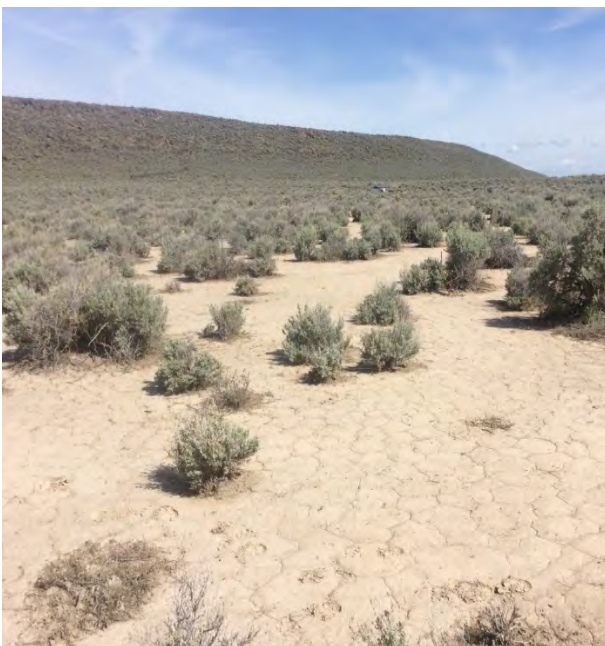
Photo ID: Photo 33

Comment: Viewpoint looking at sample point SPX20. No wetland or OHW indicators observed.

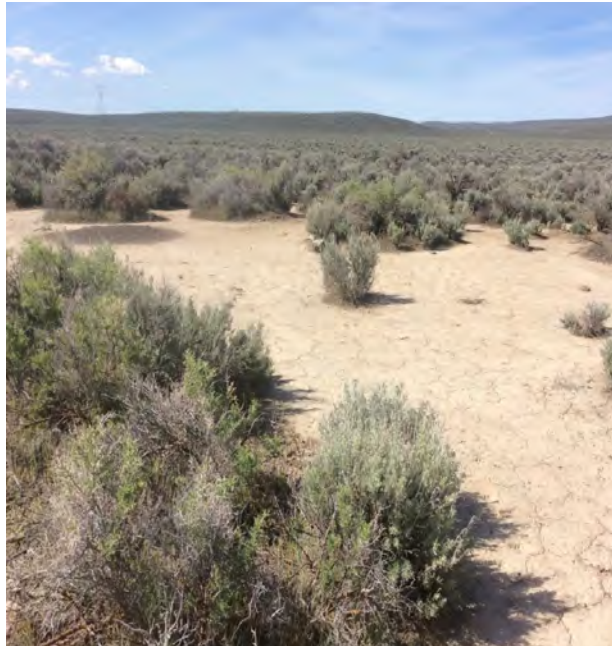
Photo ID: Photo 34

Comment: Viewpoint facing north. No OHW indicators observed.

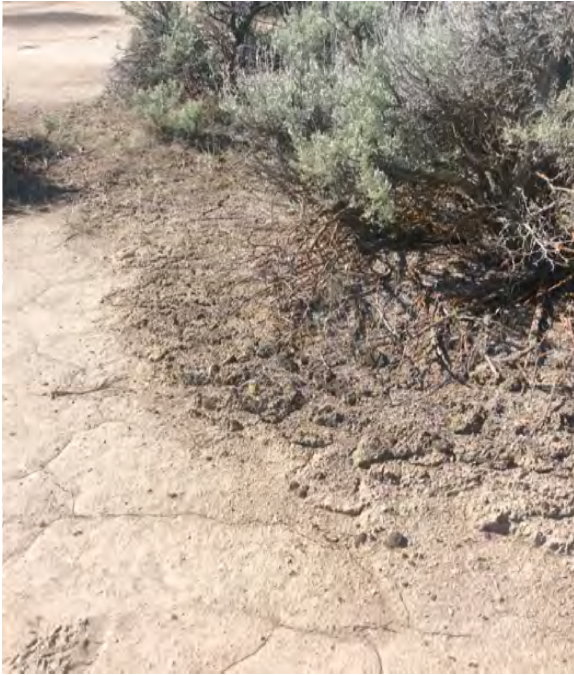
Photo ID: Photo 34

Comment: Viewpoint facing south. No wetland or OHW indicators observed.

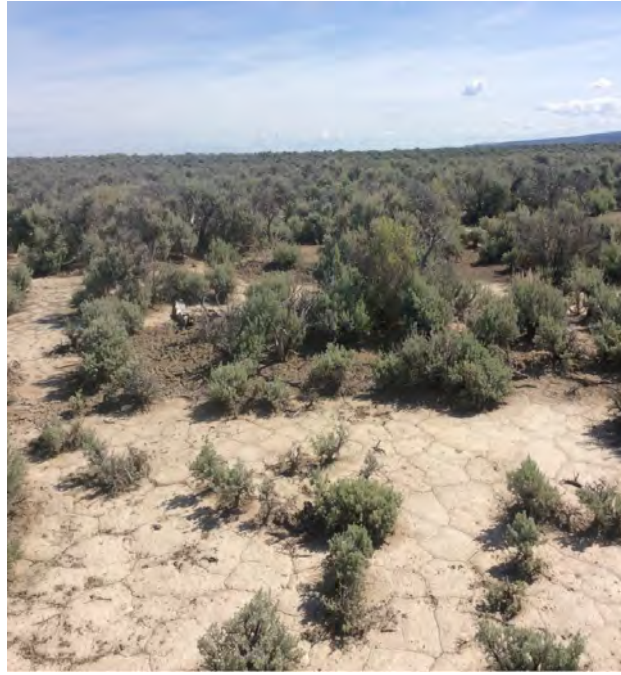
Photo ID: Photo 35

Comment: Viewpoint facing down. Margin with biotic crust next to sage and on cracked surface with no OHW indicators observed.

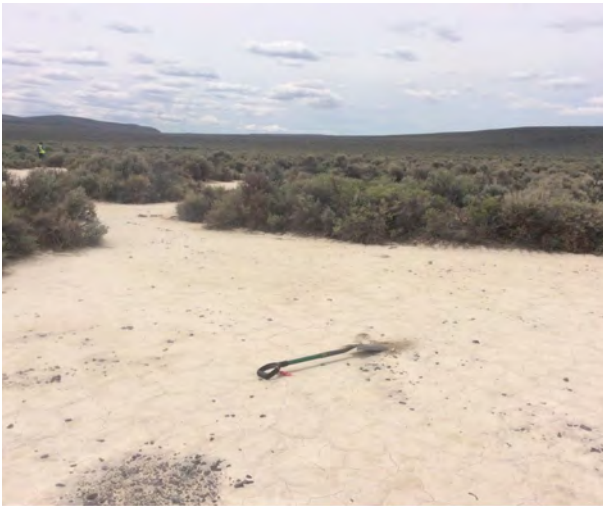
Photo ID: Photo 35

Comment: Viewpoint facing north, northeast, and east. No OHW indicators observed.

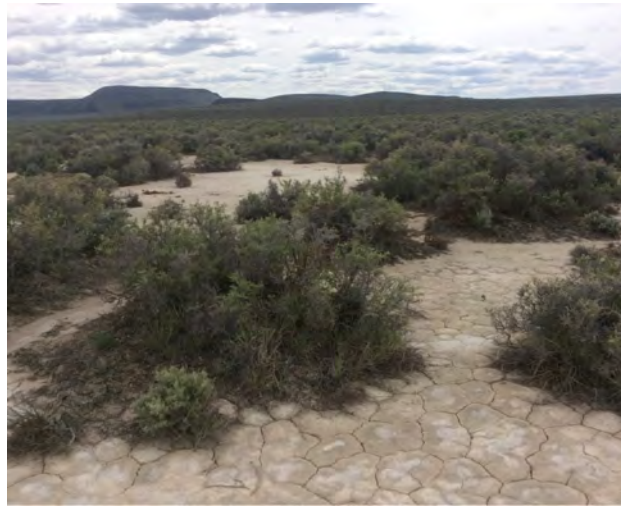
Photo ID: Photo 36

Comment: Viewpoint facing north, northeast. No OHW indicators observed.

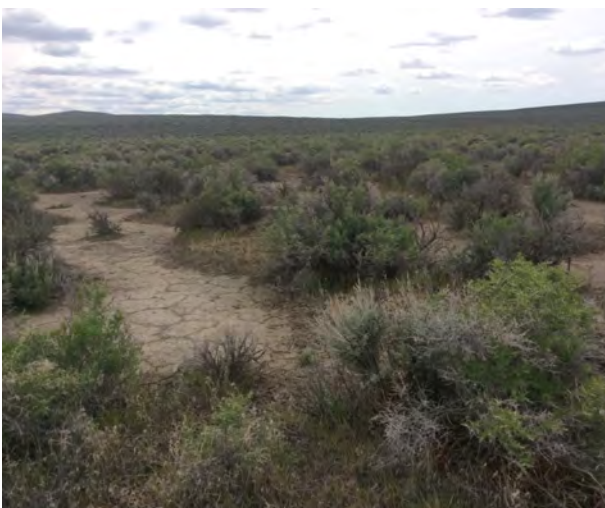
Photo ID: Photo 37

Comment: Viewpoint facing southeast. No OHW indicators observed.

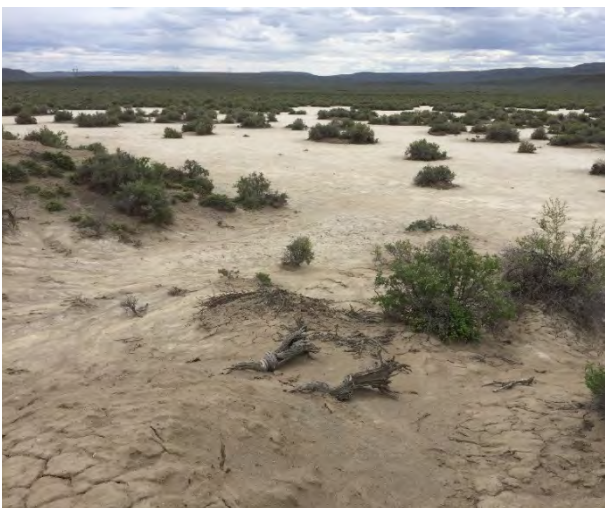
Comment: Viewpoint facing southeast. Start of sand dunes at southern end.

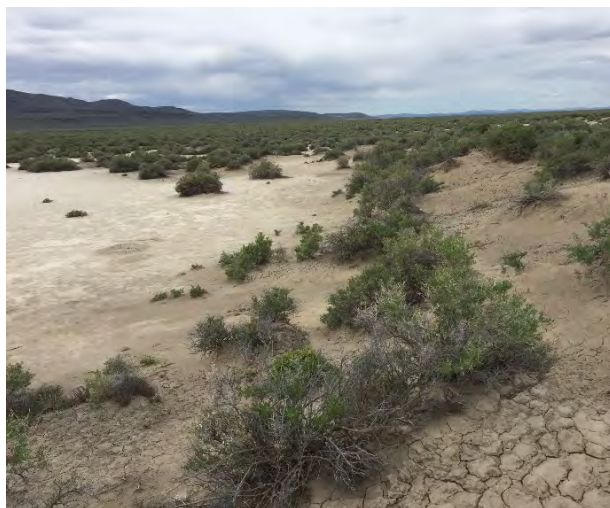
Photo ID: Photo 40

Comment: Viewpoint facing north. Sand dune area. No OHW indicators observed.

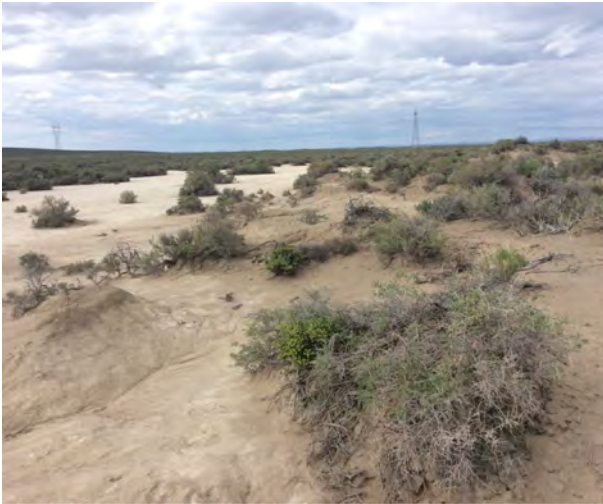
Photo ID: Photo 41

Comment: Viewpoint facing southeast. Sand dune area. No OHW indicators.

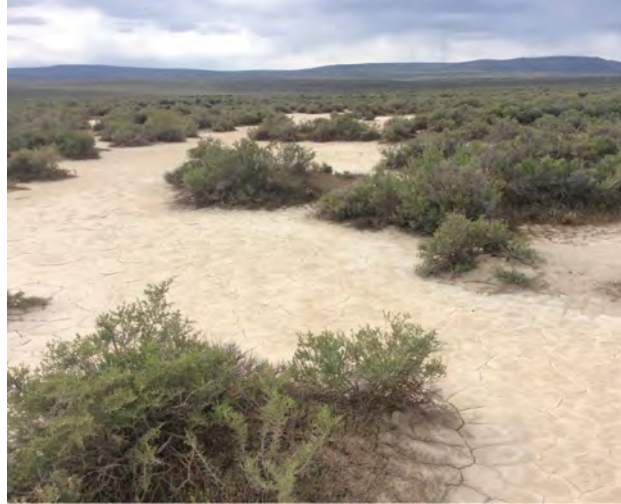
Comment: Viewpoint facing north. Sand dune area. No OHW indicators.

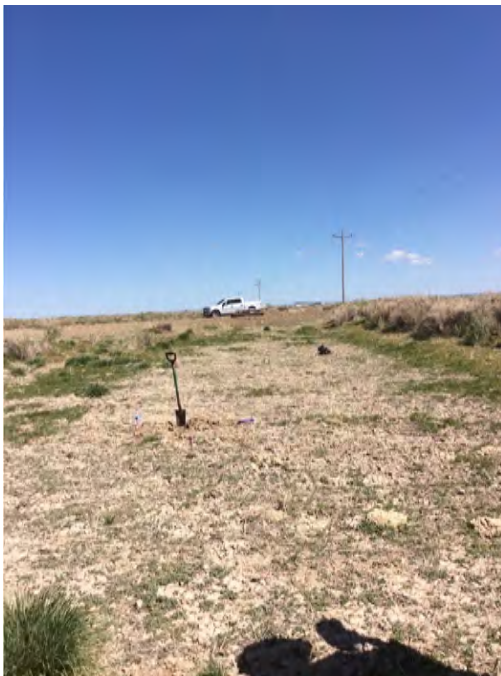
Photo ID: Photo 43

Comment: Viewpoint facing southeast. No OHW indicators observed.

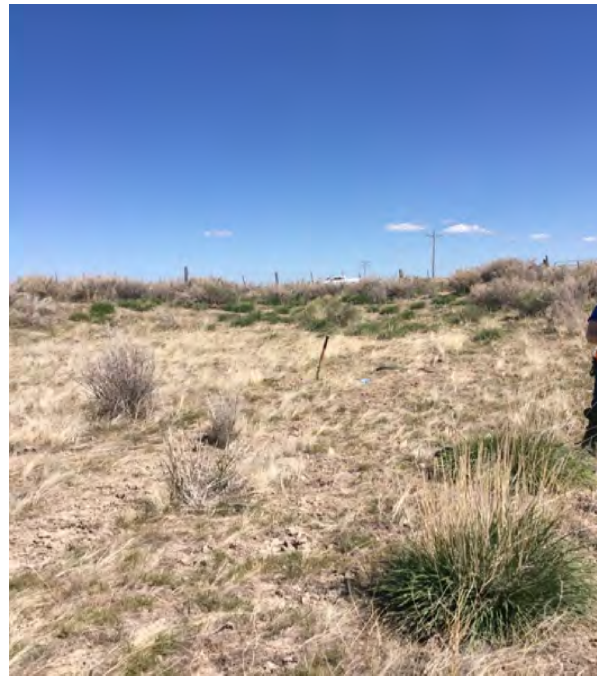
ID: SPX1 (mapped National Hydrography Dataset [NHD] feature)

Comment: Viewpoint facing north. Depressional area adjacent to mapped National Wetlands Inventory (NWI) location. Upland area with no wetland indicators.

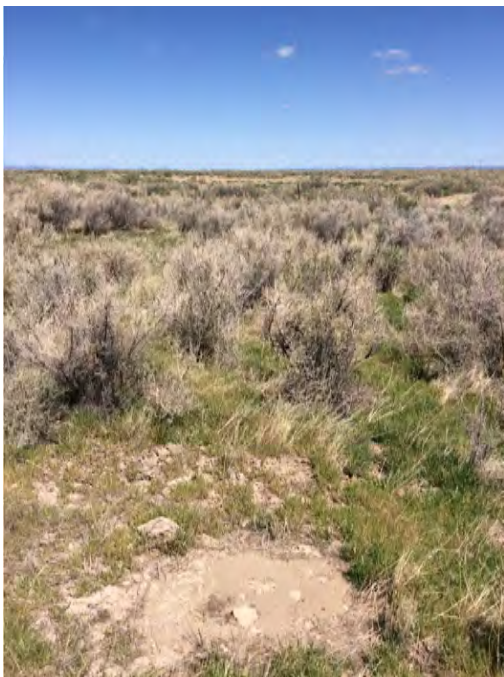
Photo ID: Photo 45

Comment: Viewpoint facing north. Depressional area adjacent to mapped NWI. Upland area with no wetland indicators.

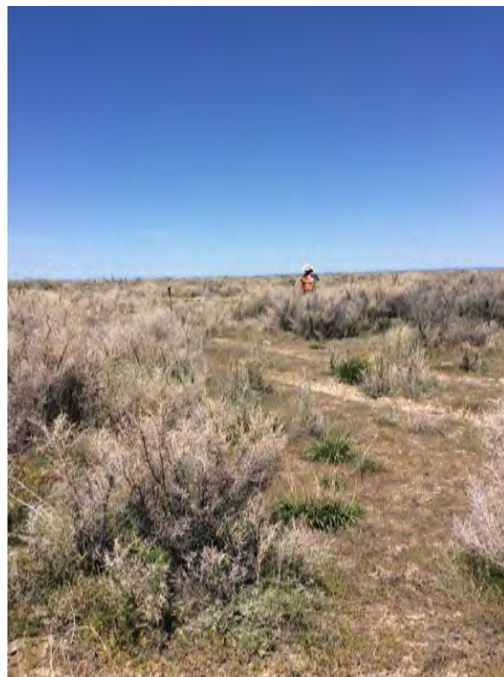
Photo ID: Photo 46
ID: SPX2a (mapped NWI feature)
Comment: Viewpoint facing north. Upland area consisting of sage shrub-steppe area with no wetland indicators.

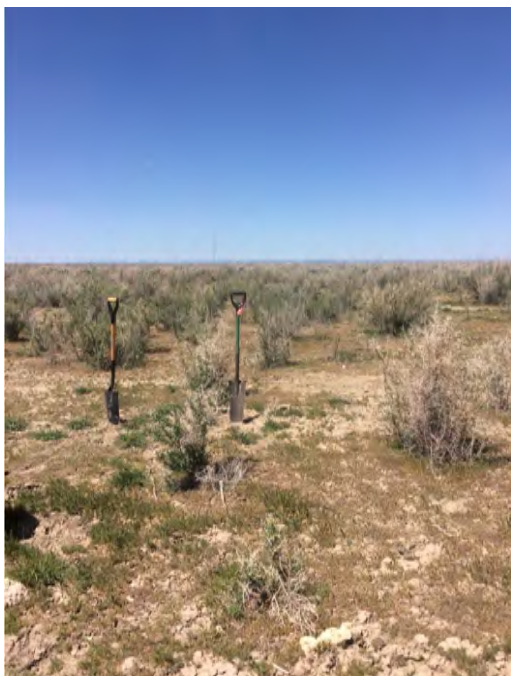
Photo ID: Photo 47
ID: SPX3 (mapped NHD feature)
Comment: Viewpoint facing north. Upland area with no wetland indicators.

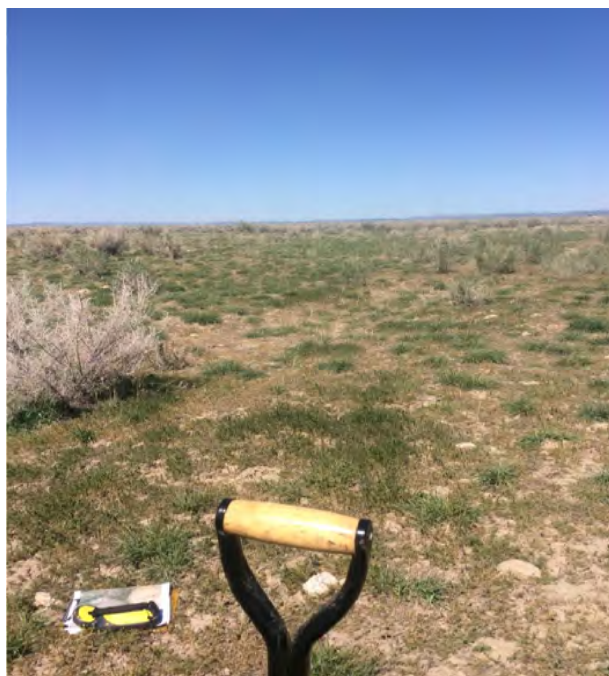
Photo ID: Photo 48
ID: SPX4a (mapped NWI feature)
Comment: Viewpoint facing south. No wetland indicators.

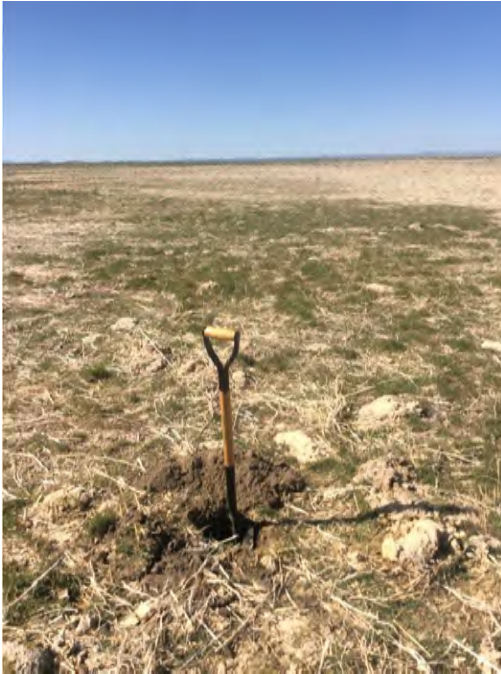
Photo ID: Photo 49
ID: SPX5 (mapped NWI feature)
Comment: Viewpoint facing east. No wetland indicators. Area in relic pivot area and is heavily grazed.

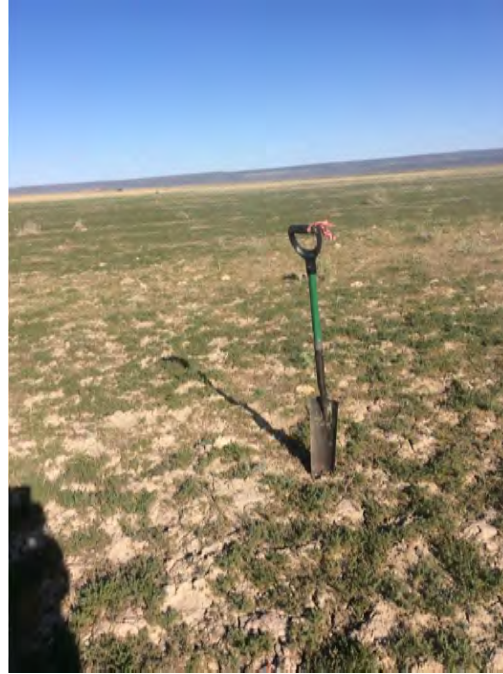
Photo ID: Photo 50
ID: SPX6a (mapped NWI feature)
Comment: Viewpoint facing north. No wetland indicators. Area in relic pivot area and is heavily grazed.

Remarks:
No wetland indicators observed (photo 50). Area heavily grazed.

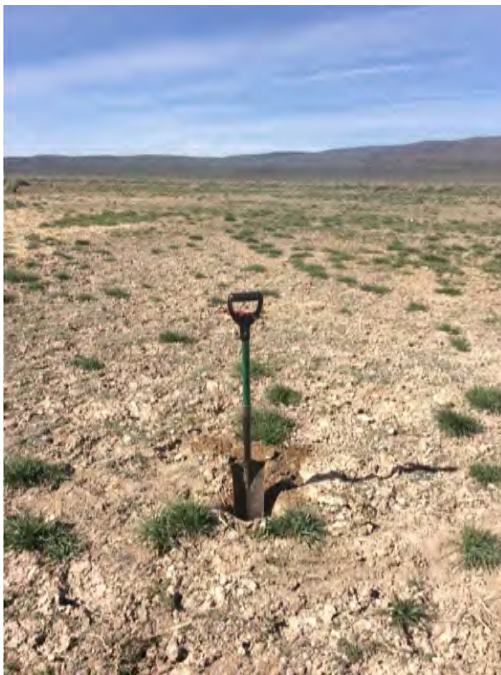
Photo ID: Photo 51
ID: SPX7a (mapped NWI feature)
Comment: Viewpoint facing east. No wetland indicators. Area in relic pivot area and is heavily grazed.

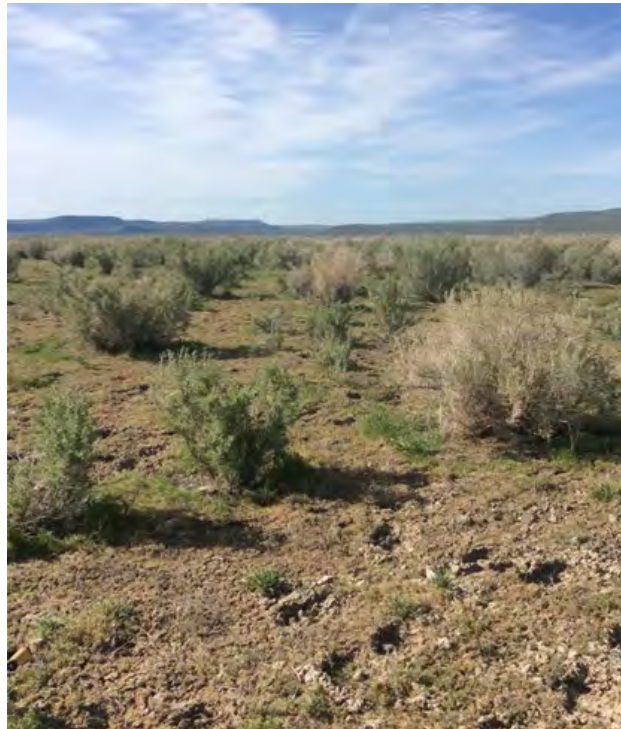
Photo ID: Photo 52
ID: SPX7b (mapped NWI feature)
Comment: Viewpoint facing west. No wetland indicators. Area in relic pivot area and is heavily grazed.

Hydrophytic Vegetation Present? Yes <input type="checkbox"/> No <input checked="" type="checkbox"/>	Is the Sampled Area within a Wetland? Yes <input type="checkbox"/> No <input checked="" type="checkbox"/>
Hydric Soil Present? Yes <input type="checkbox"/> No <input checked="" type="checkbox"/>	
Wetland Hydrology Present? Yes <input type="checkbox"/> No <input checked="" type="checkbox"/>	
Remarks: No wetland indicator (see photo 52).

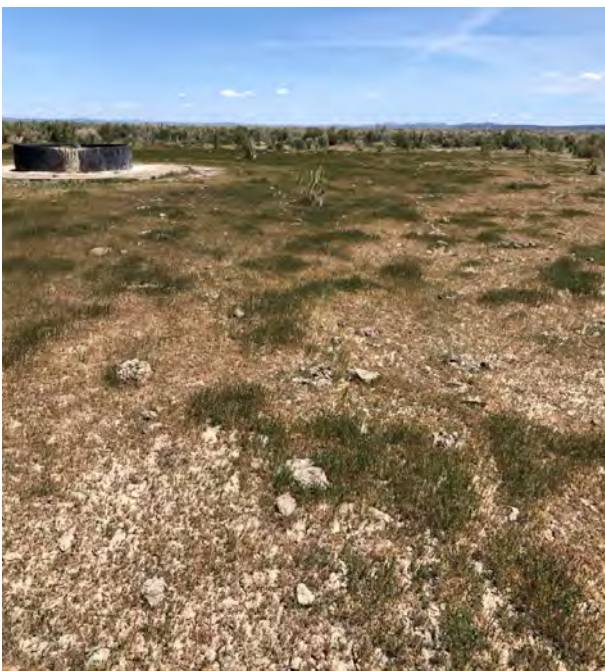
Photo ID: Photo 53
ID: SPX8 (mapped NWI feature)
Comment: Viewpoint facing east. No wetland indicators. Area in relic pivot area and is heavily grazed.

Hydrophytic Vegetation Present? Yes _____ No <input checked="" type="checkbox"/>	Is the Sampled Area within a Wetland? Yes _____ No <input checked="" type="checkbox"/>
Hydric Soil Present? Yes _____ No <input checked="" type="checkbox"/>	
Wetland Hydrology Present? Yes _____ No <input checked="" type="checkbox"/>	
Remarks: No wetland indicators (see photo 53).
