EXHIBIT J
WETLANDS
OAR 345-021-0010(1)(j)

Archway Solar Energy LLC (Applicant) proposes to construct the Archway Solar Energy Facility (Facility) in Lake County, Oregon, with generating capacity of up to 400 megawatts (MW). The Facility may also contain a battery energy component with storage capacity of up to 400 MW and discharge capacity of up to 1,600 megawatt-hours. This Exhibit J provides wetland information and analysis as required by Oregon Administrative Rules (OAR) 345-021-0010(j).

A wetland and other waters delineation, consisting of a literature review and field study, was conducted to identify potentially jurisdictional wetlands and other waters. The delineation was performed in accordance with the Oregon Removal-Fill Law and Section 404 of the Clean Water Act. The delineation report was completed in March 2020 (*Wetlands and Nonwetland Waters Delineation Report for the Archway Solar Energy Project*) (Jacobs, 2020) and updated in August 2020 (*Responses to Questions and Comments from the Oregon Department of State Lands on the Wetlands and Nonwetland Waters Delineation Report WD2020-0127*) and September 2020 (*Second Set of Responses to Questions and Comments from the

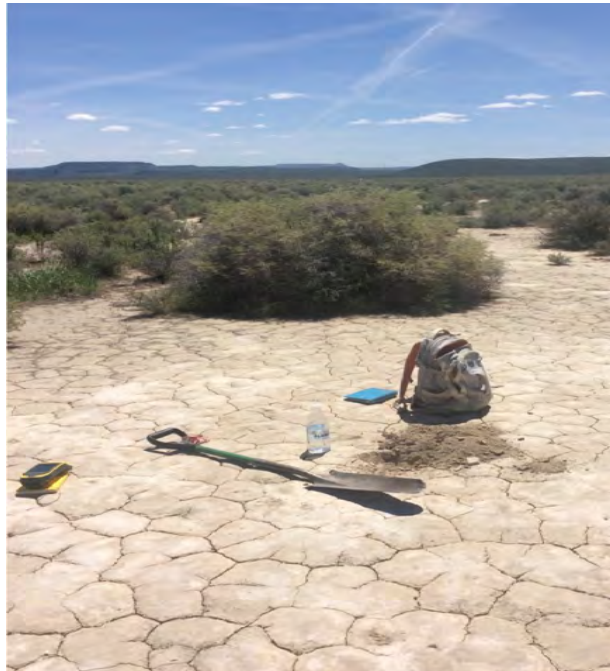
Photo ID: Photo 54
ID: SPX11 (mapped NWI feature)
Comment: Viewpoint facing east. Upland herbaceous and no wetland indicators. Area in relic pivot area and is heavily grazed.

Hydrophytic Vegetation Present? Yes _____ No <input checked="" type="checkbox"/>	Is the Sampled Area within a Wetland? Yes _____ No <input checked="" type="checkbox"/>
Hydric Soil Present? Yes _____ No <input checked="" type="checkbox"/>	
Wetland Hydrology Present? Yes _____ No <input checked="" type="checkbox"/>	
Remarks: No wetland indicators observed (see photo 54).

Hydrophytic Vegetation Present? Yes <input type="checkbox"/> No <input checked="" type="checkbox"/>	Is the Sampled Area within a Wetland? Yes <input type="checkbox"/> No <input checked="" type="checkbox"/>
Hydric Soil Present? Yes <input type="checkbox"/> No <input checked="" type="checkbox"/>	
Wetland Hydrology Present? Yes <input type="checkbox"/> No <input checked="" type="checkbox"/>	
Remarks: No wetland indicators observed (see photo 54).

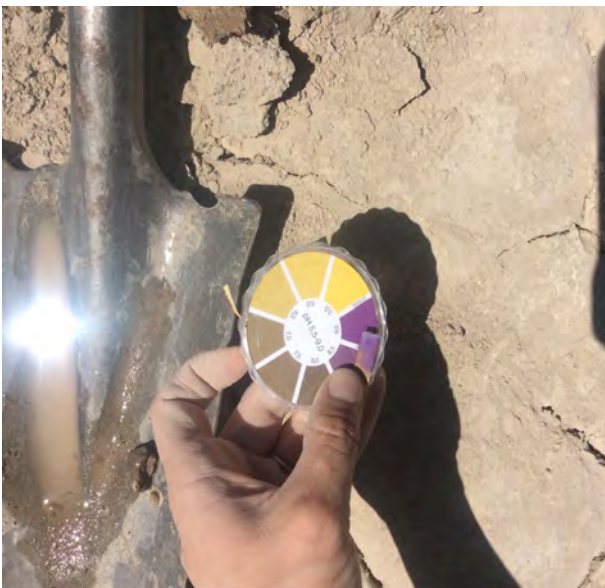
Photo ID: Photo 55
ID: SPX13 (mapped NWI feature)
Comment: Viewpoint facing south. No wetland indicators or OHW indicators.

Hydrophytic Vegetation Present? Yes _____ No <input checked="" type="checkbox"/>	Is the Sampled Area within a Wetland? Yes _____ No <input checked="" type="checkbox"/>
Hydric Soil Present? Yes _____ No <input checked="" type="checkbox"/>	
Wetland Hydrology Present? Yes _____ No <input checked="" type="checkbox"/>	
Remarks: No wetland indicators (see photo 55).

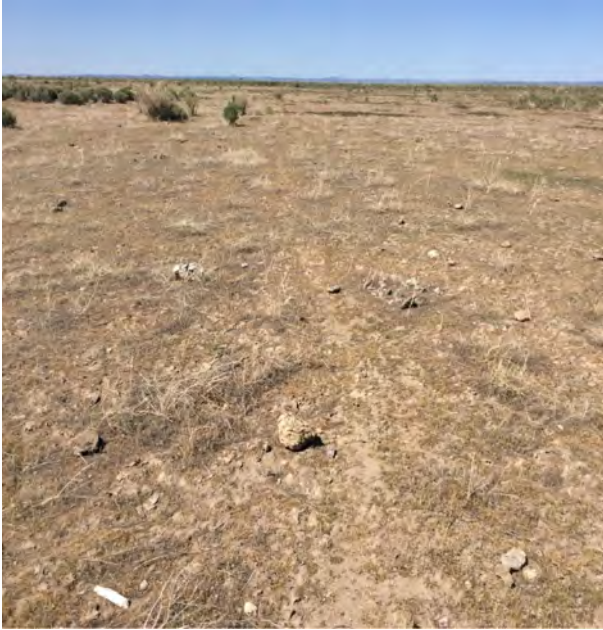
Photo ID: Photo 56
ID: SPX16 (mapped NWI feature)
Comment: Viewpoint facing east. No wetland indicators or OHW indicators.

Hydrophytic Vegetation Present? Yes <input type="checkbox"/> No <input checked="" type="checkbox"/>	Is the Sampled Area within a Wetland? Yes <input type="checkbox"/> No <input checked="" type="checkbox"/>
Hydric Soil Present? Yes <input type="checkbox"/> No <input checked="" type="checkbox"/>	
Wetland Hydrology Present? Yes <input type="checkbox"/> No <input checked="" type="checkbox"/>	
Remarks: No wetlands indicators observed (see photo 56).

Hydrophytic Vegetation Present? Yes _____ No <input checked="" type="checkbox"/>	Is the Sampled Area within a Wetland? Yes _____ No <input checked="" type="checkbox"/>
Hydric Soil Present? Yes _____ No <input checked="" type="checkbox"/>	
Wetland Hydrology Present? Yes _____ No <input checked="" type="checkbox"/>	
Remarks: No wetlands indicators observed (see photo 56).

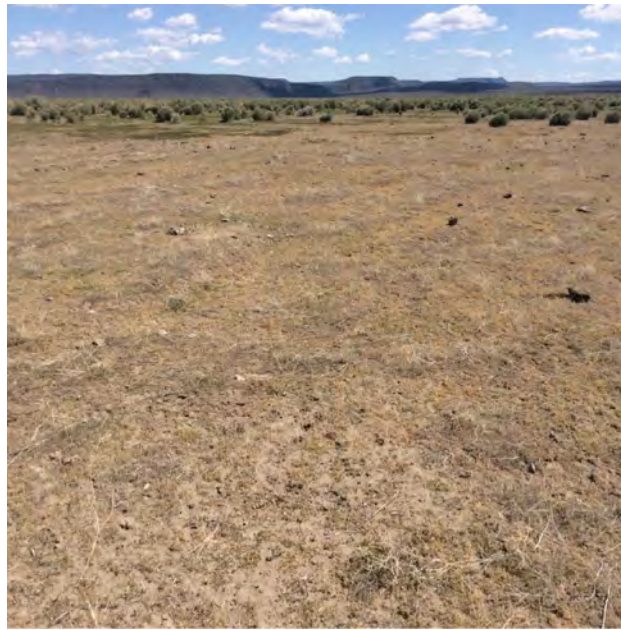
Photo ID: Photo 57

Comment: Viewpoint facing north. Typical upland view of relic pivot area that is heavily grazed.

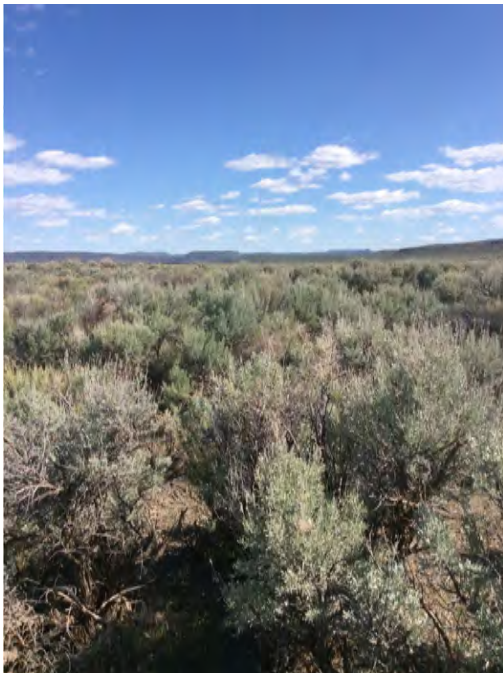
Photo ID: Photo 57

Comment: Viewpoint facing east. Typical upland view of relic pivot area that is heavily grazed.

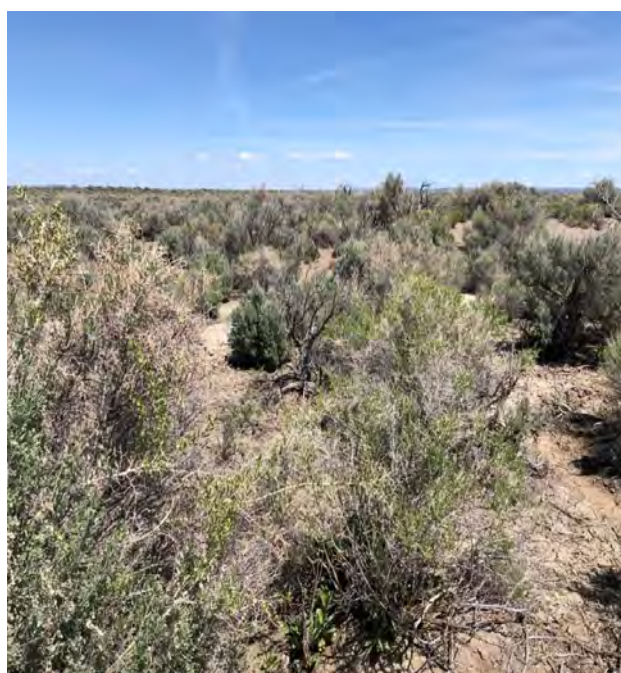
Photo ID: Photo 58

Comment: Viewpoint facing south. Sample point taken in Thornlake complex 0-2 percent soils unit.

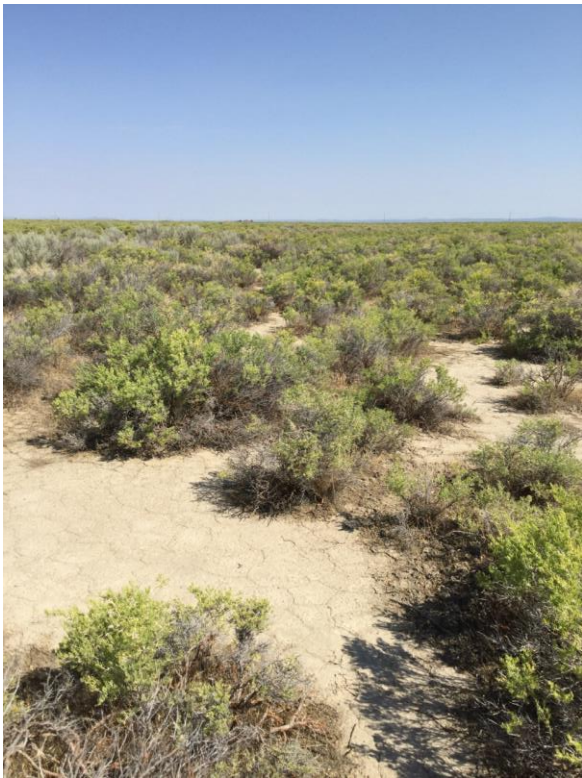
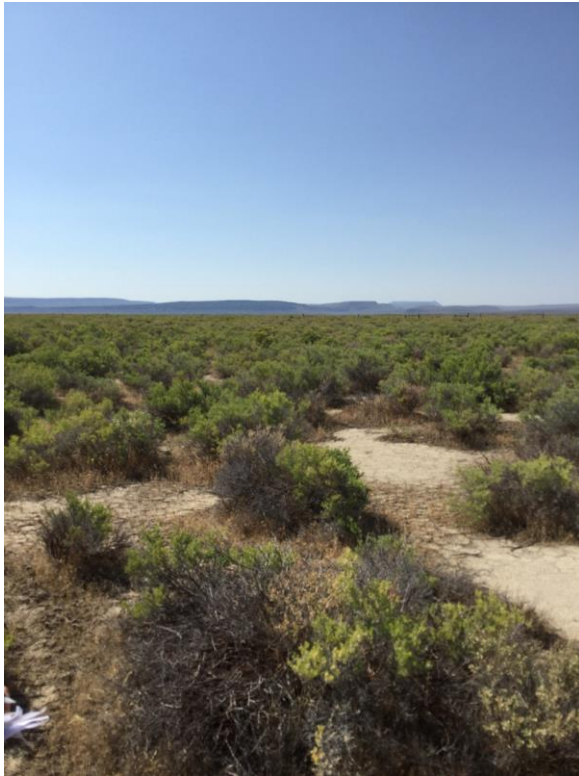
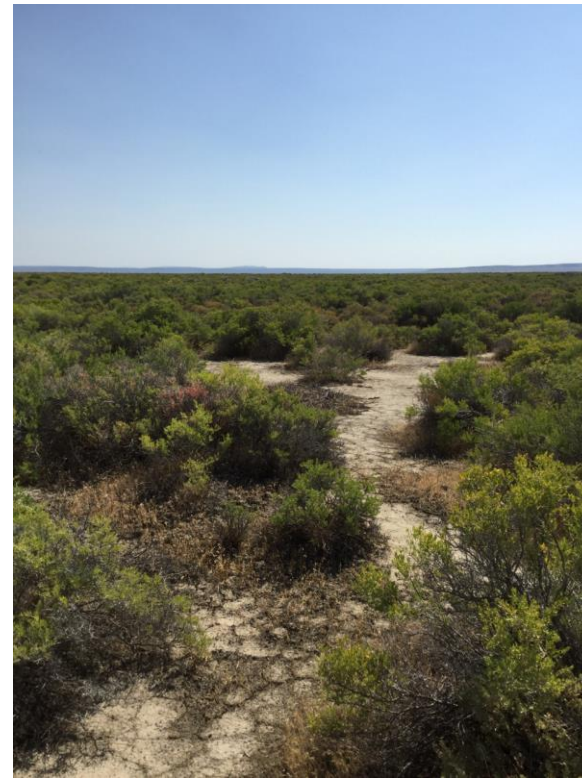
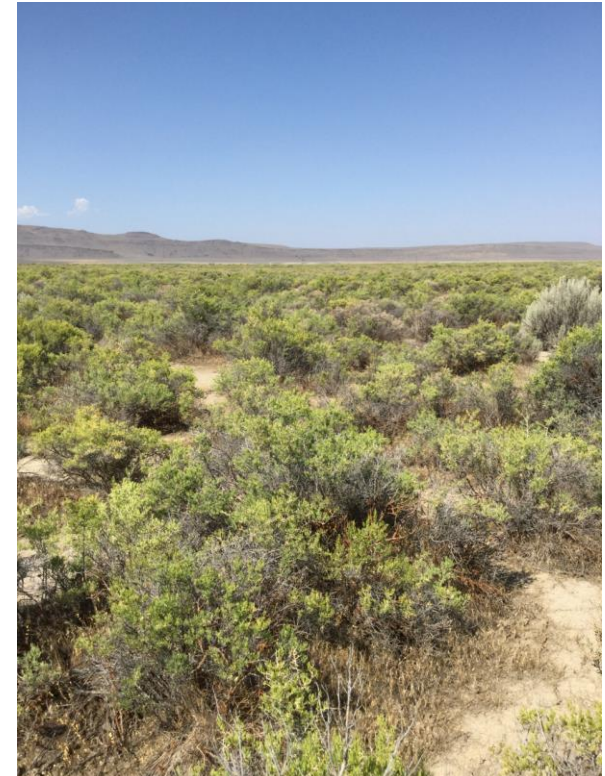
Photo Point 63 –Viewpoint Facing North, South, East & West

RESPONSE: During the original wetland delineation field survey, the entire project area was walked in transects by teams of both wetland and wildlife biologists. No photos were originally taken for these areas you reference because no OHW indicators were observed and vegetation was typical of the greasewood community found in this area. These areas were revisited in July 2020 and photos taken (see photos 60-62 in Attachment 3 to this memo and updated Figures 6-C and 6-E in Attachment 1). No additional playas with OHW marks were observed. Many of these scattered, open areas have a biotic crust within the open areas which was only observed in upland areas where playas had been identified. Also, ant mounds were observed on the open areas which also had been seen only in upland areas. These same conditions were observed in the areas west of photo 16 (see photo 63 in Attachment 3 to this memo and Figure 6-G in Attachment 1).

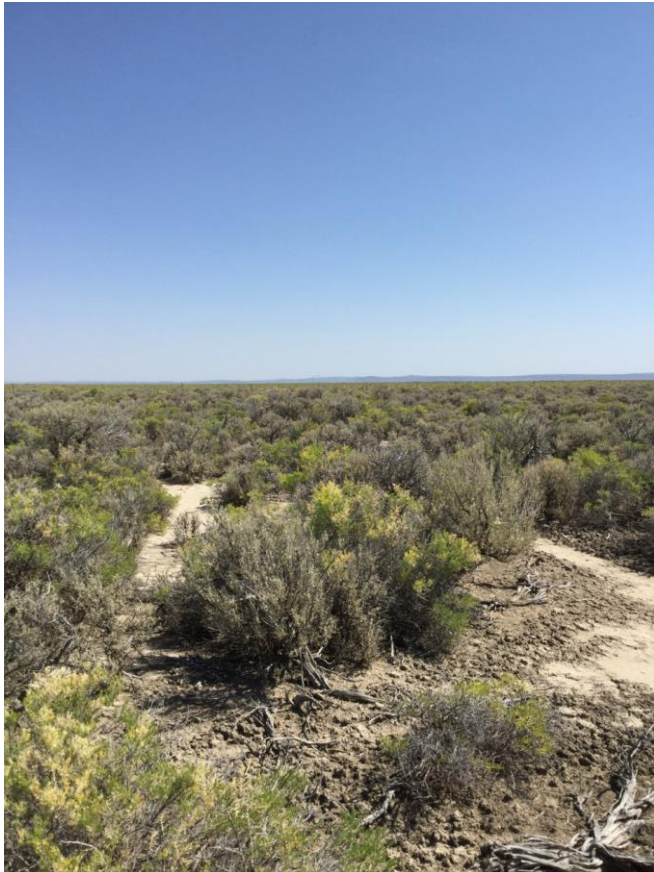
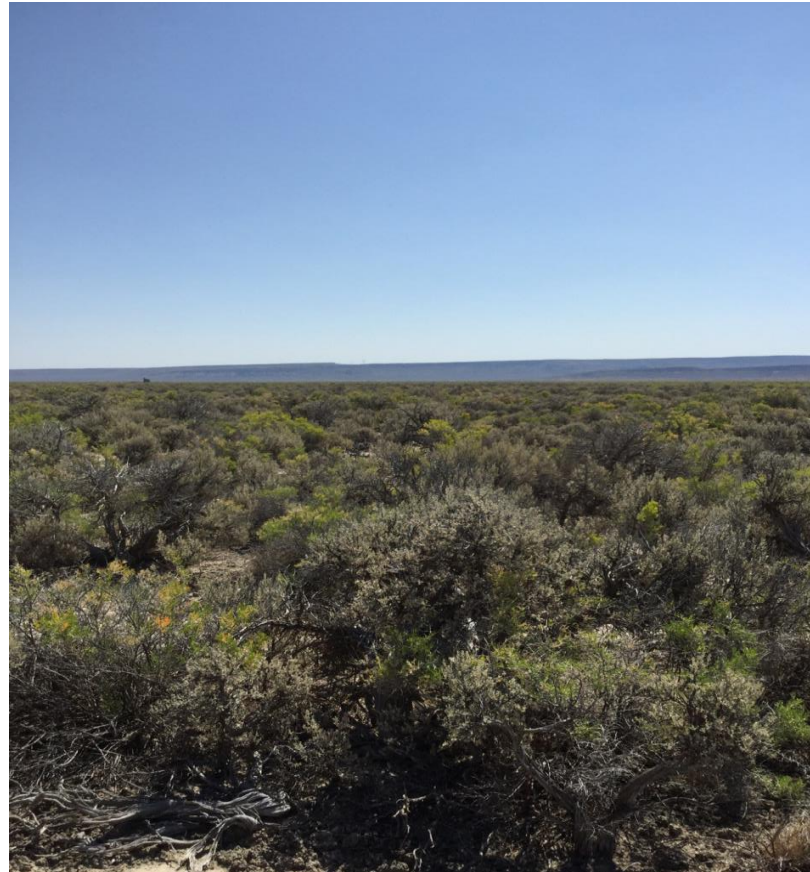
Photo Point 64 –Viewpoint Facing East & West

RESPONSE: The initial absence of the hydric sample plot was an oversight and a sample point for this hydric soil unit has been collected. See data form # SPX19 in Attachment 2 to this memo and updated Figure 6-W in Attachment 1. This area was sampled on July 29, 2020. No evidence of wetlands or nonwetland waters was observed in this area. The darker areas on the aeriels consists of upland shrubs that include *Artemisia longloba*, *Ericameria nauseosa* and *Sarcobatus vermiculatu*. No distinct flow path

was visible on the ground nor were any hydrologic indicators or ordinary high water (OHW) mark observed in this area. See photo 64 in Attachment 3 to this memo.

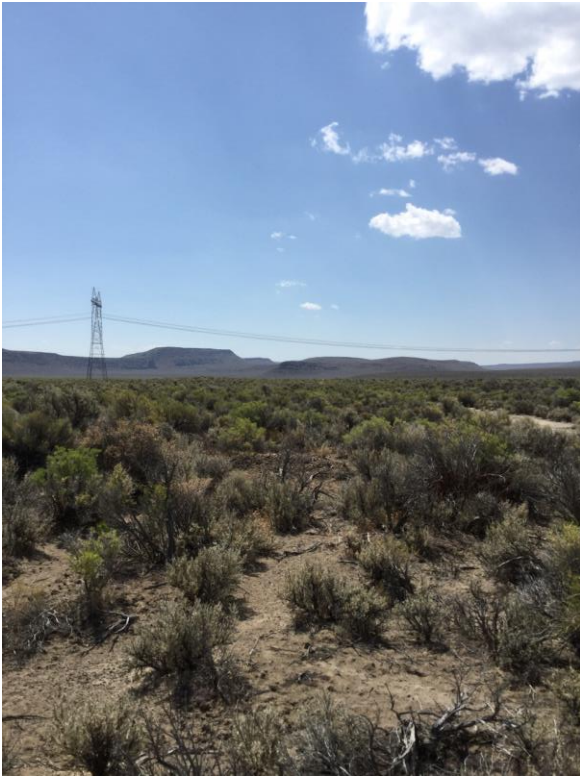
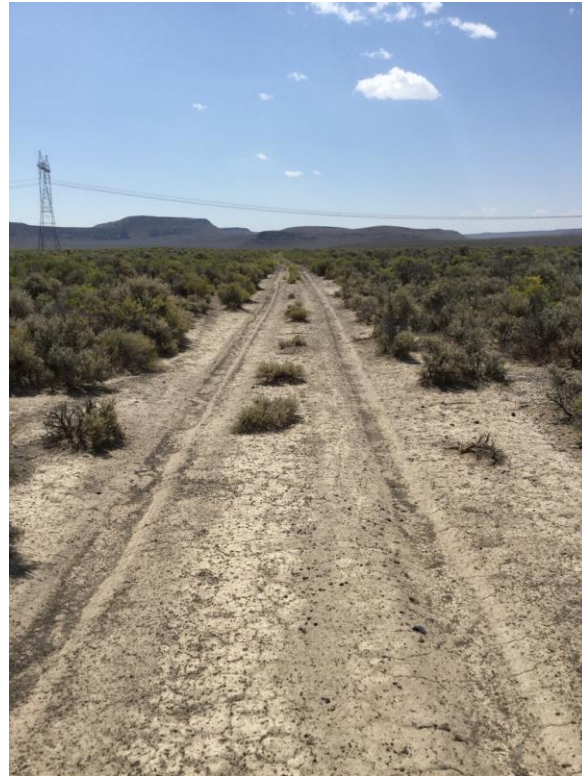
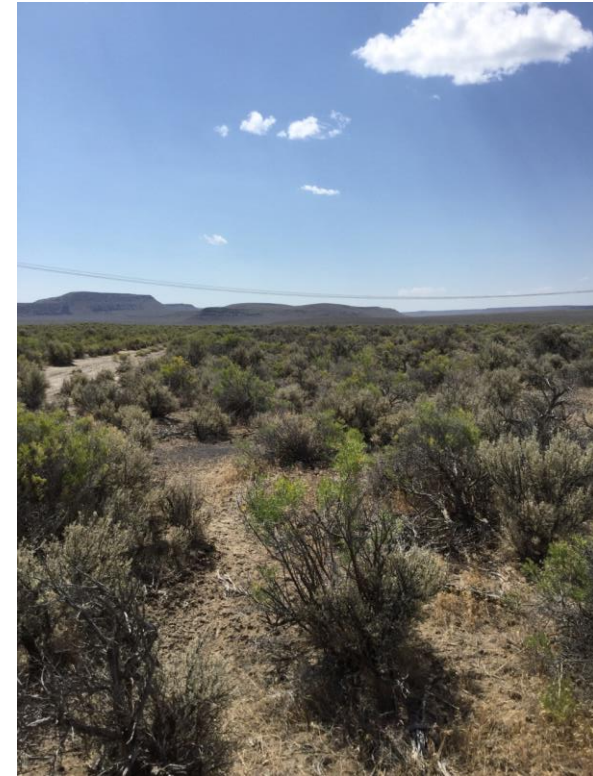
Photo Point 66 –Access Road Viewpoint Facing South

East side of access road

Center of access road

West side of access road

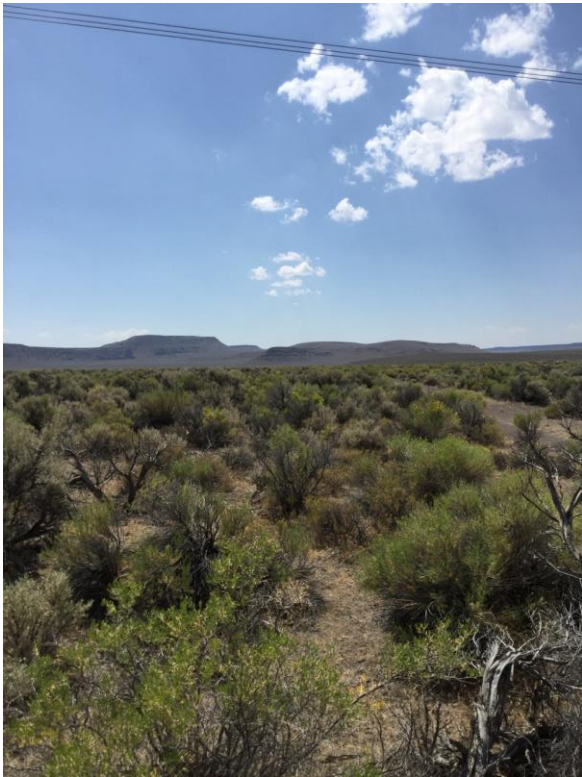
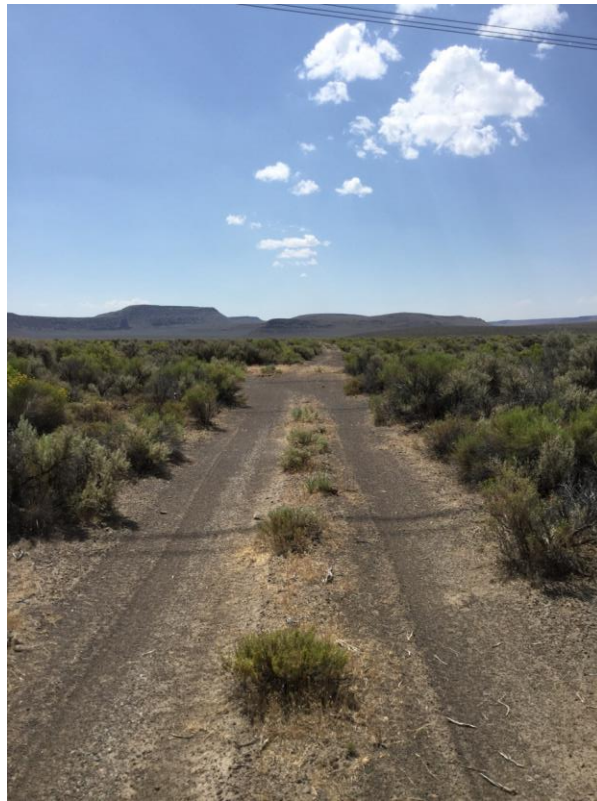
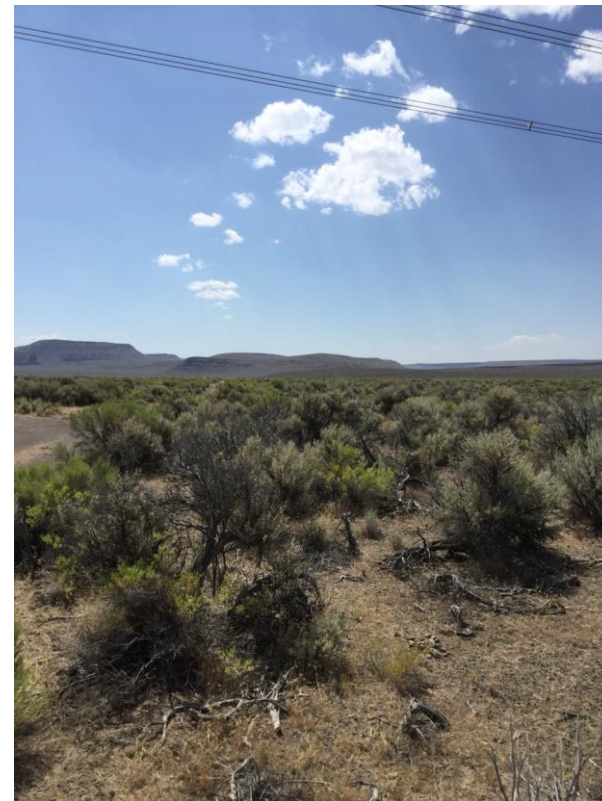
Photo Point 67 –Access Road Viewpoint Facing South

East side of access road

Center of access road

West side of access road

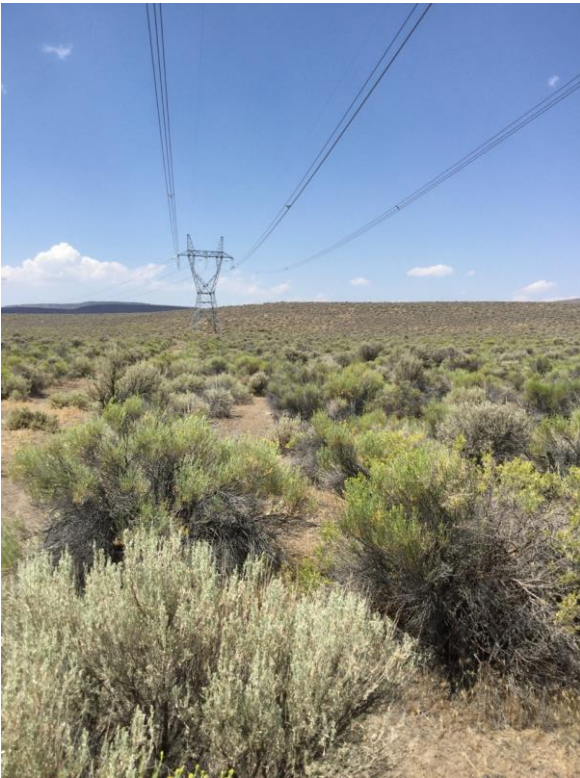
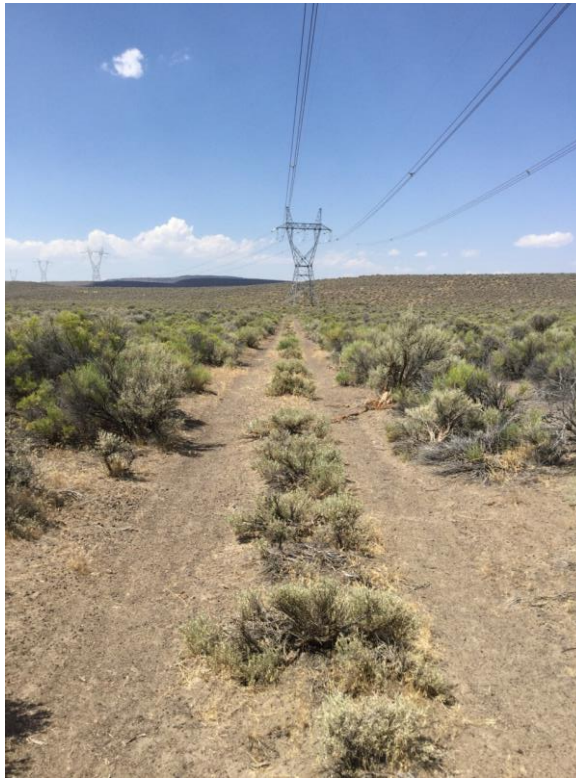
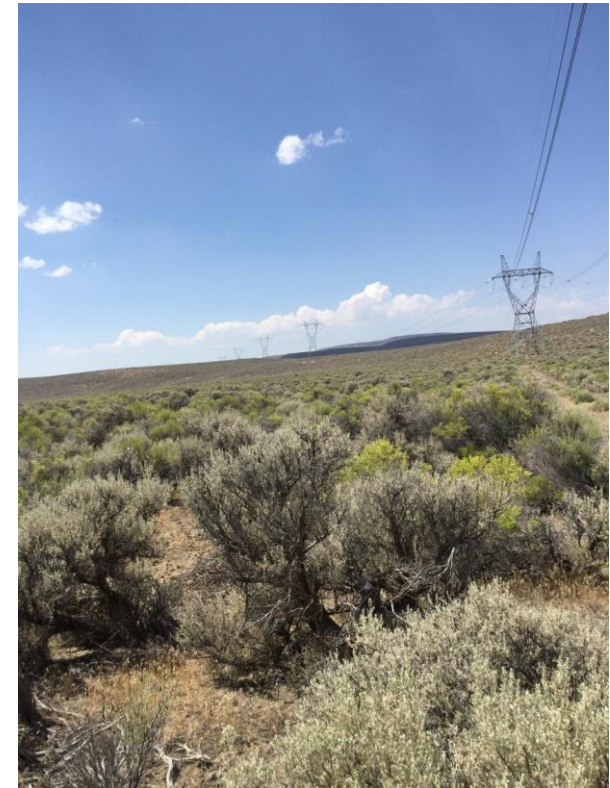
Photo Point 68 –Access Road Viewpoint Facing West, SW

North side of access road

Center of access road

South side of access road

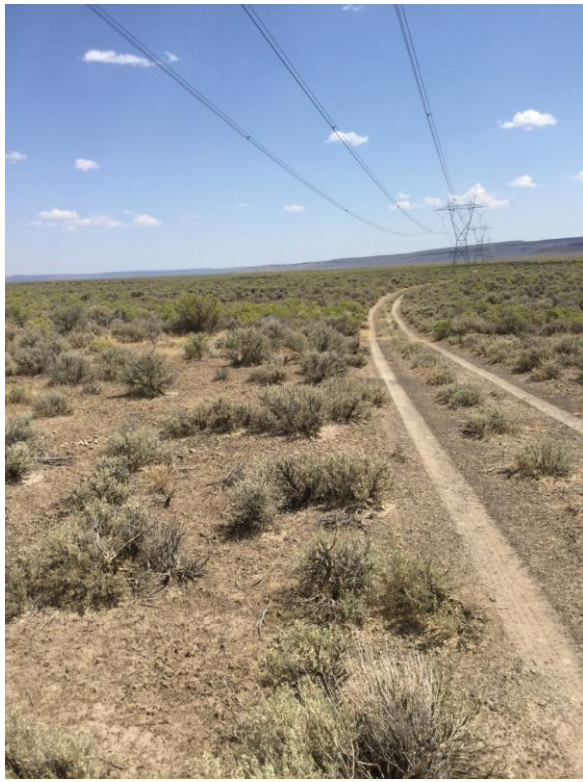
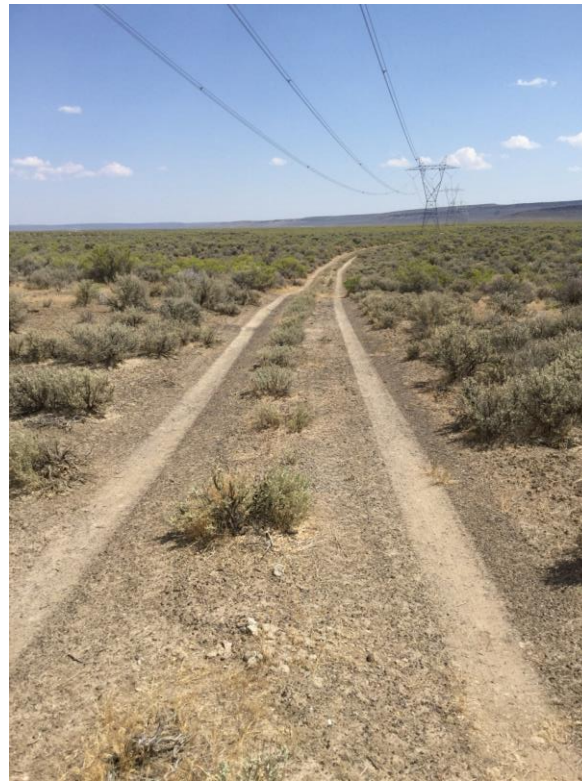
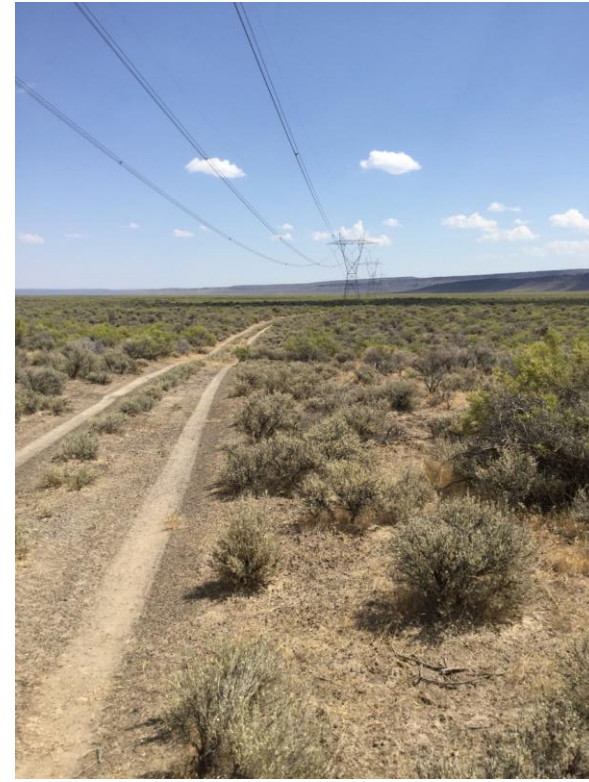
Photo Point 69 –Access Road Viewpoint Facing East

Northwest side of access road

Center of access road

Southeast side of access road
