# **Exhibit J**

## **Wetlands and Other Waters**

## Mist Resiliency Project August 2024

**Northwest Natural Gas**

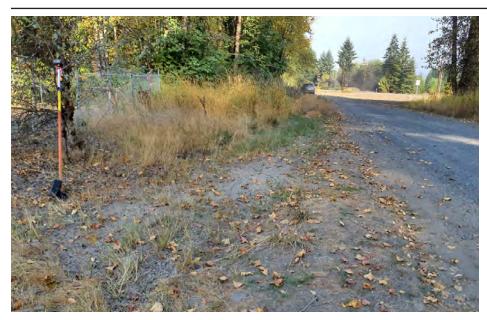
Photo 1. Southeast end of WET-01, wetland extends northwest between gravel road and laydown yard. Surface soil cracking can be seen in the foreground.. Looking NW. Taken: 9/27/2022. Lat/Long: 45.9987068, -123.2596903.

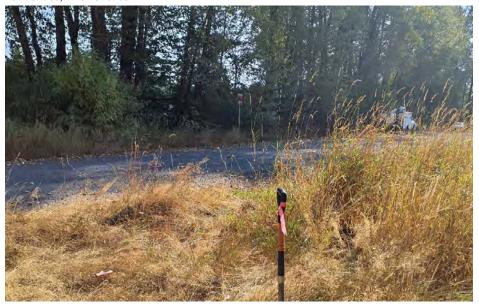
Photo 3. Shovel in pit along WET-01 boundary. Soft rush (Juncus effusus) dominates within the slight depression.. Looking SE. Taken: 9/27/2022. Lat/Long: 45.99887081, -123.259912.

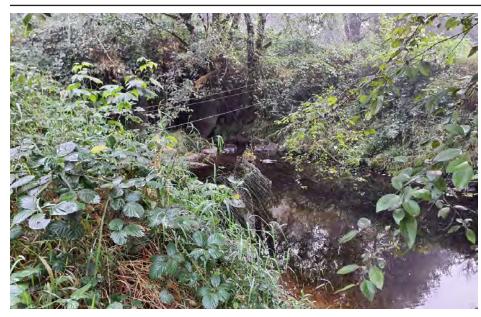
Photo 37. Culvert outflow into creek.. Looking NE. Taken: 10/6/2022. Lat/Long: 46.00766304, -123.2656578.

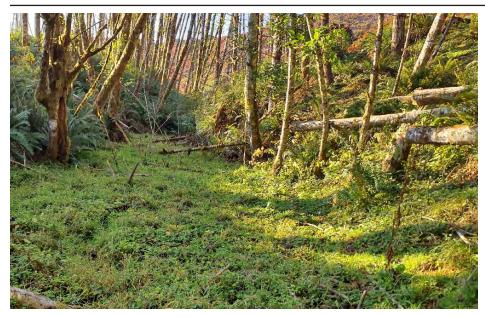
Photo 45. General site conditions of WET-10.. Looking NW. Taken: 10/6/2022. Lat/Long: 46.01414056, -123.2679911.

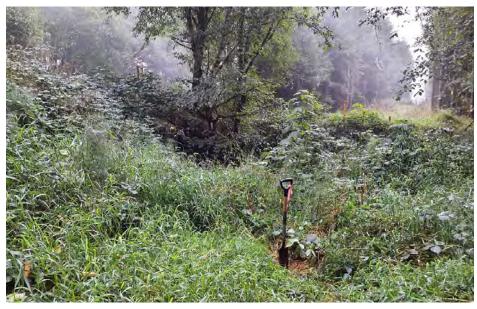
Photo 47. Shovel is at upland verification plot of WET-07a.. Looking E. Taken: 10/6/2022. Lat/Long: 46.00772743, -123.2656592.

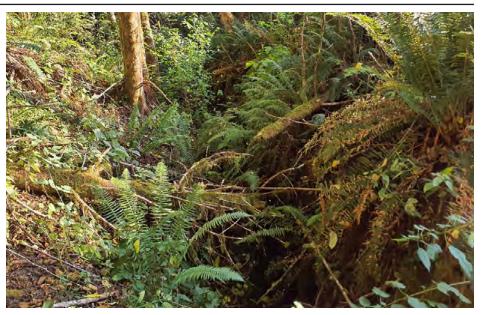
Photo 46. General site conditions of ST-02.. Looking SE. Taken: 10/7/2022. Lat/Long: 46.01402106, -123.2677977.

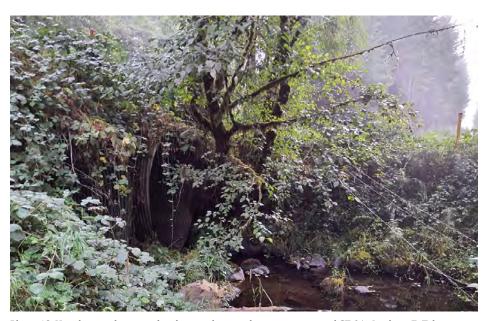
Photo 48. Very large culverts under the mainline road conveys perennial ST-01.. Looking E. Taken: 10/6/2022. Lat/Long: 46.00771432, -123.2655757.

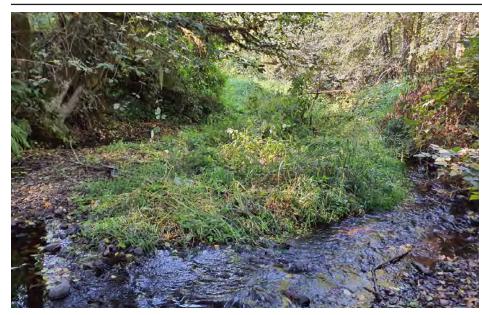
Photo 53. General site conditions of WET-07b.. Looking S. Taken: 10/6/2022. Lat/Long: 46.00761574, -123.2656526.

Wetland Name	HGM (subclass) Wetland Type	Dominant Cowardin Class	Acres	Figure #	General Conditions
WET-07b	Riverine (Flow-through)	PEM	0.01	5.14.1	Wetland is on a vegetated gravel bar below the ordinary high-water line of ST-01. This wetland is hydrologically connected underground to WET-07a. Vegetation consisted of stinging nettle ( <i>Urtica dioica</i> , FAC), reed canary grass, water parsley, and tall manna grass ( <i>Glyceria elata</i> , FACW).
WET-08	Flats	PSS	0.06	5.14.1	Low wetland follows edge of upland area north of logging road and west of ST-01. Approximately three feet below road was vegetation such as Oregon crabapple, slough sedge, climbing nightshade ( <i>Solanum dulcamara</i> , FAC), creeping buttercup ( <i>Rananculus repens</i> , FAC), and water parsley. Wetland boundary follows vegetation change and gradual elevation change with additional hydric soil confirmation.
WET-09	Flats	PEM	0.06	5.11.1	Wetland is located within a potentially disturbed site on a terrace between a larger logged hillside and a dense forest. Wetland vegetation consisted of soft rush and slough sedge.

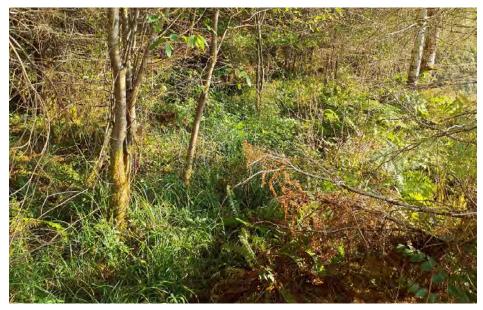
Photo 55. General site conditions of WET-09.. Looking S. Taken: 10/6/2022. Lat/Long: 46.01487445, -123.2678965.

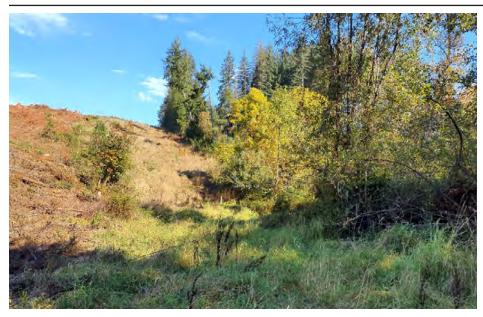
Photo 57. General site conditions of WET-11.. Looking N. Taken: 10/10/2022. Lat/Long: 46.00938111, -123.268004.

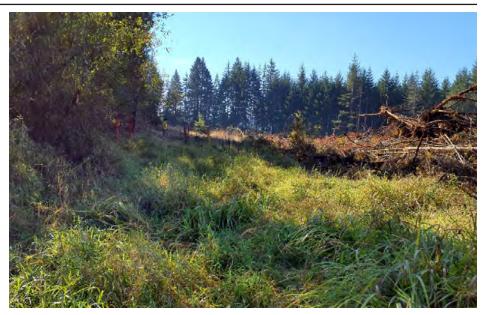
Photo 58. General site conditions of WET-11.. Looking S. Taken: 10/10/2022. Lat/Long: 46.00962635, -123.267972.

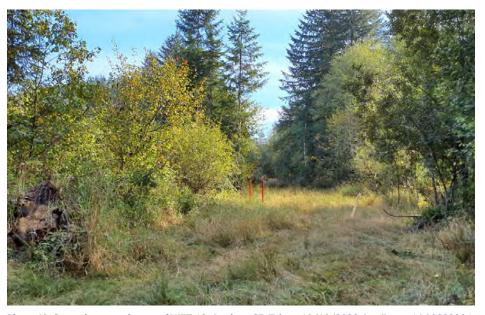
Photo 60. General site conditions of WET-12.. Looking SE. Taken: 10/10/2022. Lat/Long: 46.00833994, -123.2678142.

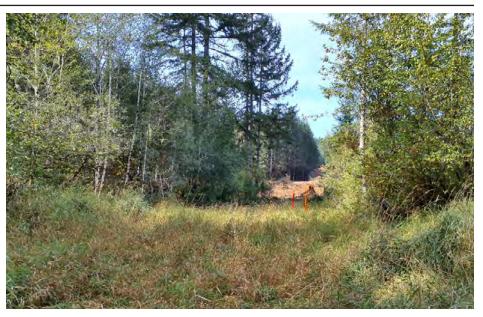
Photo 62. General site conditions of WET-12.. Looking NW. Taken: 10/10/2022. Lat/Long: 46.00814732, -123.2671607.

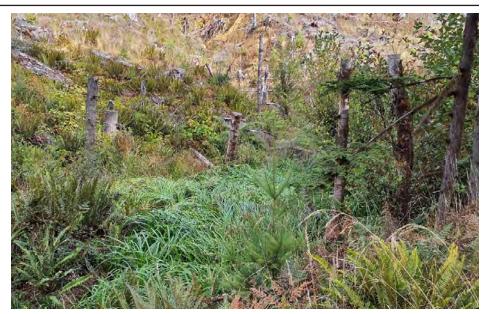
Photo 90. General site conditions of WET-15a.. Looking N. Taken: 10/11/2022. Lat/Long: 46.05107332, -123.2875457.

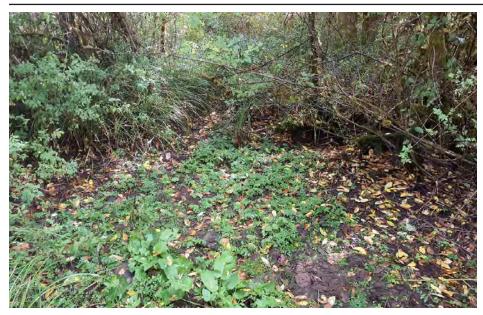
Photo 189. General site conditions at WET-19.. Looking NE. Taken: 9/26/2023. Lat/Long: 46.00469046, -123.2782502.

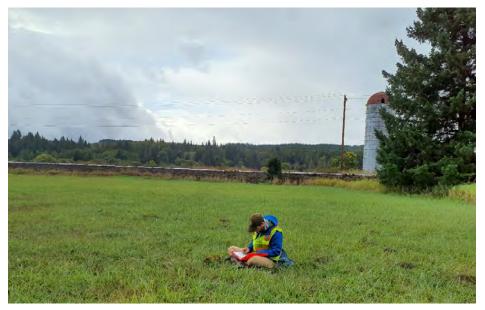
Photo 191. General site conditions at WET-19.. Looking S. Taken: 9/26/2023. Lat/Long: 46.00405565, -123.281284.

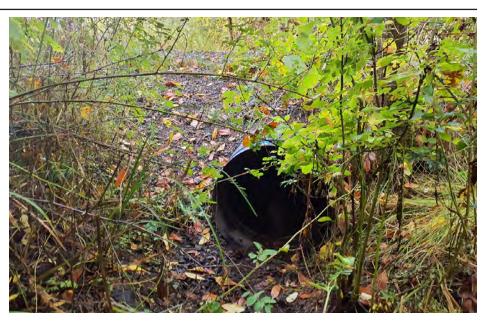
Photo 190. General site conditions at WET-19.. Looking W. Taken: 9/26/2023. Lat/Long: 46.00469998, -123.2782945.
