**Exhibit J
Waters of the State**

Umatilla-Morrow County Connect Project

Application for Site Certificate

Subject: November 2024 Addition of Route D to the Umatilla-Morrow County Connect Project, Umatilla and Morrow Counties, Oregon

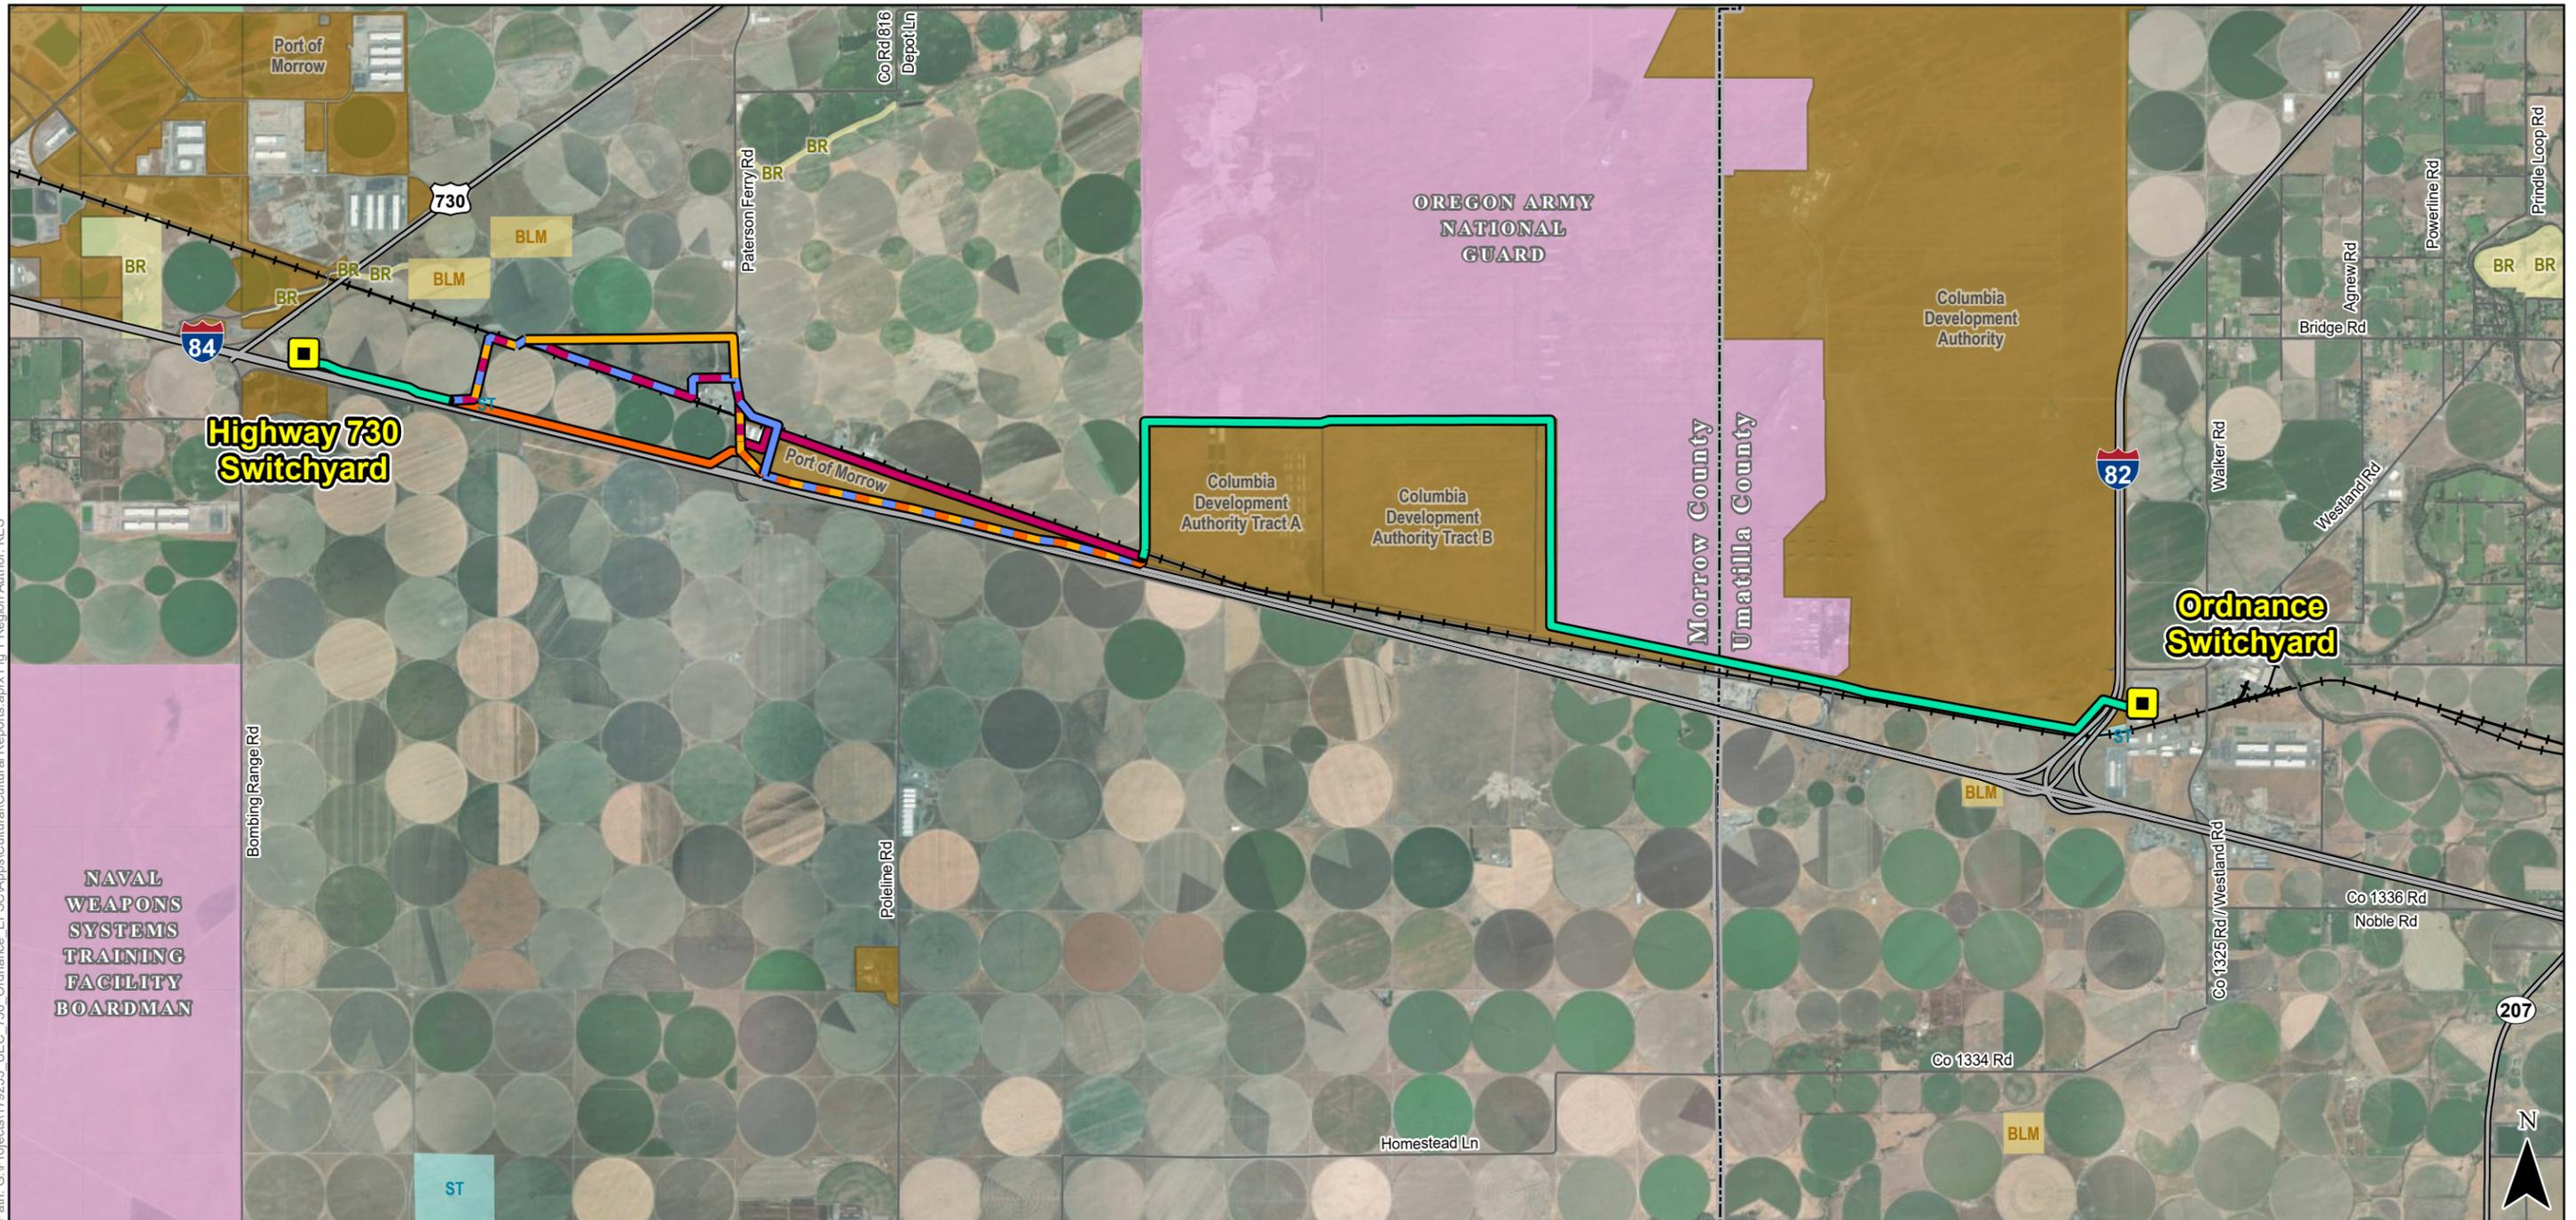
Figure 1 Project Region

In November of 2024, Umatilla Electric Cooperative (UEC) added a fourth alternative route, Route D, to the Umatilla-Morrow County Connect Project (Project). The most current design now includes four route alternatives, Routes A through D, located in Morrow and Umatilla Counties between the cities of Boardman and Hermiston (see Project Region Map, page 2).

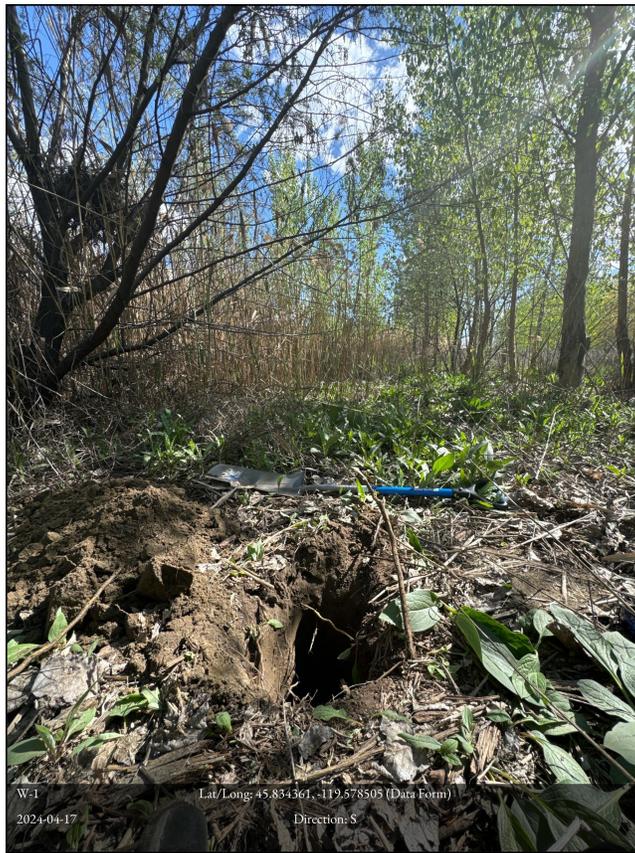
Project/Site: Umatilla-Morrow County Connect Project City/County: Morrow County Sampling Date: 2024-04-17
 Applicant/Owner: Umatilla Electric Cooperative State: Oregon Sampling Point: W-1
 Investigator(s): Quinn Radford Section, Township, Range: sec 16 T004N R026E
 Landform (hillslope, terrace, etc.): Depression Local relief (concave, convex, none): Concave Slope (%): 0-2
 Subregion (LRR): LRR B, MLRA 7 Lat: 45.834361 Long: -119.578505 Datum: WGS84
 Soil Map Unit Name: Quincy loamy fine sand, 2 to 12 percent slopes NWI classification: PEM1F
 Are climatic / hydrologic conditions on the site typical for this time of year? Yes No (If no, explain in Remarks.)
 Are Vegetation , Soil , or Hydrology significantly disturbed? Are "Normal Circumstances" present? Yes No
 Are Vegetation , Soil , or Hydrology naturally problematic? (If needed, explain any answers in Remarks.)

Remarks:
 A clear edge of *Bromus tectorum* was observed nearby, serving as a marker for the wetland boundary. However, there were insufficient hydrophytes in this area to classify it as a wetland. The deep, excessively drained soils support the growth of upland plants in area where wetlands are show by NWI to be present. Aerial photos indicate recent disturbances, leading to the rapid colonization of non-native, marginally hydrophytic plants in areas that may have once supported more hydric vegetation. Additionally, the cultivation of cottonwood trees has likely lowered the water table, altering the hydrological indicators over time. These factors suggest that this area was likely a wetland, as evidenced by hydrological and soil indicators.

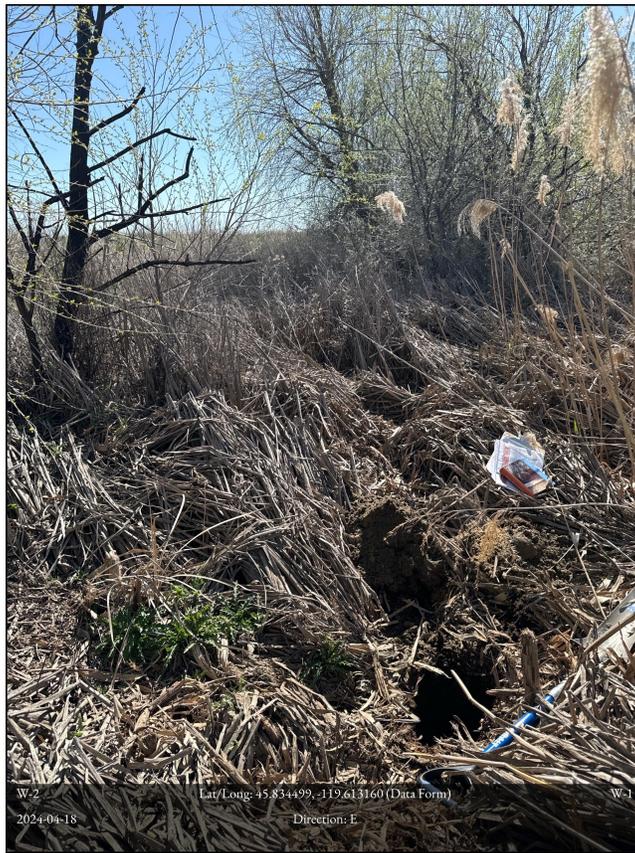
Project/Site: Umatilla-Morrow County Connect Project City/County: Morrow County Sampling Date: 2024-04-18
 Applicant/Owner: Umatilla Electric Cooperative State: Oregon Sampling Point: W-2
 Investigator(s): Quinn Radford Section, Township, Range: sec 18 T004N R026E
 Landform (hillslope, terrace, etc.): Depression Local relief (concave, convex, none): Concave Slope (%): 0-2
 Subregion (LRR): LRR B, MLRA 7 Lat: 45.834499 Long: -119.613160 Datum: WGS84
 Soil Map Unit Name: Quincy loamy fine sand, 2 to 12 percent slopes NWI classification: None
 Are climatic / hydrologic conditions on the site typical for this time of year? Yes No (If no, explain in Remarks.)
 Are Vegetation , Soil , or Hydrology significantly disturbed? Are "Normal Circumstances" present? Yes No
 Are Vegetation , Soil , or Hydrology naturally problematic? (If needed, explain any answers in Remarks.)

Remarks:
Very clear wetland site.

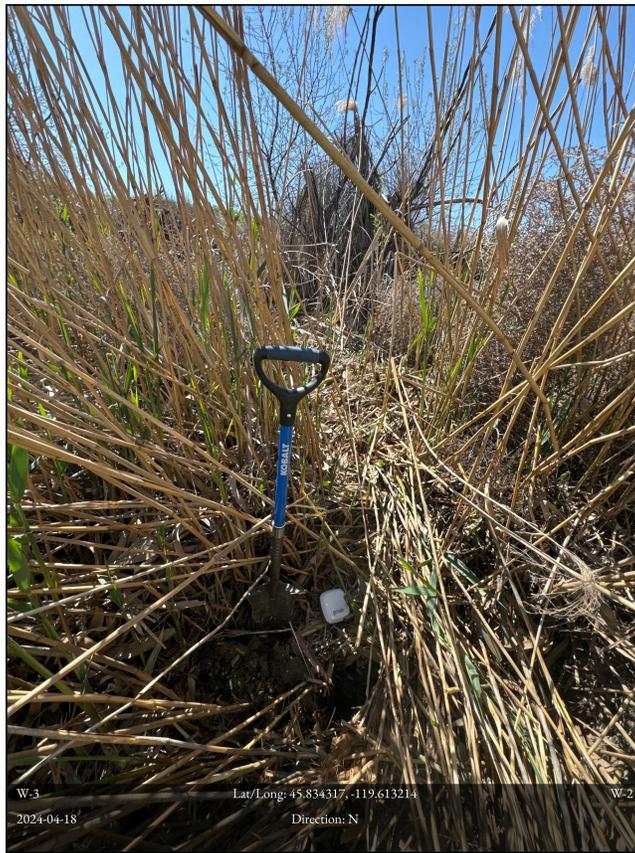
Project/Site: Umatilla-Morrow County Connect Project City/County: Morrow County Sampling Date: 2024-04-18
 Applicant/Owner: Umatilla Electric Cooperative State: Oregon Sampling Point: W-3
 Investigator(s): Quinn Radford Section, Township, Range: sec 18 T004N R026E
 Landform (hillslope, terrace, etc.): Depression Local relief (concave, convex, none): None Slope (%): 0-2
 Subregion (LRR): LRR B, MLRA 7 Lat: 45.834621 Long: -119.578937 Datum: WGS84
 Soil Map Unit Name: Quincy loamy fine sand, 2 to 12 percent slopes NWI classification: None
 Are climatic / hydrologic conditions on the site typical for this time of year? Yes No (If no, explain in Remarks.)
 Are Vegetation , Soil , or Hydrology significantly disturbed? Are "Normal Circumstances" present? Yes No
 Are Vegetation , Soil , or Hydrology naturally problematic? (If needed, explain any answers in Remarks.)

Depth (inches)	Matrix		Redox Features				Texture	Remarks
	Color (moist)	%	Color (moist)	%	Type ¹	Loc ²		
0-4	7.5YR 6/2	95	7.5YR 5/6	5	CS	M	FSL	
4-20	7.5YR 5/3	100					FSL

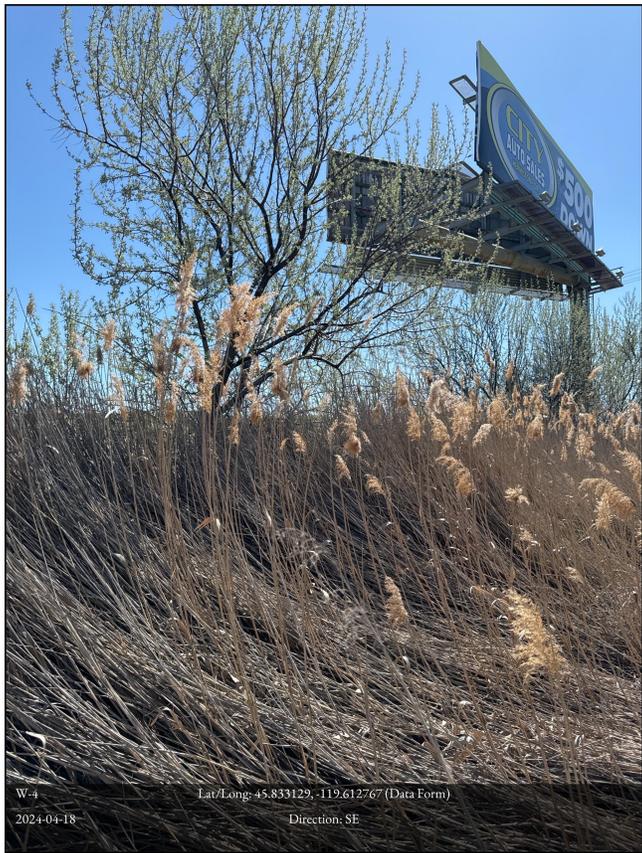
Project/Site: Umatilla-Morrow County Connect Project City/County: Morrow County Sampling Date: 2024-04-18
 Applicant/Owner: Umatilla Electric Cooperative State: Oregon Sampling Point: W-4
 Investigator(s): Quinn Radford Section, Township, Range: sec 18 T004N R026E
 Landform (hillslope, terrace, etc.): Depression Local relief (concave, convex, none): Concave Slope (%): 0-2
 Subregion (LRR): LRR B, MLRA 7 Lat: 45.833129 Long: -119.612767 Datum: WGS84
 Soil Map Unit Name: Quincy loamy fine sand, 2 to 12 percent slopes NWI classification: None
 Are climatic / hydrologic conditions on the site typical for this time of year? Yes No (If no, explain in Remarks.)
 Are Vegetation , Soil , or Hydrology significantly disturbed? Are "Normal Circumstances" present? Yes No
 Are Vegetation , Soil , or Hydrology naturally problematic? (If needed, explain any answers in Remarks.)

Depth (inches)	Matrix		Redox Features				Texture	Remarks
	Color (moist)	%	Color (moist)	%	Type ¹	Loc ²		
0-6	7.5YR 2.5/1	90	7.5YR 5/6	10	CS	M	FSL

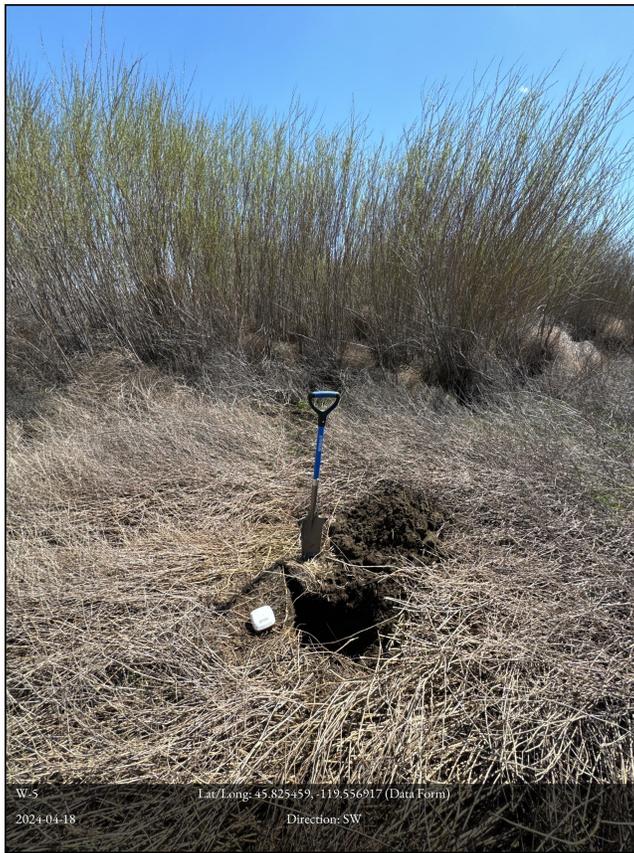
Project/Site: Umatilla-Morrow County Connect Project City/County: Morrow County Sampling Date: 2024-04-18
 Applicant/Owner: Umatilla Electric Cooperative State: Oregon Sampling Point: W-5
 Investigator(s): Quinn Radford Section, Township, Range: sec 15 T004N R026E
 Landform (hillslope, terrace, etc.): Depression Local relief (concave, convex, none): Concave Slope (%): 0-2
 Subregion (LRR): LRR B, MLRA 7 Lat: 45.825459 Long: -119.556917 Datum: WGS84
 Soil Map Unit Name: Quincy loamy fine sand, 2 to 12 percent slopes NWI classification: None
 Are climatic / hydrologic conditions on the site typical for this time of year? Yes No (If no, explain in Remarks.)
 Are Vegetation , Soil , or Hydrology significantly disturbed? Are "Normal Circumstances" present? Yes No
 Are Vegetation , Soil , or Hydrology naturally problematic? (If needed, explain any answers in Remarks.)

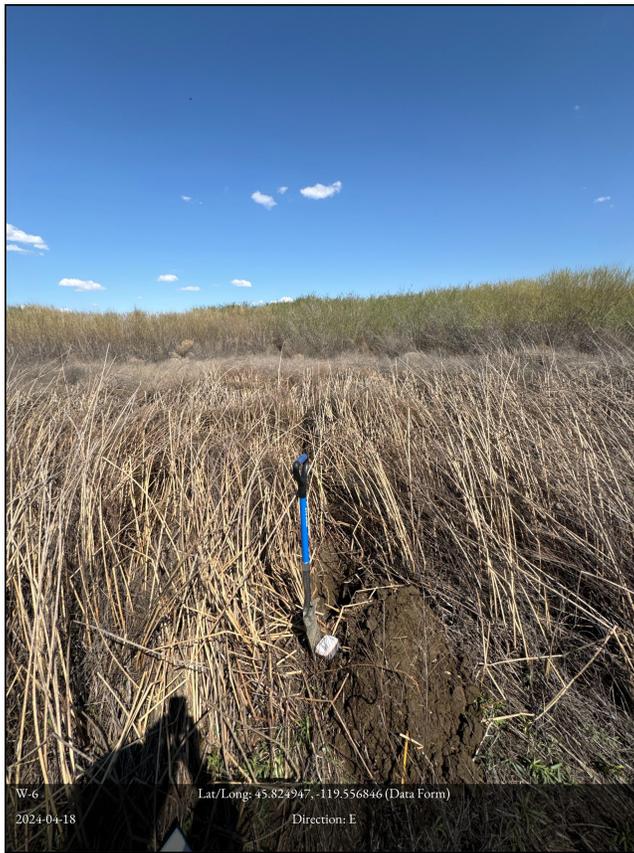
Project/Site: Umatilla-Morrow County Connect Project City/County: Morrow County Sampling Date: 2024-04-18
 Applicant/Owner: Umatilla Electric Cooperative State: Oregon Sampling Point: W-6
 Investigator(s): Quinn Radford Section, Township, Range: sec 15 T004N R026E
 Landform (hillslope, terrace, etc.): Dip Local relief (concave, convex, none): Concave Slope (%): 0-2
 Subregion (LRR): LRR B, MLRA 7 Lat: 45.824947 Long: -119.556846 Datum: WGS84
 Soil Map Unit Name: Quincy loamy fine sand, 2 to 12 percent slopes NWI classification: None
 Are climatic / hydrologic conditions on the site typical for this time of year? Yes No (If no, explain in Remarks.)
 Are Vegetation , Soil , or Hydrology significantly disturbed? Are "Normal Circumstances" present? Yes No
 Are Vegetation , Soil , or Hydrology naturally problematic? (If needed, explain any answers in Remarks.)

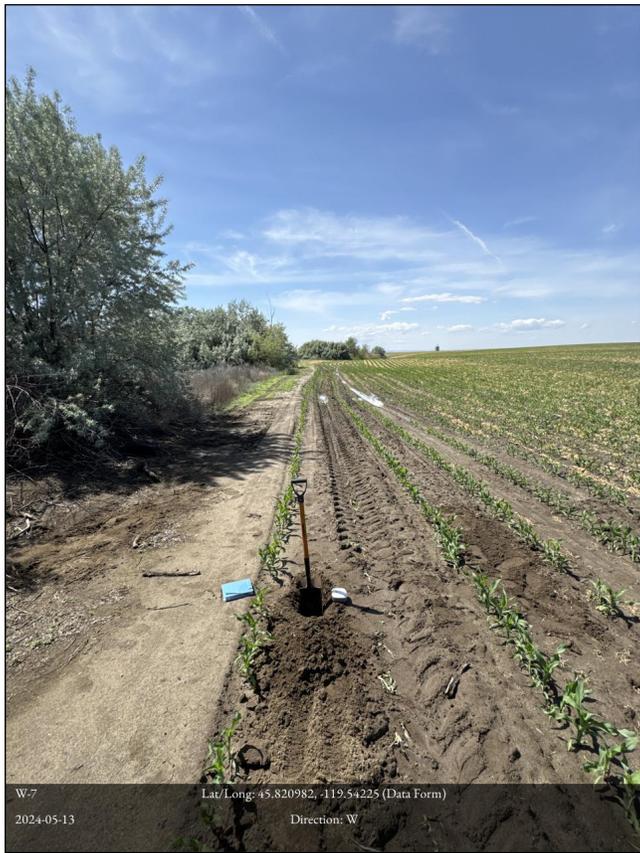
Project/Site: Umatilla-Morrow County Connect Project City/County: Morrow County Sampling Date: 2024-05-13
 Applicant/Owner: Umatilla Electric Cooperative State: Oregon Sampling Point: W-7
 Investigator(s): Quinn Radford Section, Township, Range: sec 22 T004N R026E
 Landform (hillslope, terrace, etc.): Depression Local relief (concave, convex, none): Concave Slope (%): 0-2
 Subregion (LRR): LRR B, MLRA 7 Lat: 45.820982 Long: -119.54225 Datum: WGS84
 Soil Map Unit Name: Quincy loamy fine sand, 2 to 12 percent slopes NWI classification: None
 Are climatic / hydrologic conditions on the site typical for this time of year? Yes No (If no, explain in Remarks.)
 Are Vegetation , Soil , or Hydrology significantly disturbed? Are "Normal Circumstances" present? Yes No
 Are Vegetation , Soil , or Hydrology naturally problematic? (If needed, explain any answers in Remarks.)

Depth (inches)	Matrix		Redox Features				Texture	Remarks
	Color (moist)	%	Color (moist)	%	Type ¹	Loc ²		
0-24	7.5YR 4/4	85	7.5YR 5/8	15	CS	M	FSL	Irrigated field

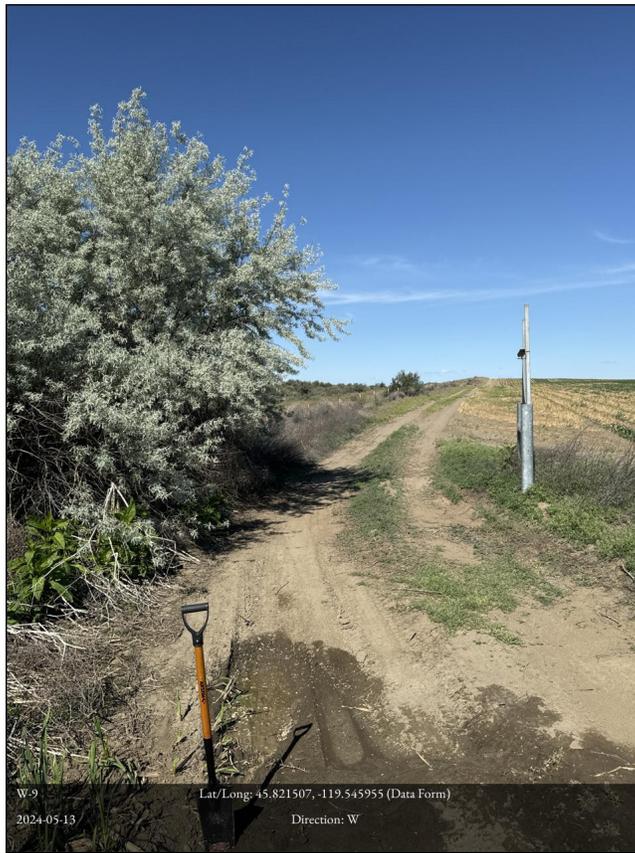
W-9

Depth (inches)	Matrix		Redox Features				Texture	Remarks
	Color (moist)	%	Color (moist)	%	Type ¹	Loc ²		
0-6	7.5YR 4/2	100					FSL	
6-24	7.5YR 5/6	100			CS	M/PL	FSL

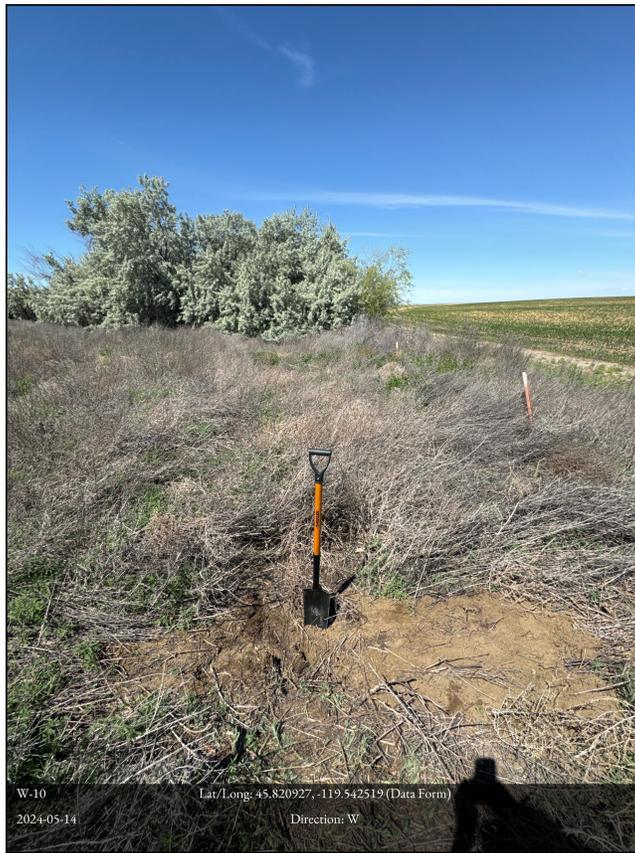
W-10

Depth (inches)	Matrix		Redox Features				Texture	Remarks
	Color (moist)	%	Color (moist)	%	Type ¹	Loc ²		
0-5	7.5YR 4/3	100					FSL	
5-30	7.5YR 4/3	90	7.5YR 5/8	10	CS	M	FSL	Sandy redox
