State and Local Laws and Regulations Exhibit

Cascade Renewable Transmission

Wasco, Hood River, and Multnomah Counties, Oregon

Submitted to
Oregon Energy Facility Siting Council

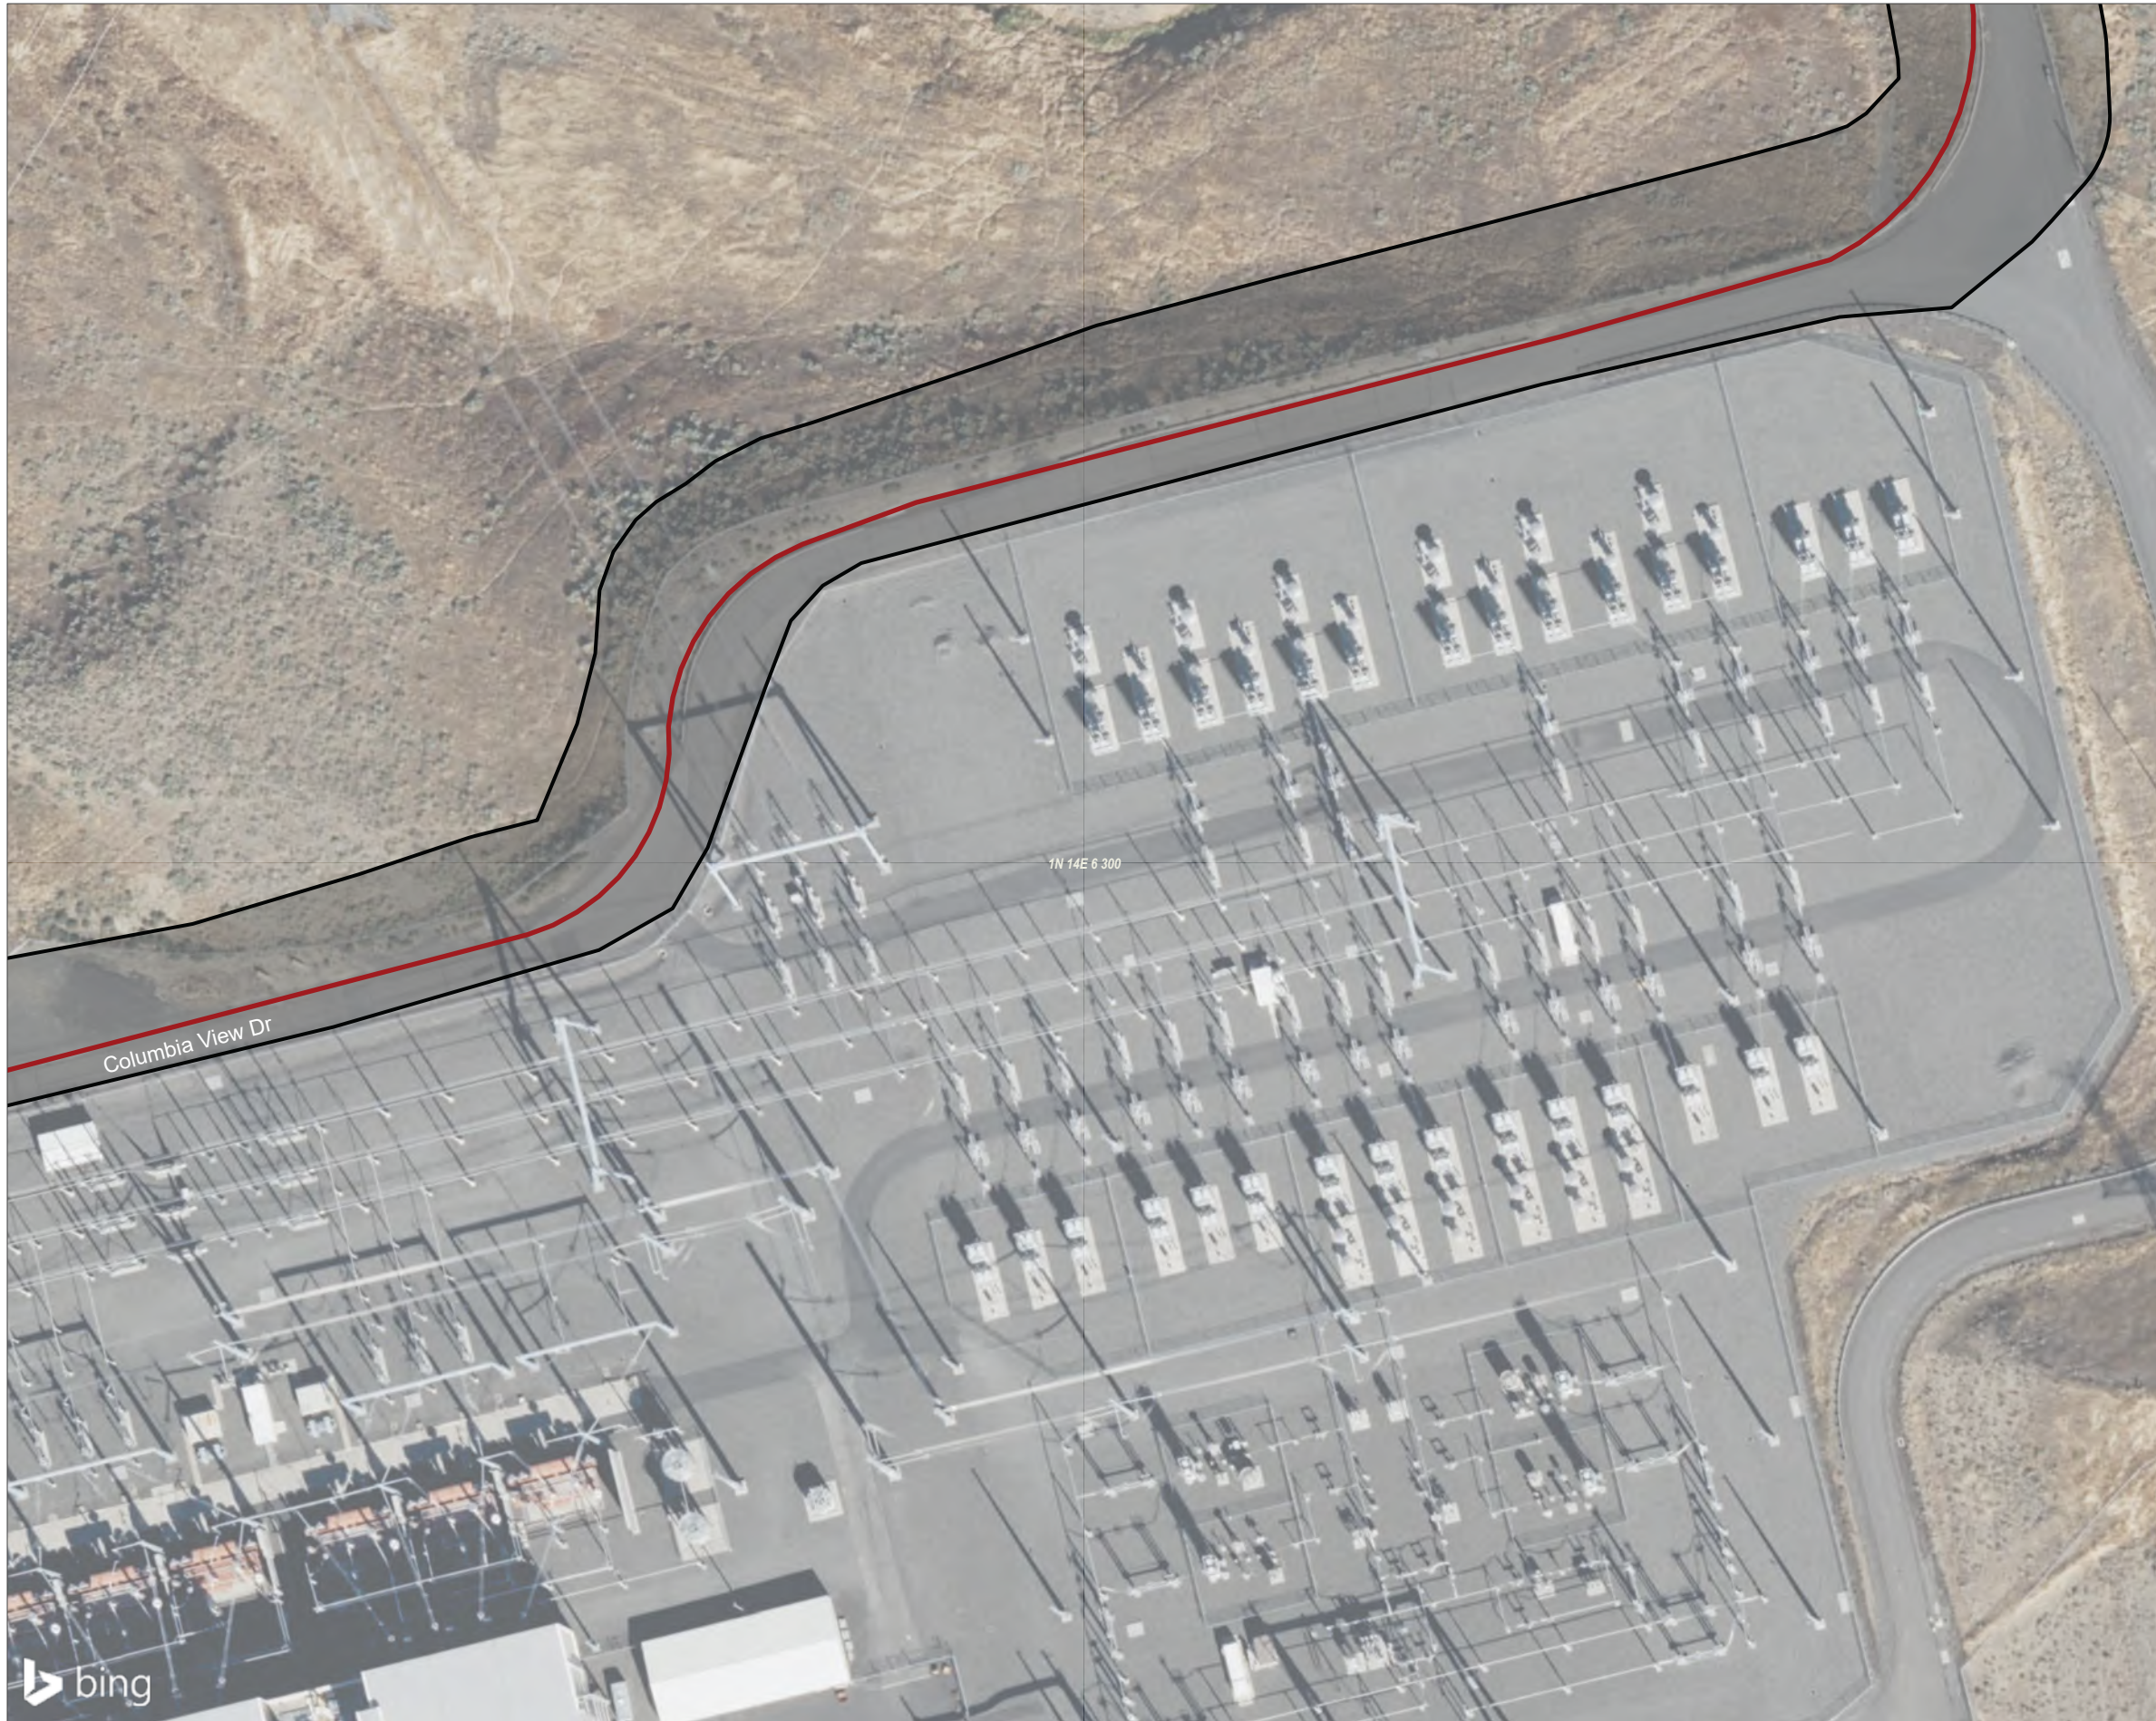
FIGURE 5 WETLAND & WATER SURVEY MAP
PAGE 59 OF 64
DATE: 4/9/2025
TOWNSHIP AND RANGE: T01N R13E/R14E
SECTION: 1, 6, 7, 12
USGS QUAD NAME:
THE DALLES SOUTH AND PETERSBURG

SAMPLE PLOT LOCATIONS, WETLAND, AND HTL AND OHW BOUNDARIES WERE RECORDED USING AN ARROW EOS GNSS RECEIVER WITH SUB-METER ACCURACY AND PLOTTED ONTO 2017 AERIAL IMAGES. THE AERIAL IMAGERY MAY NOT ALIGN WITH GPS DATA AND HAS NOT BEEN GROUND TRUTHED, AND COULD BE OFFSET ROUGHLY +/- 10 FEET.

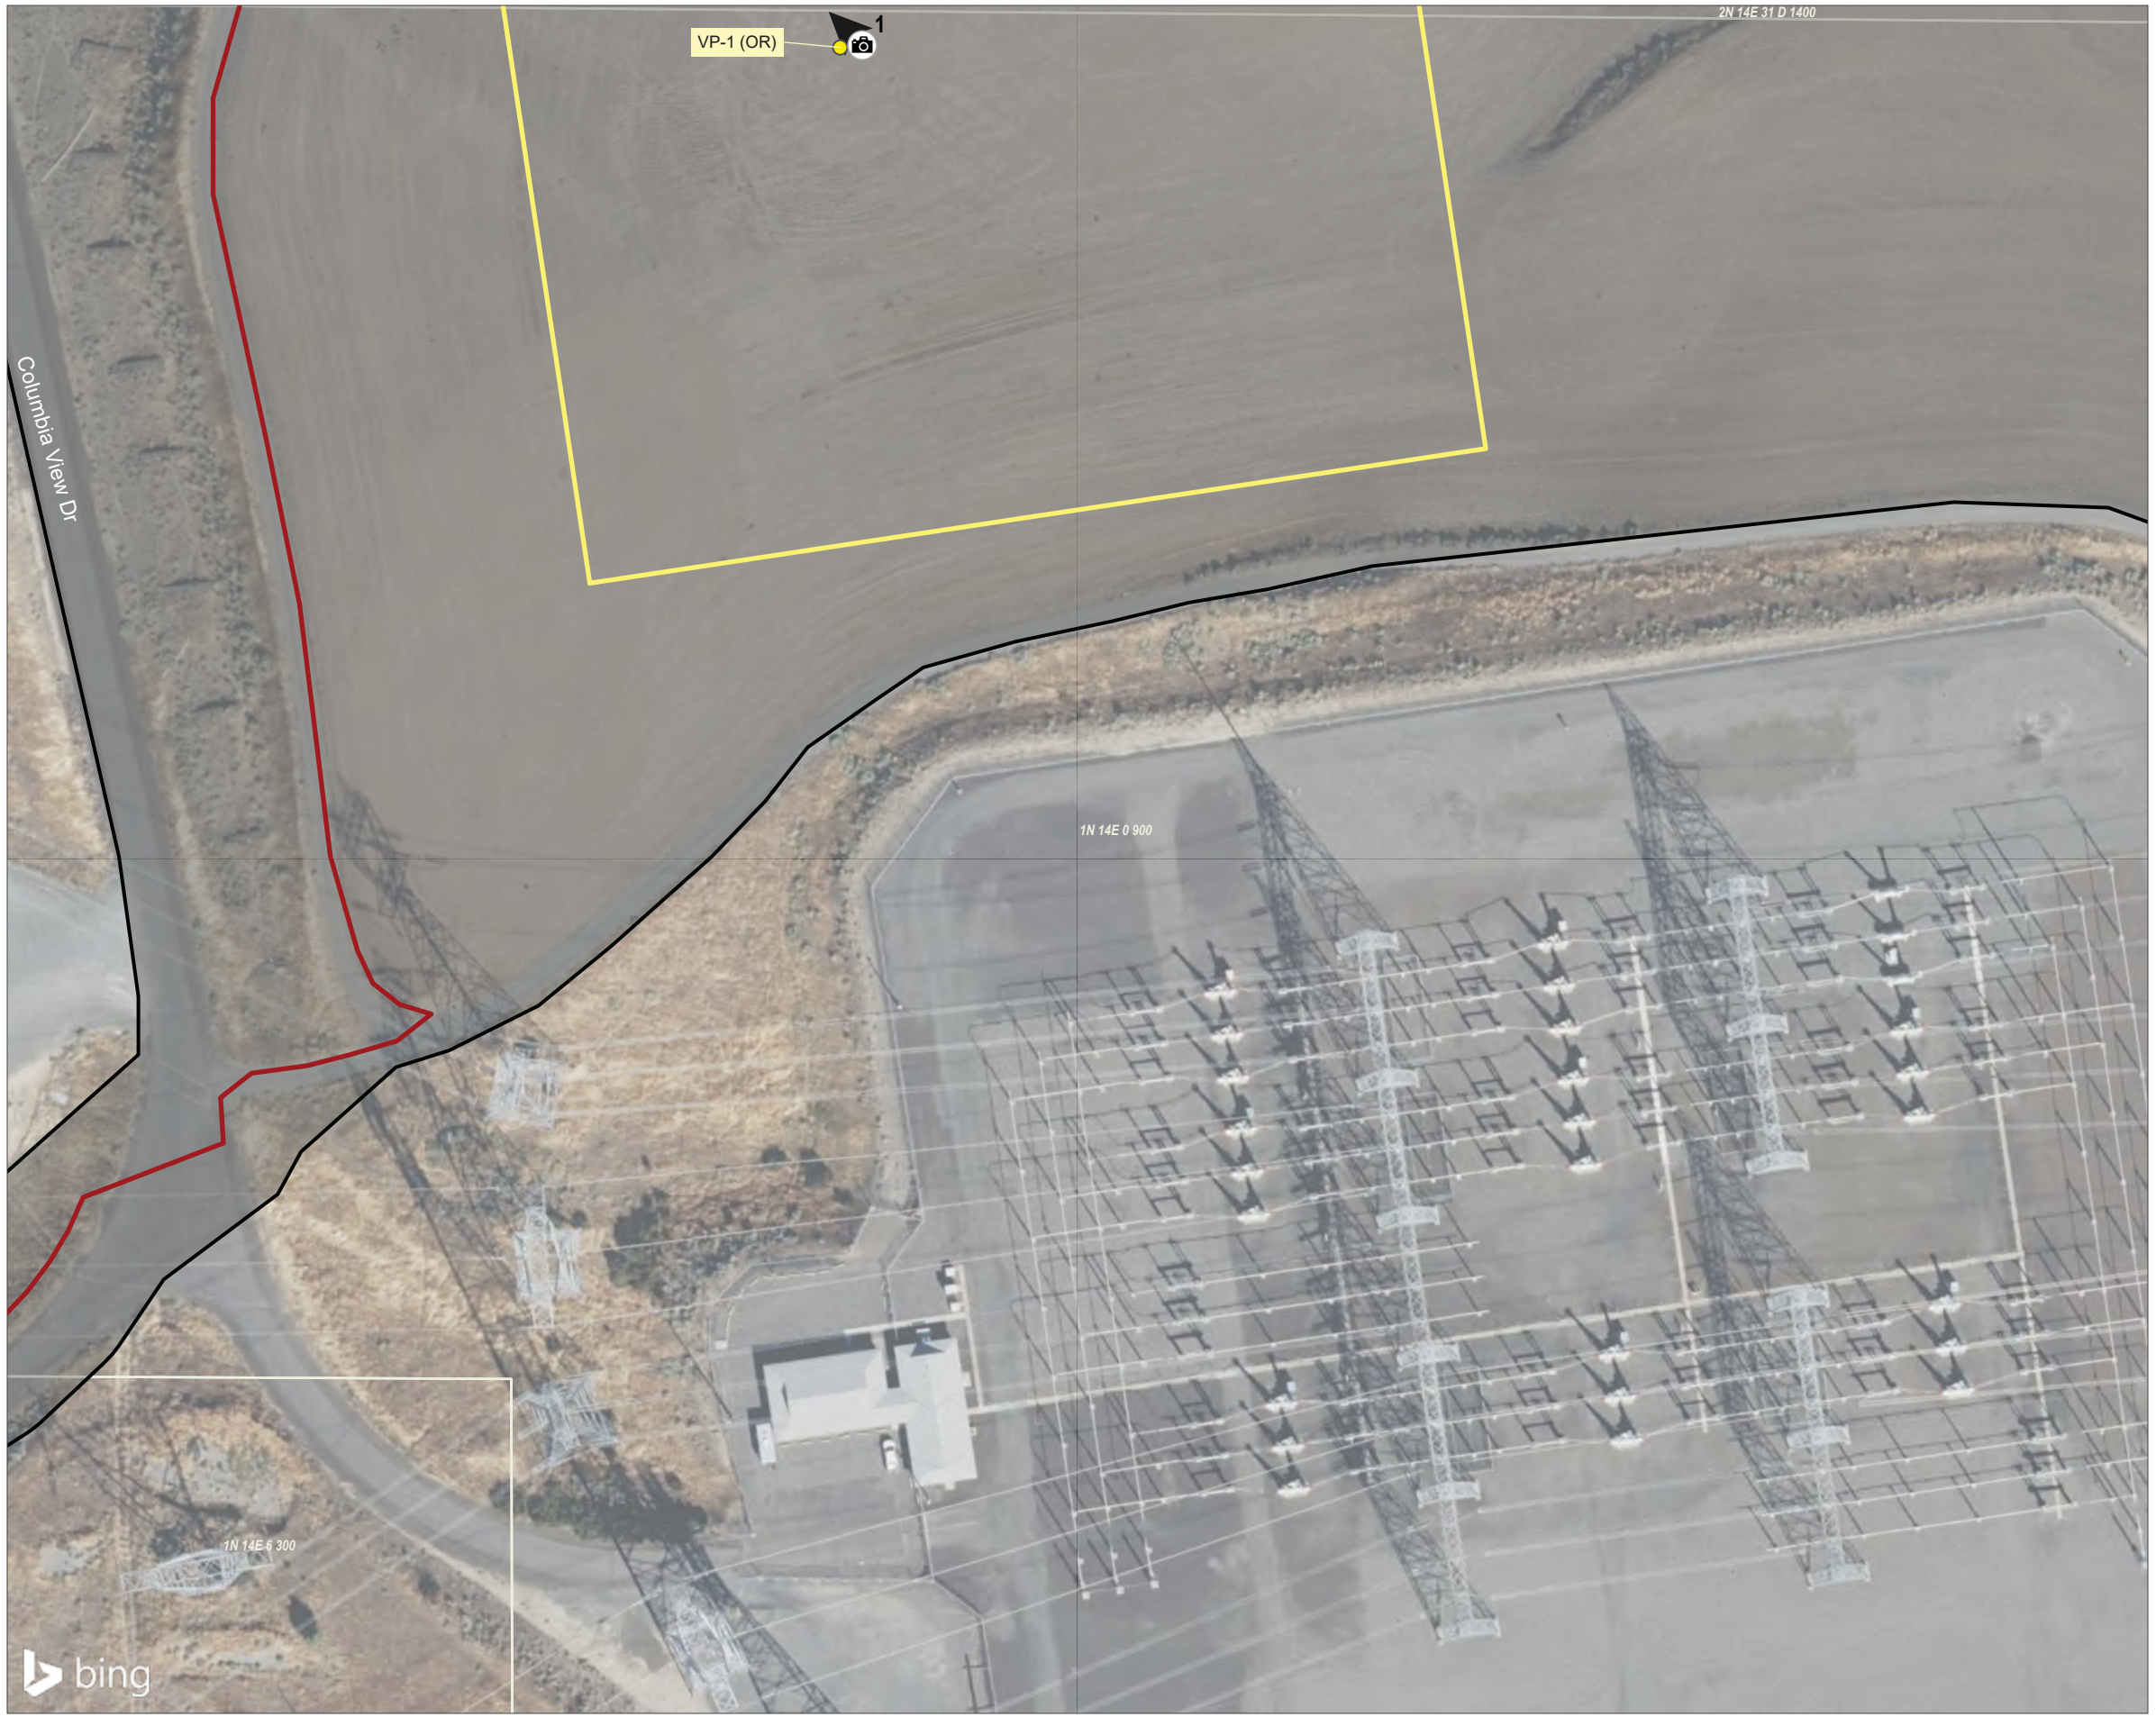
FIGURE 5 WETLAND & WATER SURVEY MAP
PAGE 62 OF 64
DATE: 4/9/2025
TOWNSHIP AND RANGE: T01N/T02N R14E
SECTION: 5, 6, 31, 32
USGS QUAD NAME:
PETERSBURG

- PROPOSED ALIGNMENT
- INSTALLATION VIA TRENCHING
 - EASTERN CONVERTER STATION
 - SAMPLE PLOT
 - PHOTO POINT
 - WETLAND AND WATERS SURVEY AREA
 - TAXLOT

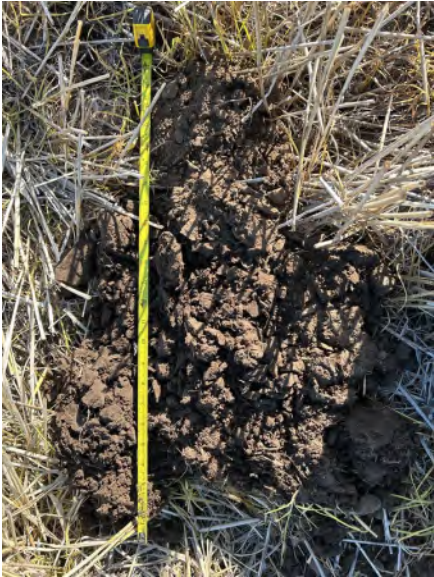
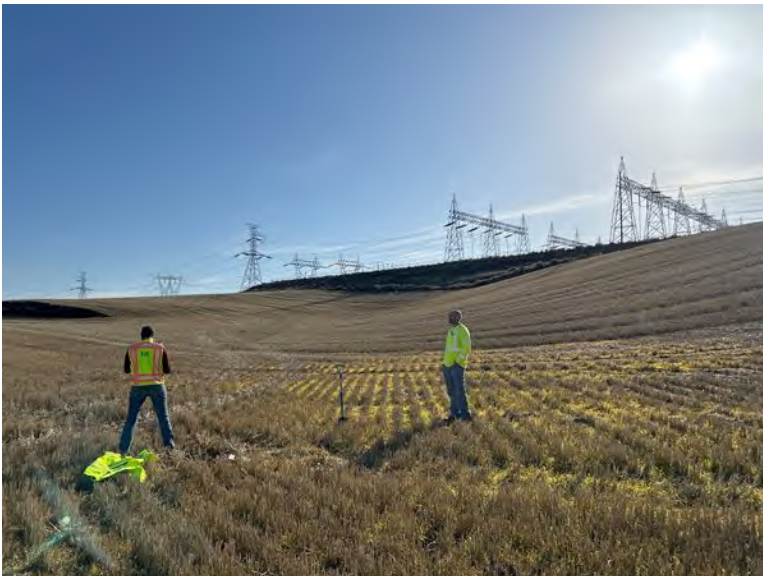
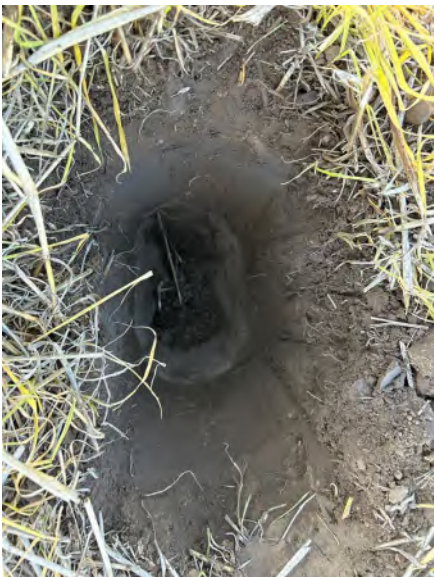
VP-1 (OR)

Remarks:
 Sample plot established at a toe slope on a bluff above the Columbia River in an actively farmed wheat field. Wheat had been harvested at the time of the wetland survey. No wetland indicators observed in the plot.

Depth (inches)	Matrix		Redox Features				Texture	Remarks
	Color (moist)	%	Color (moist)	%	Type ¹	Loc ²		
0-12	7.5YR 3/1	100					Silt Loam	
12-24	10YR 3/2	100					Silt Loam

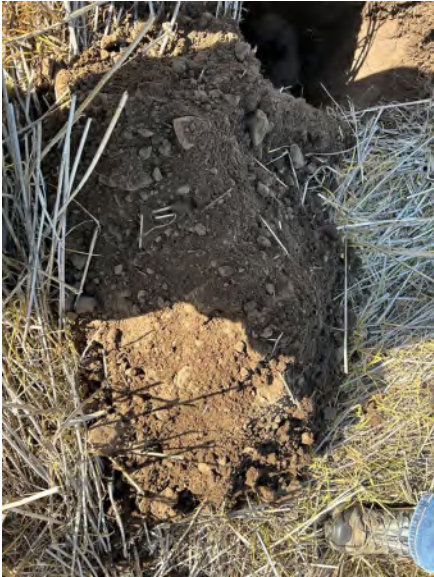
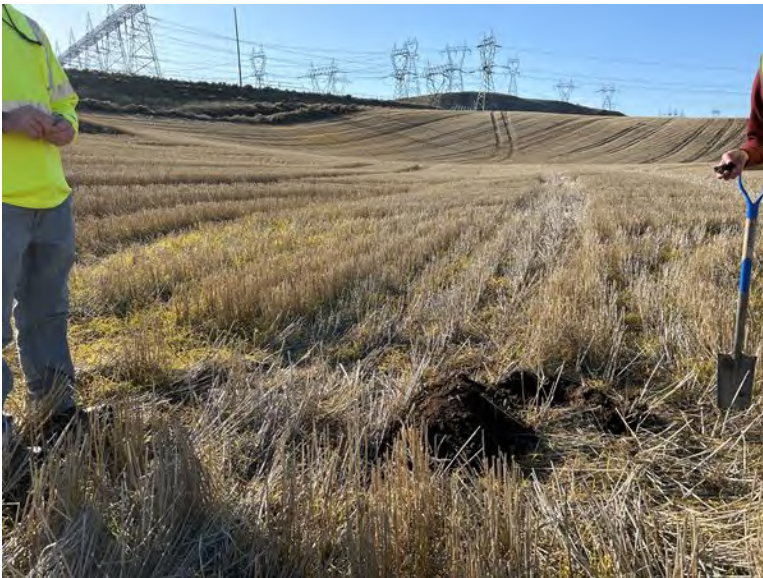
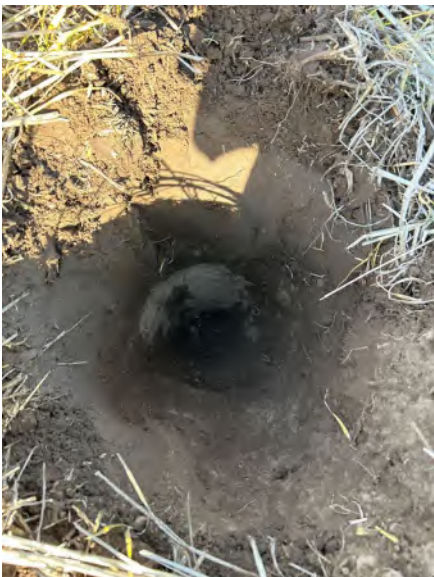
VP-2 (OR)

Remarks:
 Sample plot established at a toe slope on a bluff above the Columbia River in an actively farmed wheat field. Wheat had been harvested at the time of the wetland survey. No wetland indicators observed in the plot.

Depth (inches)	Matrix		Redox Features				Texture	Remarks
	Color (moist)	%	Color (moist)	%	Type ¹	Loc ²		
0-11	7.5YR 3/1	100					Silt Loam	
11-20	10YR 3/2	100

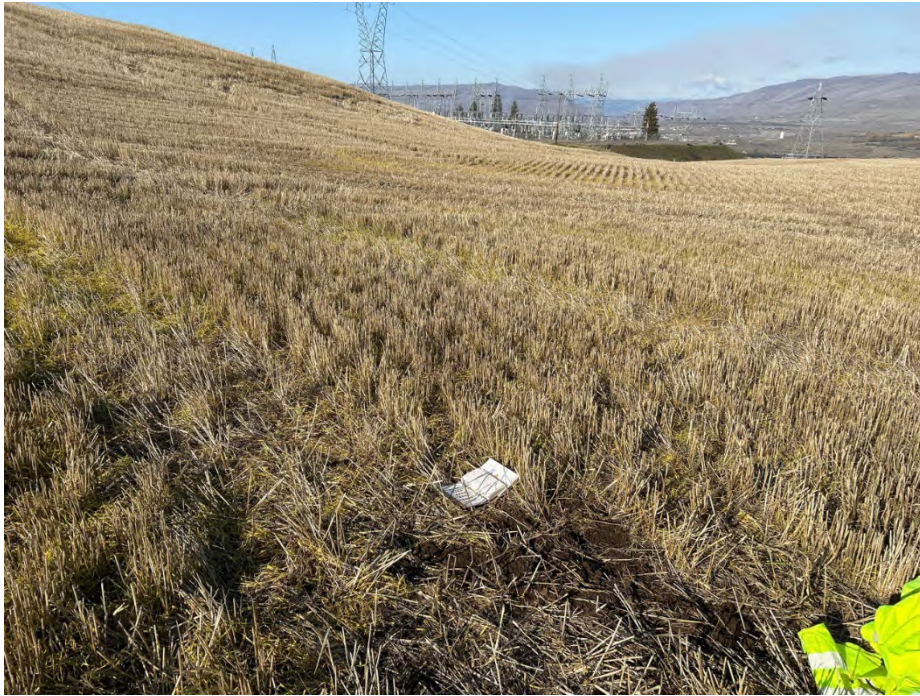
Photo 1	Overview of Verification Plot 1 (VP-1); proposed eastern converter site location in The Dalles, Oregon.
Date: 11/08/23	
Direction: Northwest

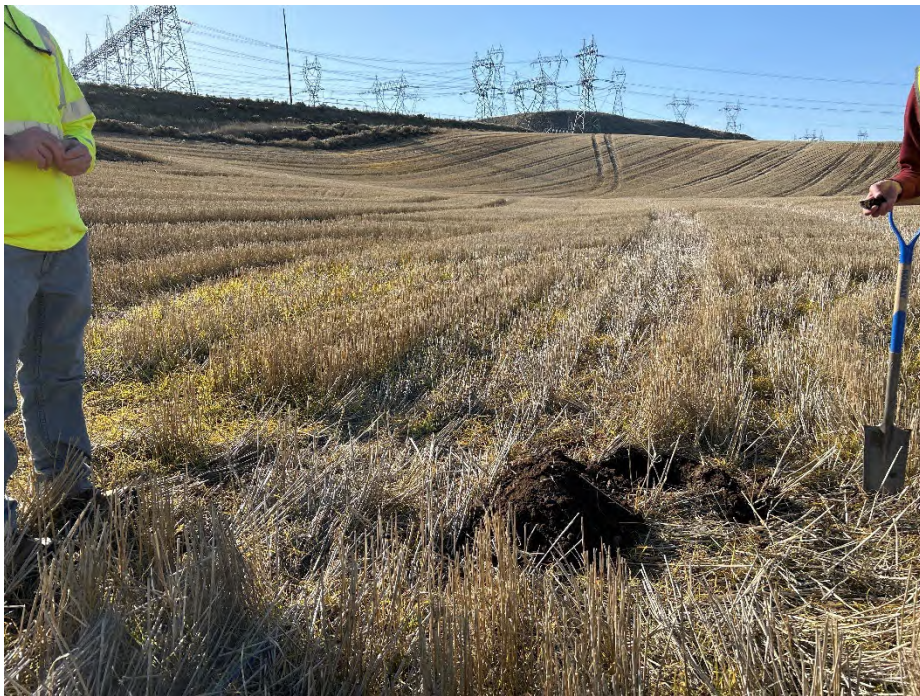
Photo 2	Overview of Verification Plot 2 (VP-2); near proposed eastern converter site location in The Dalles, OR.
Date: 11/08/23	
Direction: West

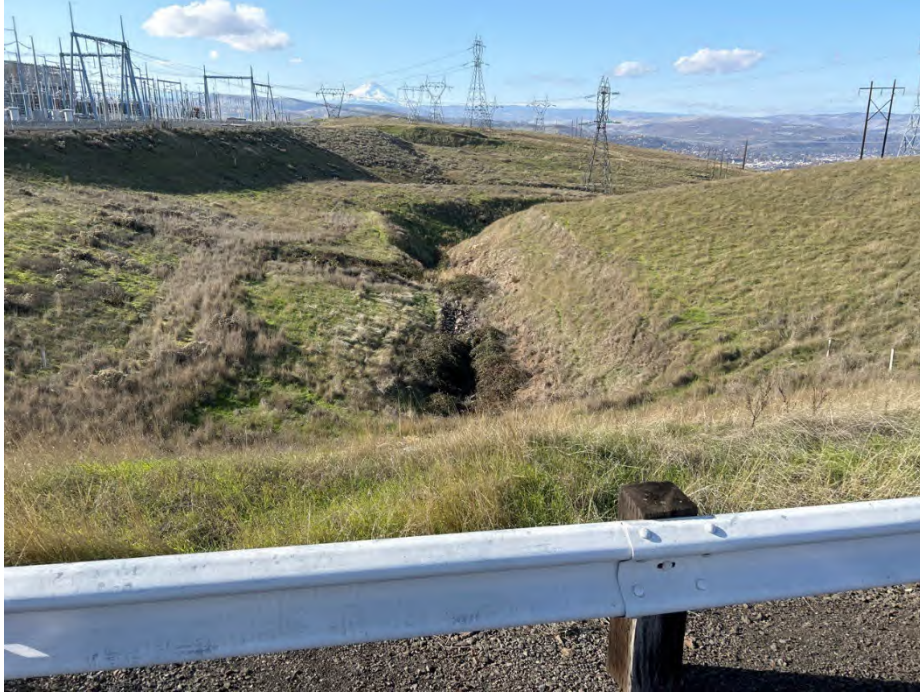
Photo 3a	Looking downstream at an ephemeral drainage (Drainage 1) beneath Columbia View Drive, culvert occurs roughly 75 feet below road grade.
Date: 11/08/23	
Direction: Southwest

See Appendix A, Figure 6, Page 59 for map of drainage. Ground level photographs (Photos 3a and 3b) are found in Appendix C.

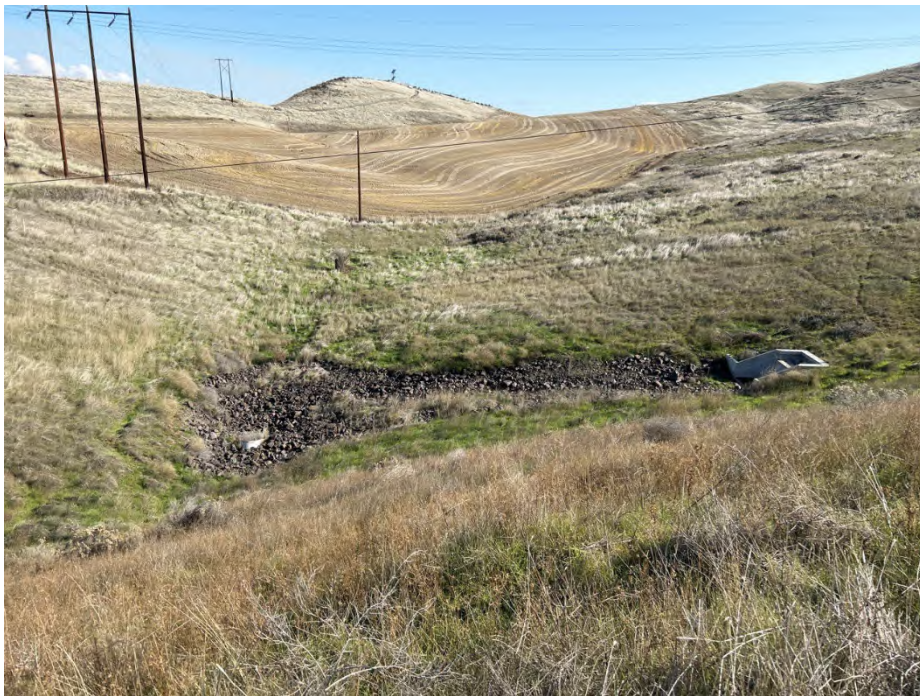
Photo 3b	Looking upstream at an ephemeral drainage (Drainage 1) beneath Columbia View Drive, culvert occurs roughly 75 feet below road grade.
Date: 11/08/23	
Direction: Northeast

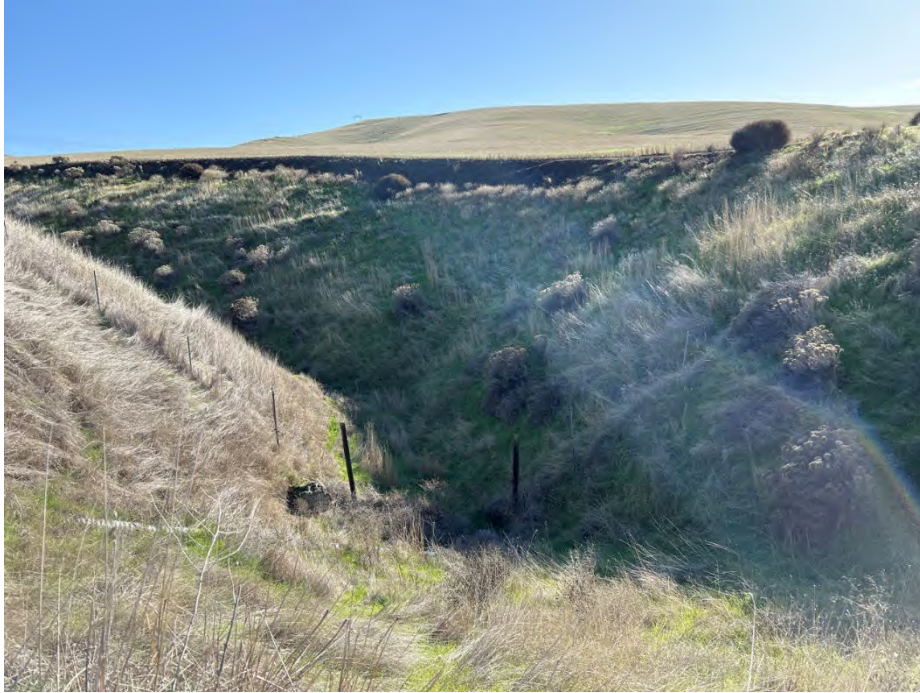
Photo 4a	Looking upstream at an ephemeral drainage (Drainage 2) to Threemile Creek beneath Columbia View Drive; culvert present roughly 30-40 feet below road grade.
Date: 11/08/23	
Direction: East

See Appendix A, Figure 6, Page 54 and 55 for map of drainage. Ground level photographs (Photos 4a. 4b. and 5) are found in Appendix C.

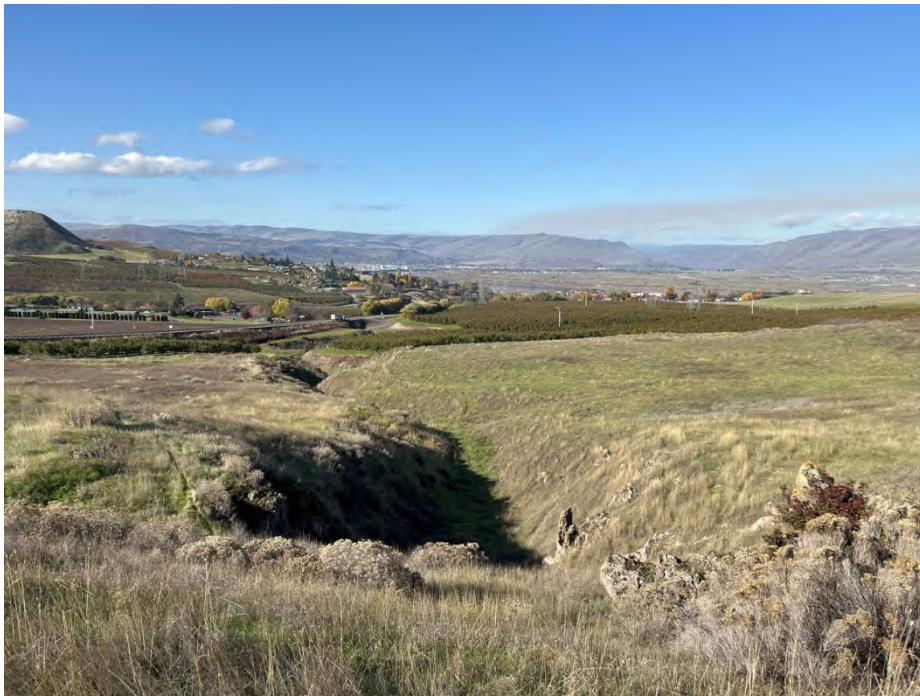
Photo 4b	Looking downstream at an ephemeral drainage (Drainage 2) to Threemile Creek beneath Columbia View Drive; culvert present roughly 30-40 feet below road grade.
Date: 11/08/23	
Direction: Northwest

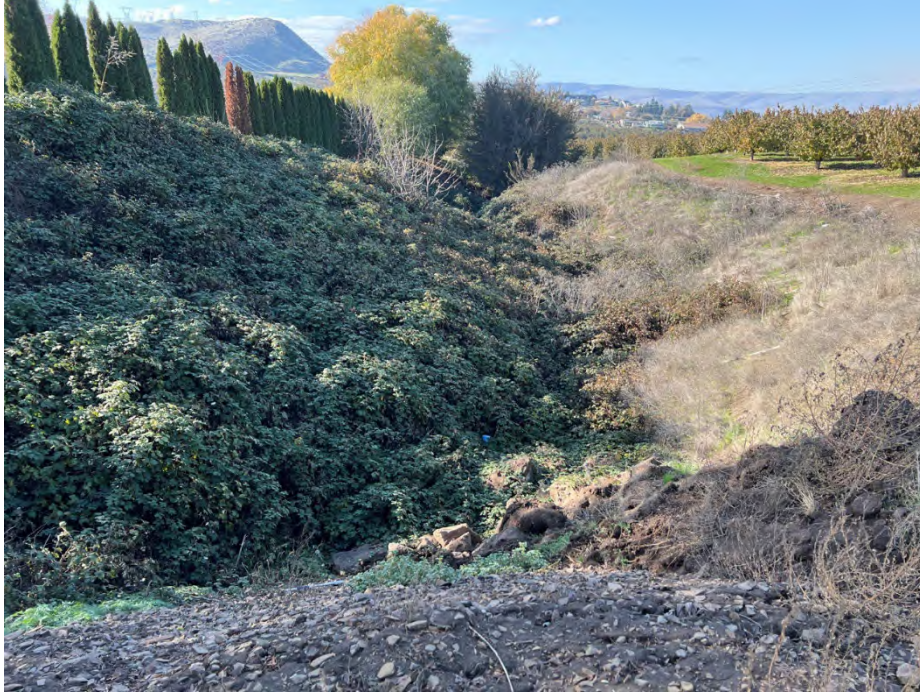
Photo 5	Looking downstream at an ephemeral drainage (Drainage 2) to Threemile Creek located west of OR-197.
Date: 11/08/23	
Direction: West

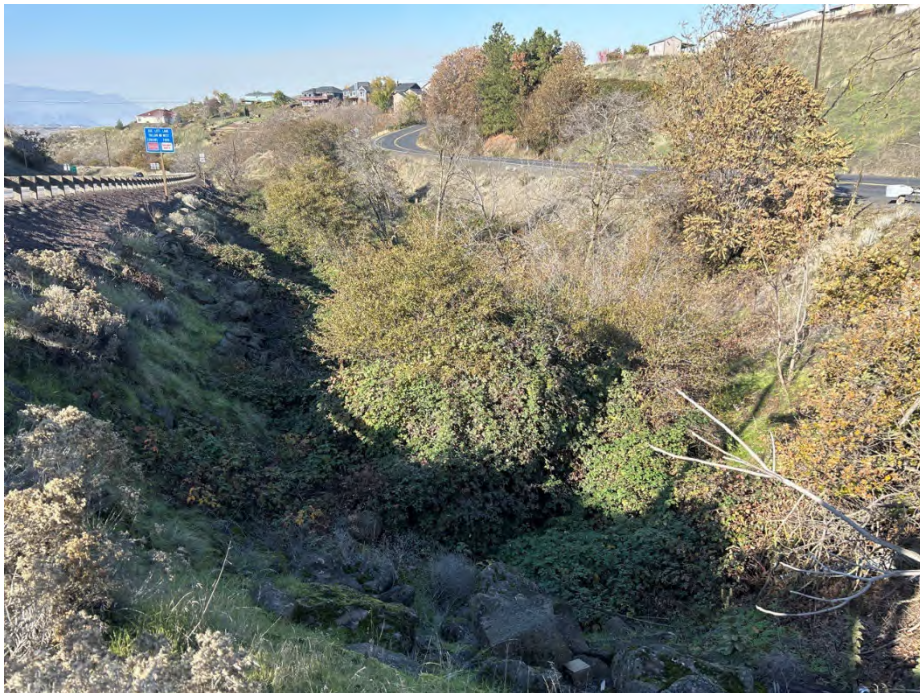
Photo 6	Threemile Creek adjacent to the east of OR-197. Streambed occurs roughly 50 feet below road grade.
Date: 11/08/23	
Direction: Northwest

Threemile Creek is located within the SA at multiple locations along the east end of the project in The Dalles, Oregon (Figure 5, pages 49 through 52, Appendix A; Photos 6 through 8, Appendix C). In the SA, the creek is mapped in the NWI as PSS1C and in the NHD as an intermittent waterbody. Threemile Creek is located in Threemile Creek Watershed (HUC 170701050402; OSU 2025). The creek originates in the foothills of the east side of Mt. Hood and generally flows northeast to its confluence with the Columbia River. The stream gradient within the survey corridor varied between 2 and 10 percent with steeper gradients occurring upslope and adjacent to US 197. The existing riparian area has been truncated by urban development through the majority of the SA and generally consisted of an overstory of Russian olive (*Elaeagnus angustifolia*), Himalayan blackberry, and a varied herbaceous layer. Threemile Creek flows beneath US 197 between HDD Area 17 and 18 (Figure 5, page 52, Appendix A) and south of HDD Area 16 via culvert, and again beneath OR 30 west of HDD Area 14 via culvert (Figure 5, page 50 and 51, Appendix A). In these locations, both US-197 and OR 30 are elevated from the ground surface due to road fill while Threemile Creek flows beneath them. Threemile Creek also flows parallel to the proposed trench location south of I-84 (Figure 5, page 49, Appendix A). In this location, the OHW of Threemile Creek is approximately 100 feet east of the proposed cable location. Threemile Creek has an associated wetland within the SA, Wetland 4, near the northeast portion of the SA. Threemile Creek and Wetland 4 continue off site to the north.

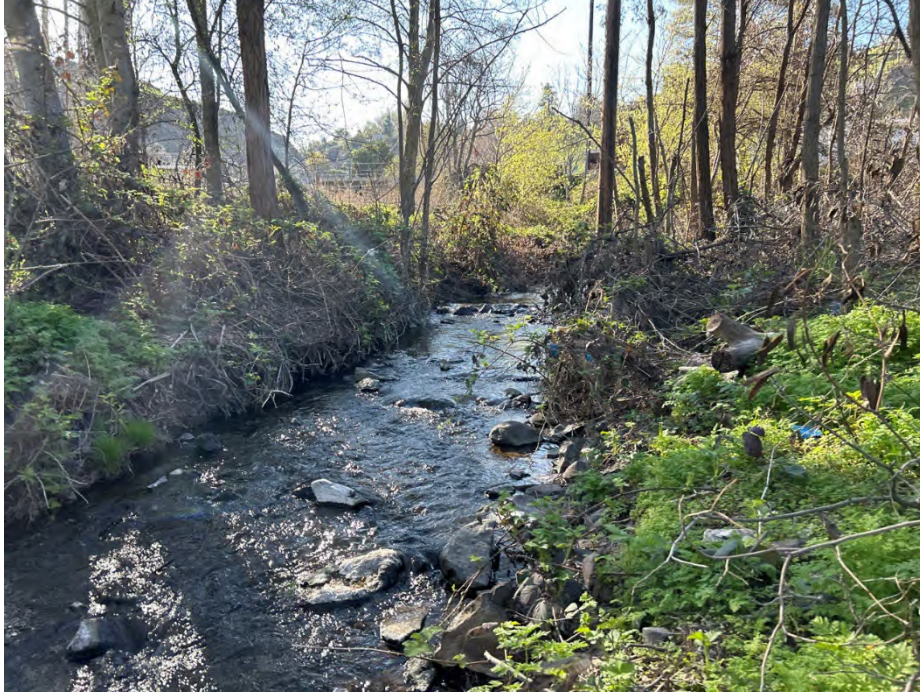
Photo 7	Threemile Creek, looking upstream.
Date: 04/02/24	
Direction: South

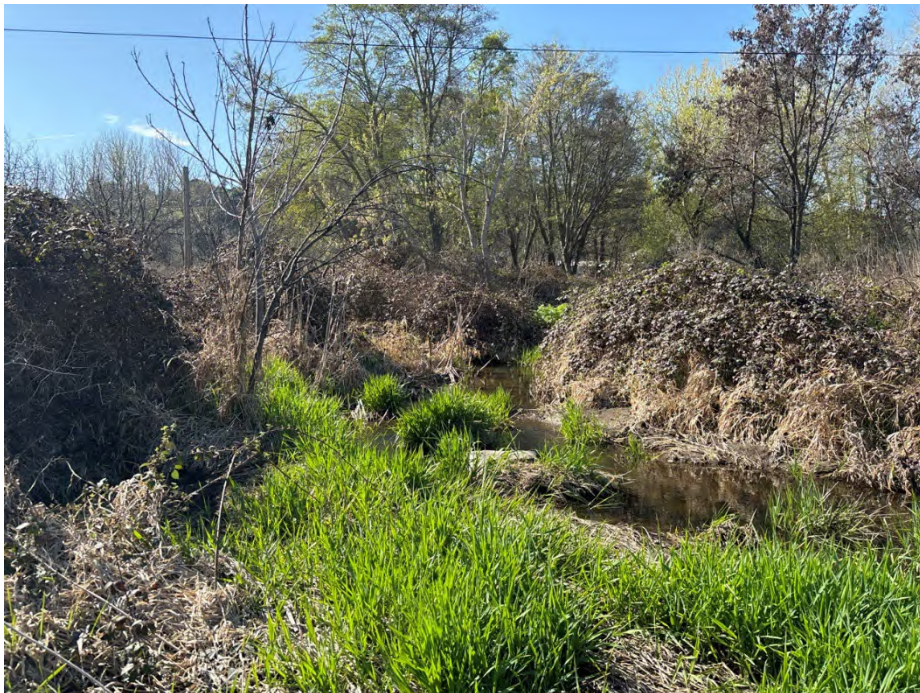
Photo 8	Looking upstream at Threemile Creek and Wetland 4. Mosaic of reed canary grass and broadleaf cattail occur within the ordinary high water mark.
Date: 04/02/24	
Direction: South

Wetland 4 (0.05 acres) is a riverine wetland located within the OHW of Threemile Creek and is within the Threemile Creek watershed (HUC 170701050402; OSU 2025) (Figure 5, pages 49, Appendix A; Photos 8, Appendix C). The wetland is mapped in the NWI as PSS1C. Dominant vegetation includes reed canarygrass and cattail (*Typha latifolia*). Red alder and Himalayan blackberry occur at the edges of the wetland and stream. Vegetation in Wetland 4 was classified in the field as PSS (Cowardin 1979). Wetland hydrology indicators include surface water, high water table, and saturation and are attributed to the wetland proximity to Threemile Creek. Soil pits were not dug for Wetland 4; hydric soils are assumed present.

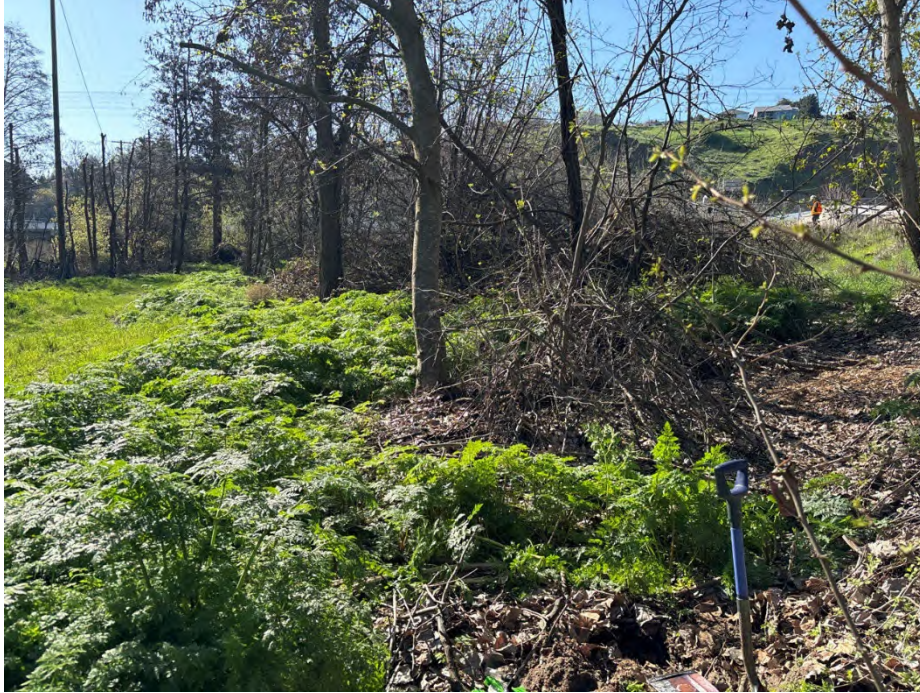
Photo 9	Verification Plot 3 (VP-3); area determined to be upland.
Date: 04/02/24	
Direction: South

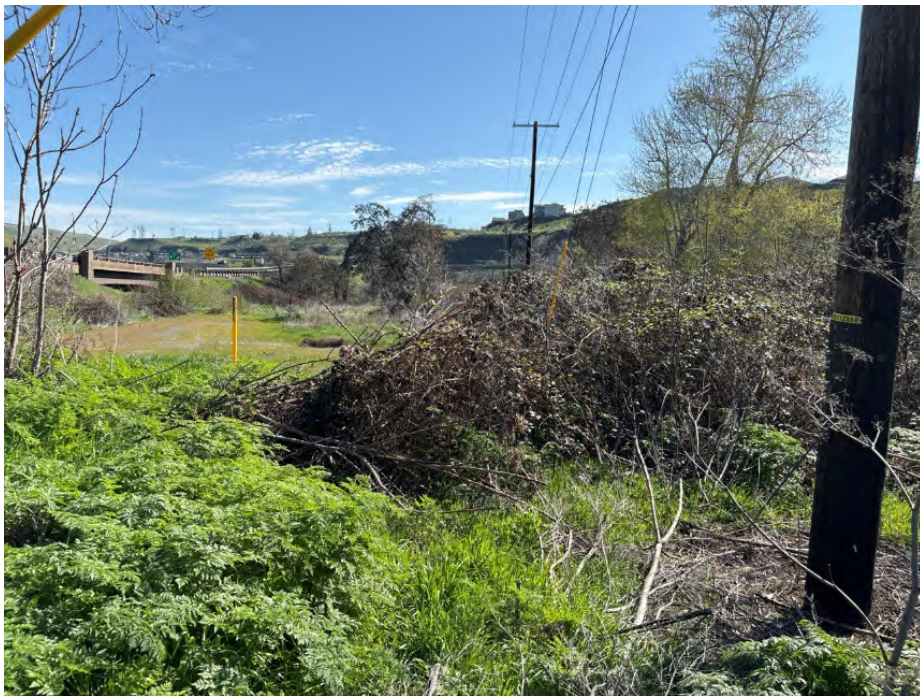
Photo 10	Verification Plot 4 (VP-4); roadside depressional area determined to be upland.
Date: 04/02/24	
Direction: Northwest

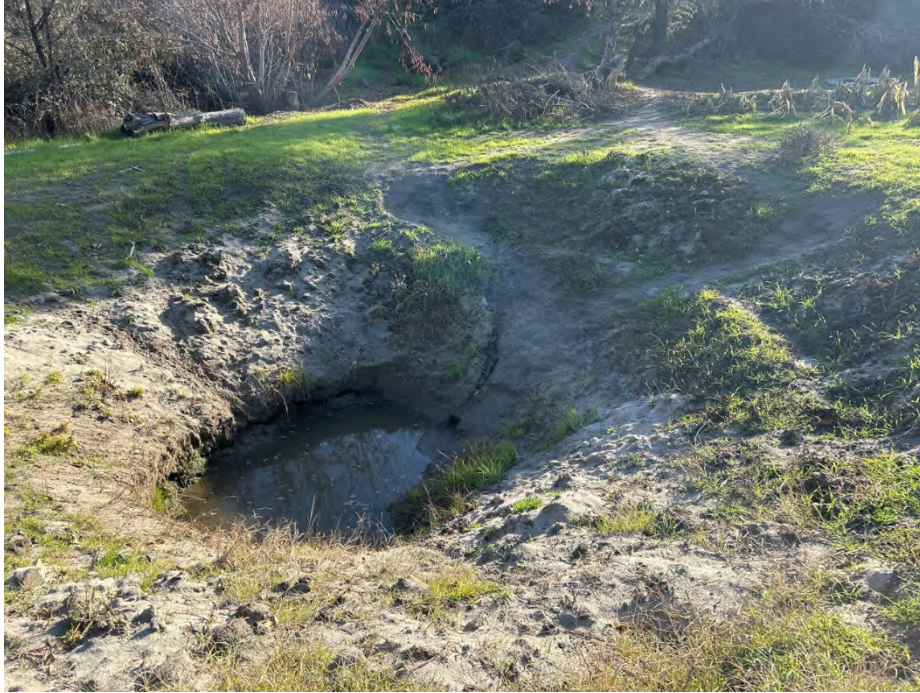
Photo 11	Human-excavated pit (Pit 1) created in uplands.
Date: 11/08/23	
Direction: Southeast

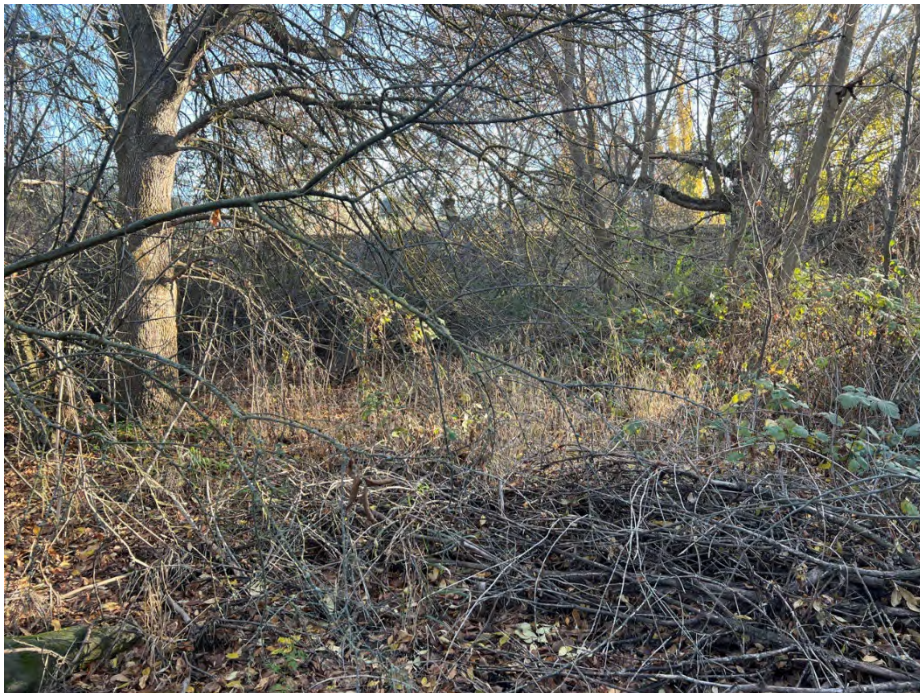
Photo 12a	Verification Plot 5 (VP-5). Depressional area mapped by the NWI; area determined to be upland.
Date: 11/08/23	
Direction: South

The depressional area south of I-84 and north and south of Tie Plant Road near Verification Plot 5 (VP-5) and HDD Area 12 is an NWI-mapped palustrine shrub-scrub/emergent (PSS/EMCh1) wetland (Figure 5, Pages 43 and 44, Appendix A). A few dispersed black cottonwood trees (*Populus balsamifera*) and nootka rose (*Rosa nutkana*) were noted on the west end of the depressional area but did not form a dominant community. Biologists observed that the majority of the depression was filled with large boulders and the vegetation community was dominated by upland species, including tree of heaven (*Ailanthus altissima*), Russian olive (*Elaeagnus angustifolia*), Canada thistle (*Cirsium arvense*), bull thistle (*Cirsium vulgare*), common mullein (*Verbascum thapsus*), blackberry (*Rubus armeniacus*) and upland grasses mainly Bermuda grass (*Cynodon dactylon*), downy brome (*Bromus tectorum*). A pit, roughly 15 feet x 10 feet was noted within HDD Area 12 (Photo 11, Appendix C). Surface water was observed approximately 4 feet below ground level, no inlet or outlet was present, hydrology is likely from a high-water table. Vegetation surrounding the pit was mostly absent except for dispersed patches of Bermuda grass and an unidentified *Poa* species. Lands within the HDD Area 12 footprint were comprised mostly of bare sandy ground with dispersed occurrences of upland grasses with blackberry, Russian olive and tree of heaven occurrences at the boundaries. Verification Plot 5 (VP-5) was established just west of this area, in the lowest point of the depression where minor change in vegetation occurs. The verification plot is located near a culvert from beneath I-84 to the north; no signs of flow were observed during the field investigation. Based on desktop and field investigations, this area was determined to be upland.

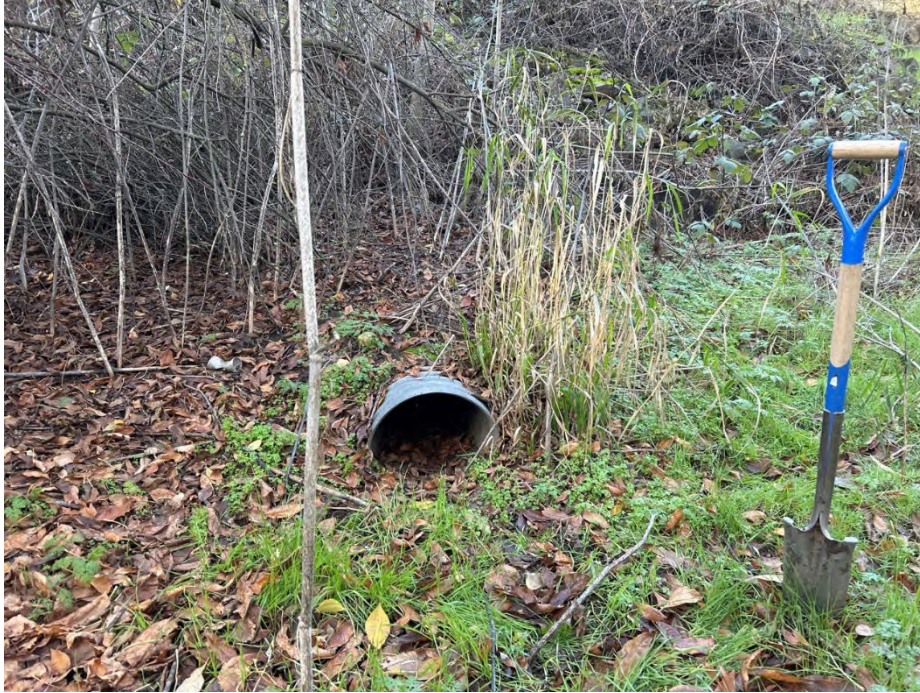
Photo 12b	Culvert placed beneath adjacent road grade, no signs of recent flow.
Date: 11/08/23	
Direction: North

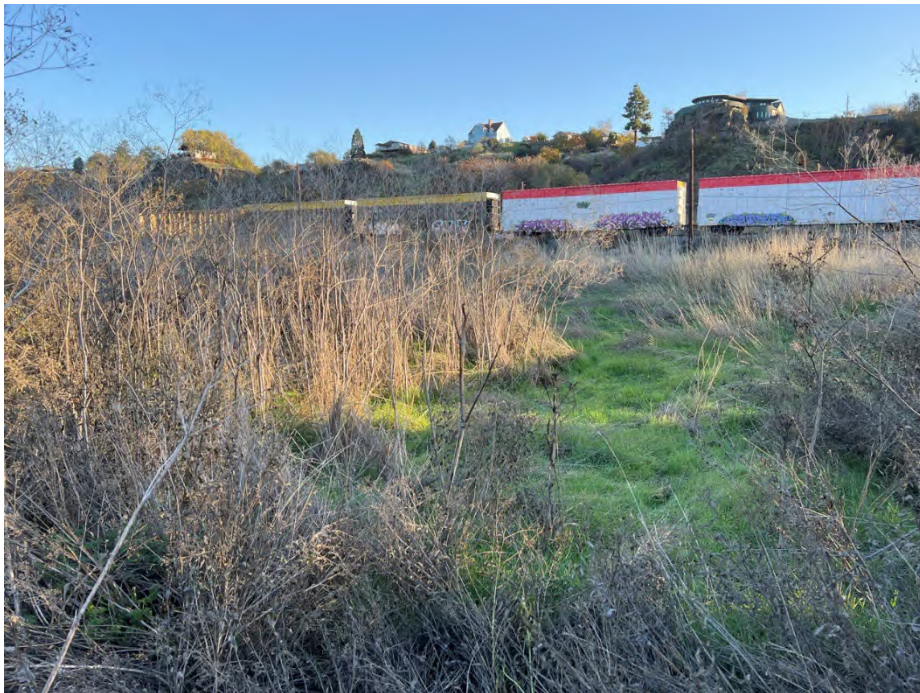
Photo 13	Verification Plot 6 (VP-6); depressional area determined to be upland.
Date: 11/08/23	
Direction: Southeast

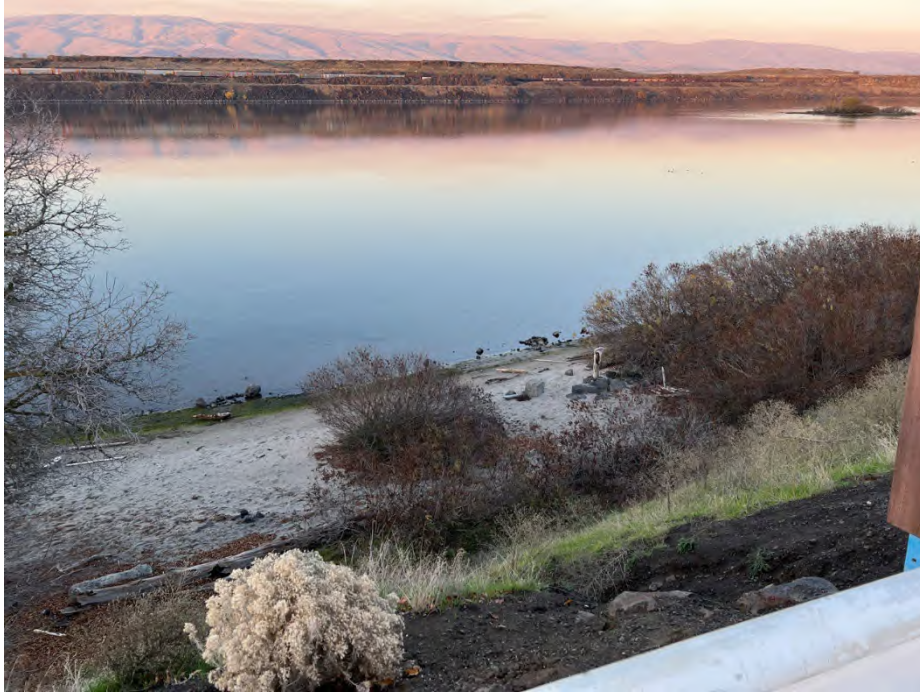
Photo 14	Overview of Columbia River shoreline within survey area in The Dalles.
Date: 11/08/23	
Direction: Northeast

The Columbia River is located within the east and west ends of the SAs and is located in the Lower - and Middle Columbia River Basins (HUC 170800 and 170701; OSU 2025) (Figure 5, pages 27, 28, 36, 37, 41, and 42, Appendix A; Photos 14, 27 and 28, Appendix C). The Columbia River is mapped in the NWI and NHD as a traditional navigable water (TNW). The Columbia River and its tributaries form the fourth largest river basin in North America, originating at Columbia Lake in British Columbia. The Columbia River is buffered by riparian habitat on both the east and west end as it flows through the project area, and is generally characterized as contiguous intact riparian vegetation, as described in the SFAM report. The proposed line will enter the Columbia River outside of the OHW at project HDD Area 12 and be installed via HDD to Cofferdam 4 within the OHW (Figure 5, page 42 and 43, Appendix A). From Cofferdam 4, the line will be installed via hydroplow within the OHW of the Columbia River as it is placed moving west up to a cofferdam located outside Hayden Island. The line will be drilled beneath the OHW to HDD Area 08 on Hayden Island (Figure 5, page 41, Appendix A). From HDD Area 08, the cable will be placed along Hayden Island via trench and be drilled beneath the Columbia River via HDD between the two HDD Areas 06 and 07, both of which are located outside the OHW (Figure 5, pages 36 and 37, Appendix A). All HDD areas and above ground trenching are located outside the OHW of the Columbia River and are placed in previously cleared areas with minimal to no riparian vegetation. The SFAM report was developed for in-water work in the Columbia River and will be submitted separately.
